**Subject:** Revised Condition Survey Report of Consultancy Services for Preparation of Detailed Project Report (DPR) for the work of Renovation/Modernization of Existing Navigation Lock at Farakka.

## CONSULTANCY SERVICES FOR PREPARATION OF DETAILED PROJECT REPORT (DPR) FOR THE WORK OF RENOVATION/MODERNIZATION OF EXISTING NAVIGATION LOCK AT FARAKKA

## Condition Survey Report

August 2022

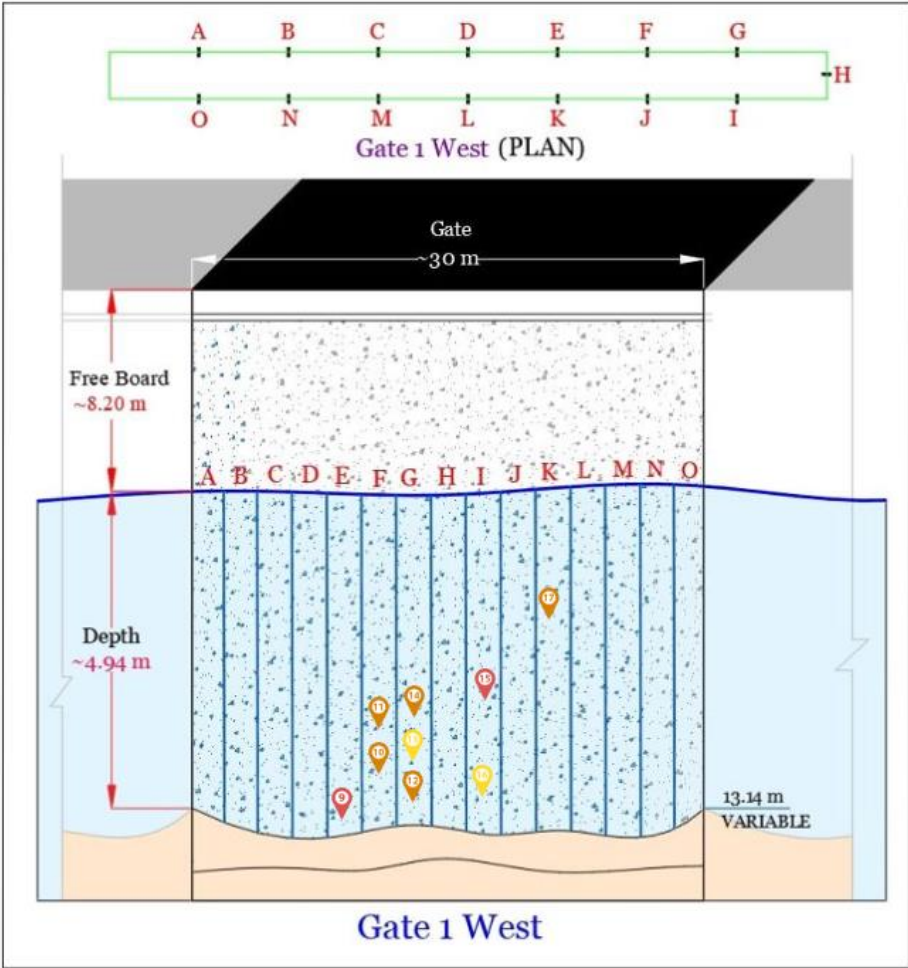
4.2.2 Heatmap of observations at Gate1 West

Figure 8: Heat map and Observations at Gate1 West

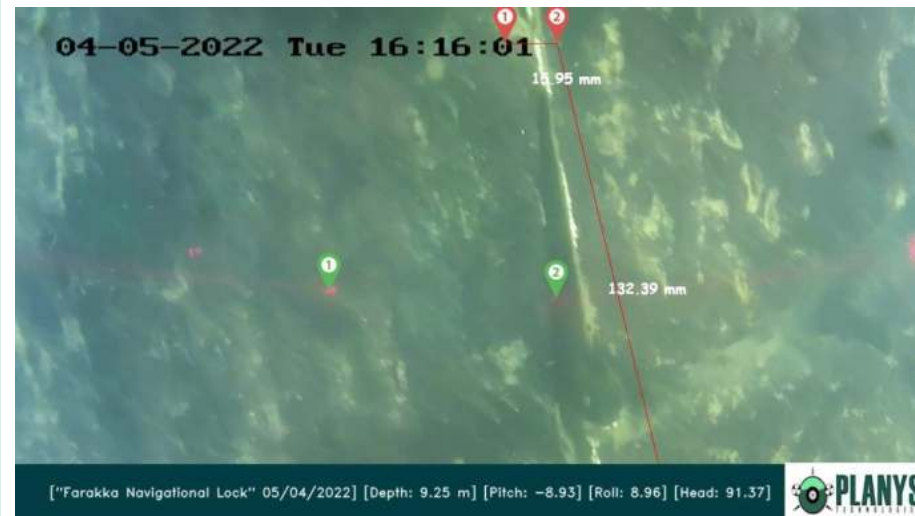
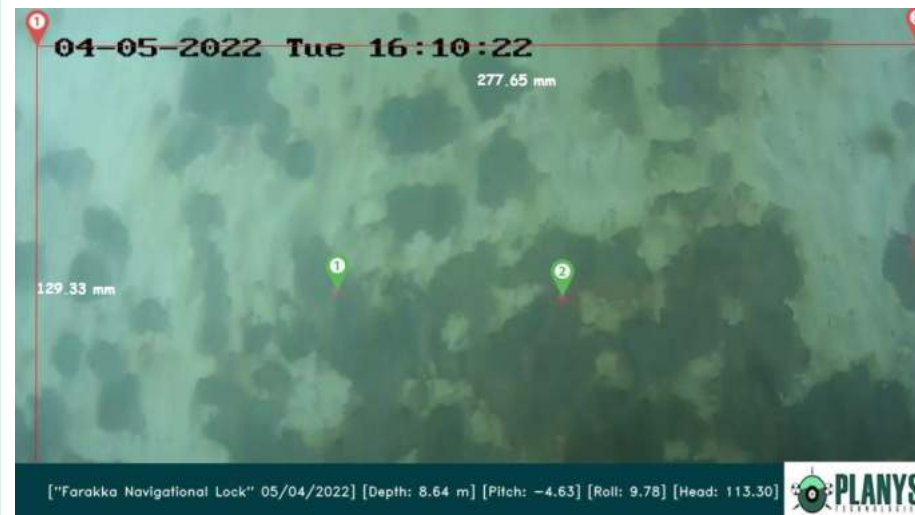
<p><b>O14</b></p>	<p>Cavity/Moderate</p>	<p>Gate 1 West H &amp; 9.25</p>	<p>132.39 X 15.39</p>
<p><b>O15</b></p>	<p>Corrosion/Major</p>	<p>Gate 1 West I &amp; 8.64</p>	<p>277.65 X 129.33</p>

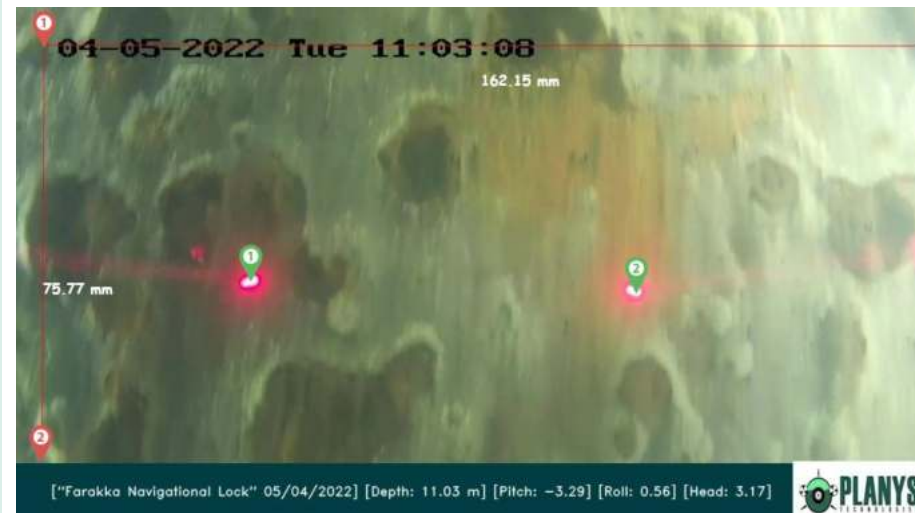
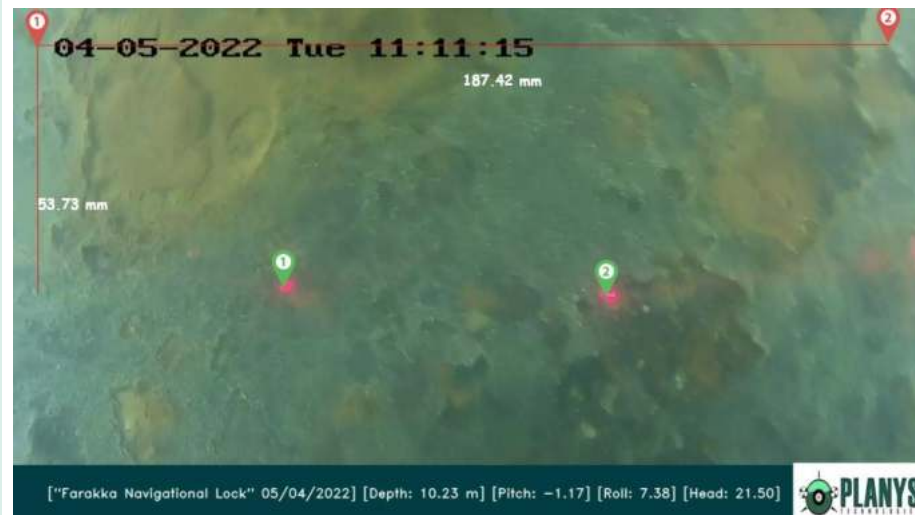
<p><b>O19</b></p>	<p>Corrosion/Major</p>	<p>Gate 2 East D &amp; 11.03</p>	<p>162.15 X 75.77</p>
<p><b>O20</b></p>	<p>Surface Deformation/Moderate</p>	<p>Gate 2 East G &amp; 10.23</p>	<p>187.42 X 53.73</p>

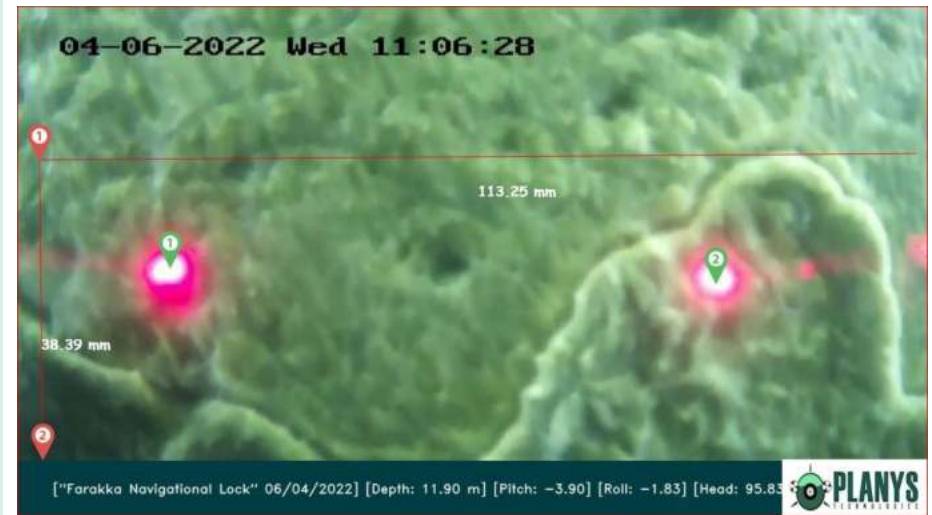
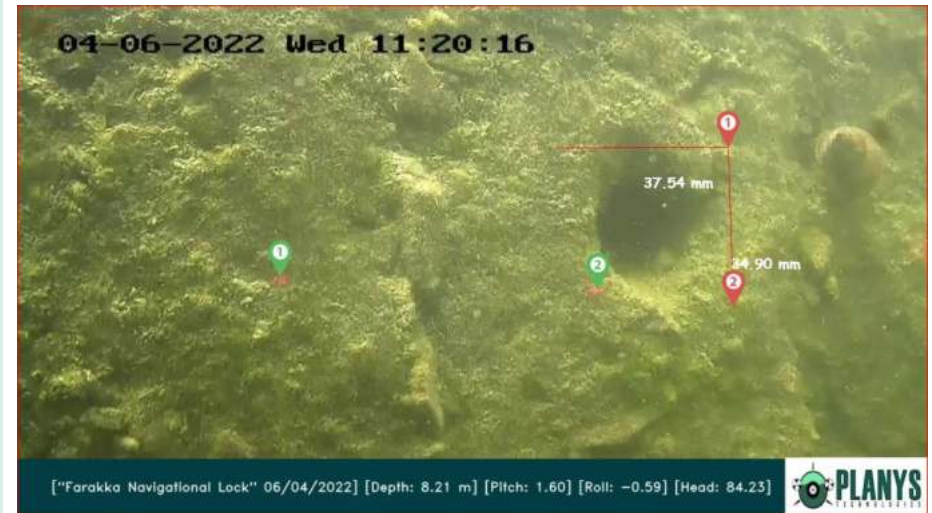
<p><b>O30</b></p>	<p>Surface Deformation/Moderate</p>	<p>Wall West 1 &amp; 11.90</p>	<p>113.25 X 38.39</p>
<p><b>O31</b></p>	<p>Cavity/Minor</p>	<p>Wall West 2 &amp; 8.21</p>	<p>37.54 X 34.90</p>

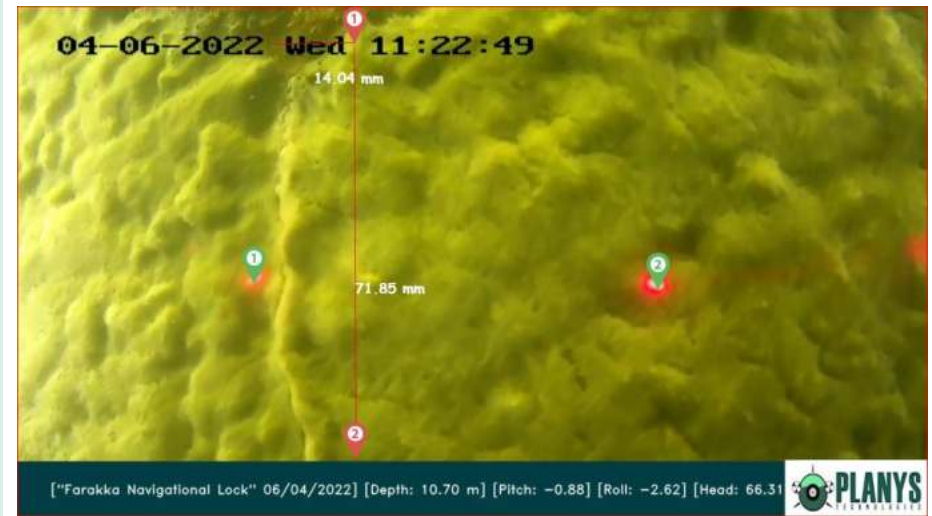
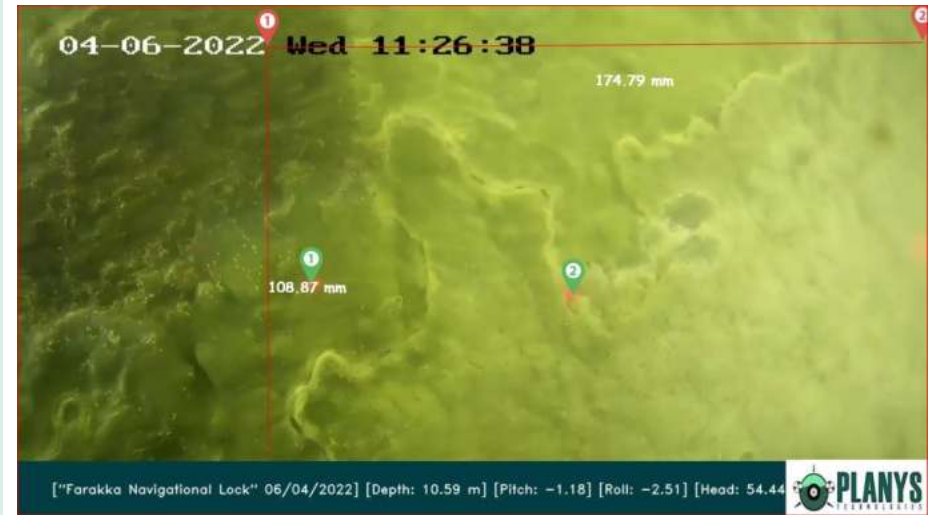
<p>O34</p>	<p>Surface Deformation/Minor</p>	<p>Wall West 2 &amp; 10.70</p>	<p>71.85 X 14.04</p>
<p>O35</p>	<p>Pin Holes/Minor</p>	<p>Wall West 3 &amp; 10.59</p>	<p>174.79 X 108.87</p>

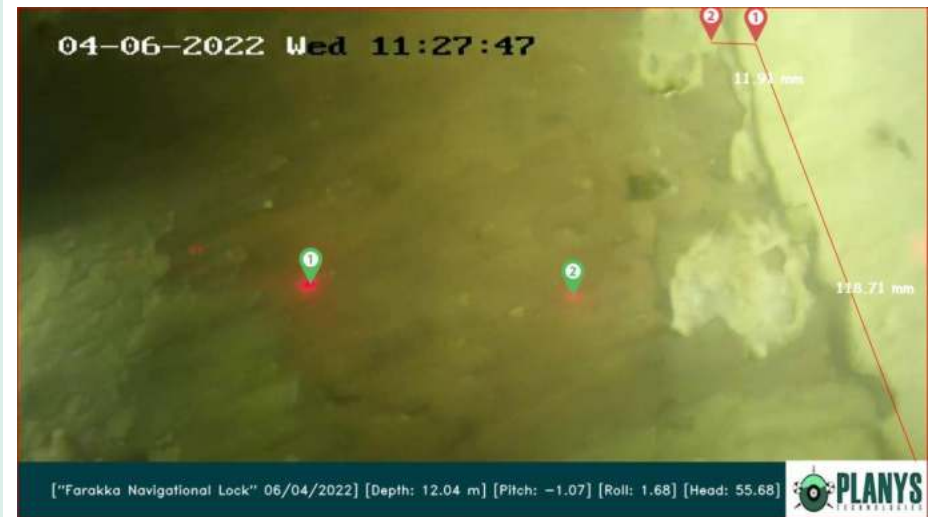
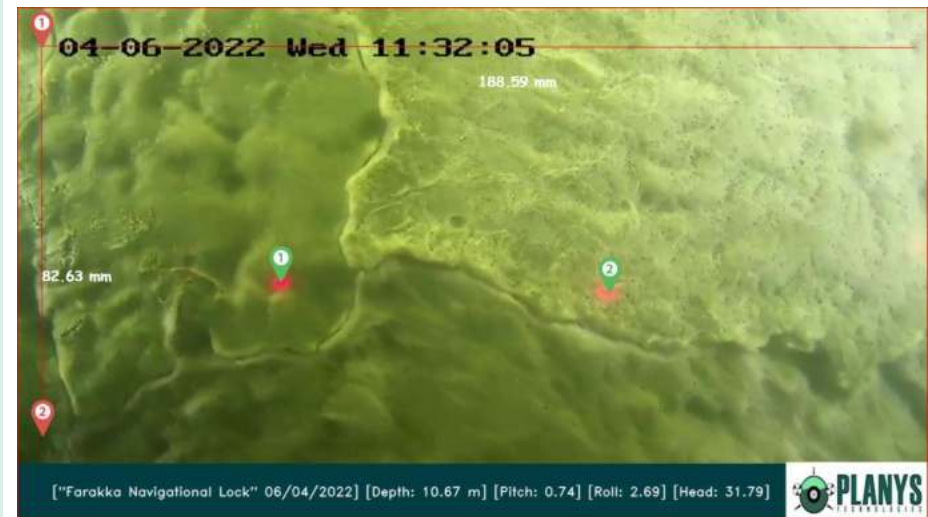
<p><b>O36</b></p>	<p>Crack/Moderate</p>	<p>Wall West 3 &amp; 12.04</p>	<p>118.71 X 11.91</p>
<p><b>O37</b></p>	<p>Crack/Moderate</p>	<p>Wall West 4 &amp; 10.67</p>	<p>118.59 X 82.63</p>

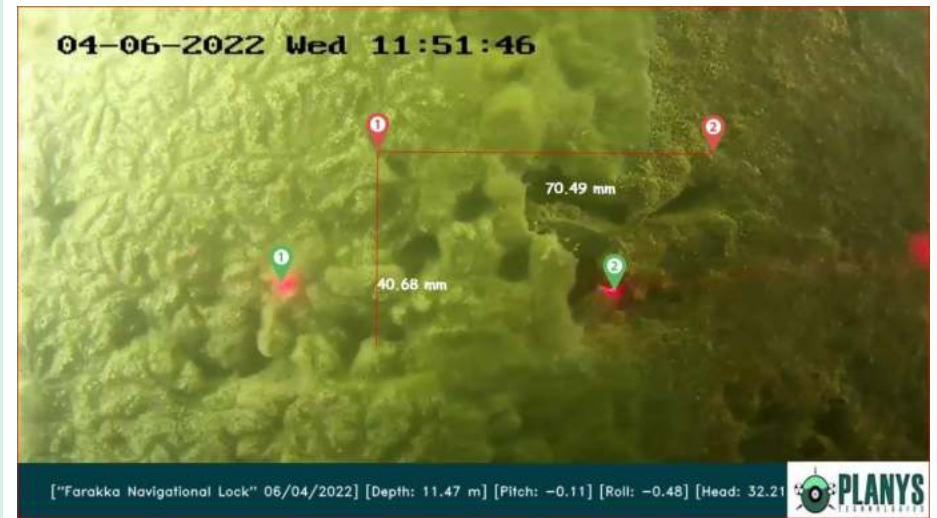
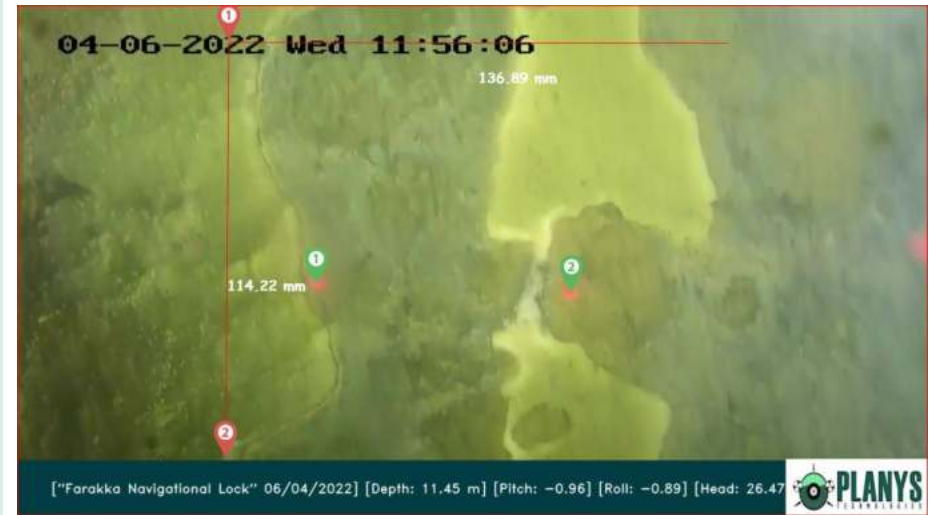
<p><b>O40</b></p>	<p>Cavity/Moderate</p>	<p>Wall West 9 &amp; 11.47</p>	<p>70.49 X 40.68</p>
<p><b>O41</b></p>	<p>Crack/Moderate</p>	<p>Wall West 10 &amp; 11.45</p>	<p>136.89 X 114.22</p>

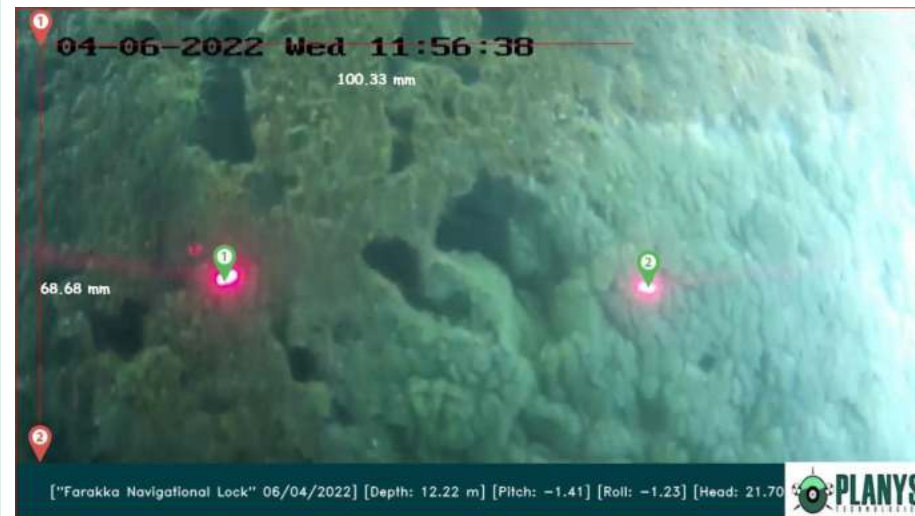
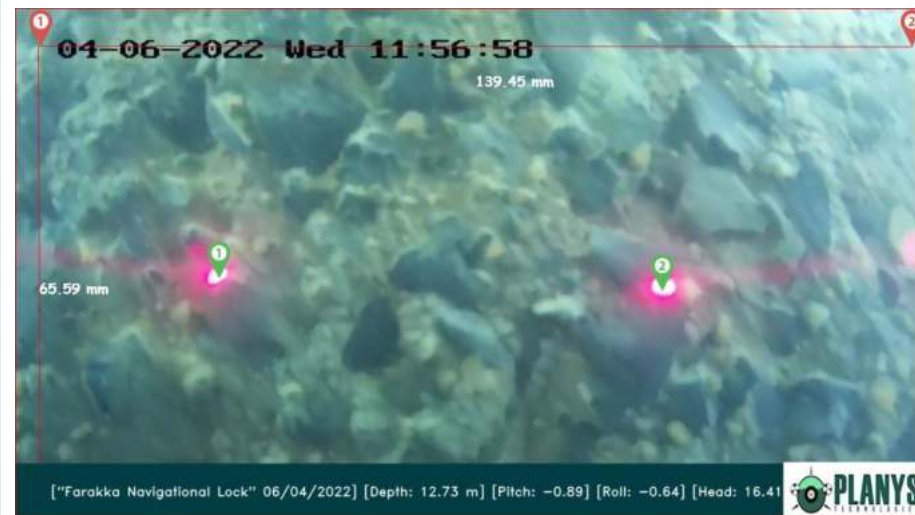
<p><b>O42</b></p>	<p>Cavity/Moderate</p>	<p>Wall West 10 &amp; 12.22</p>	<p>100.33 X 68.68</p>
<p><b>O43</b></p>	<p>Honeycomb Formation/Moderate</p>	<p>Wall West 10 &amp; 12.73</p>	<p>139.45 X 65.59</p>

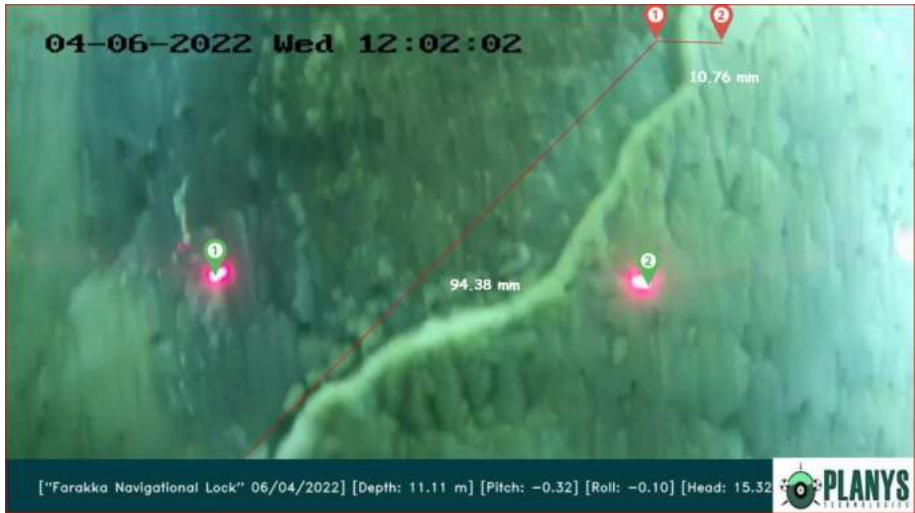
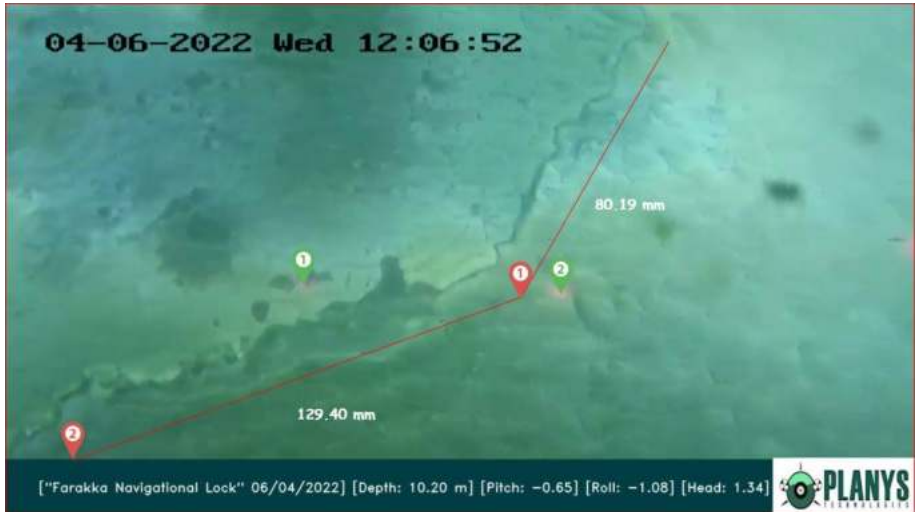
<p>O44</p>	<p>Crack/Moderate</p>	<p>Wall West 11 &amp; 11.11</p>	<p>94.38 X 10.76</p>
<p>O45</p>	<p>Crack/Moderate</p>	<p>Wall West 12 &amp; 10.20</p>	<p>129.40 X 80.19</p>

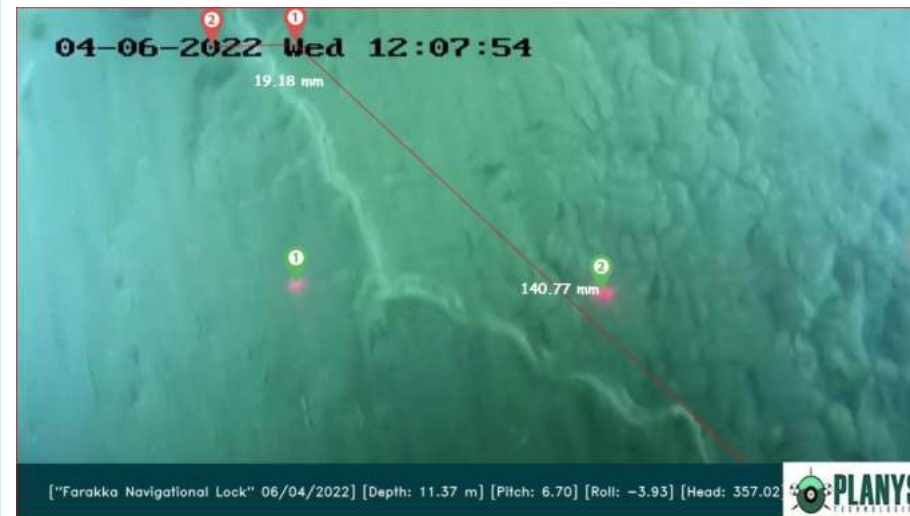
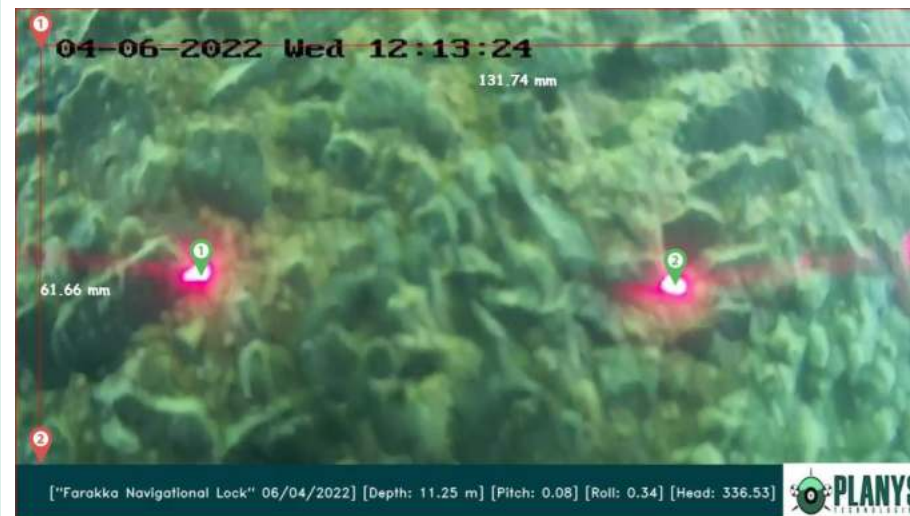
<p><b>O46</b></p>	<p>Crack/Moderate</p>	<p>Wall West 12 &amp; 11.37</p>	<p>140.77 X 19.18</p>
<p><b>O47</b></p>	<p>Honeycomb Formation/Moderate</p>	<p>Wall West 13 &amp; 11.25</p>	<p>131.74 X 61.66</p>

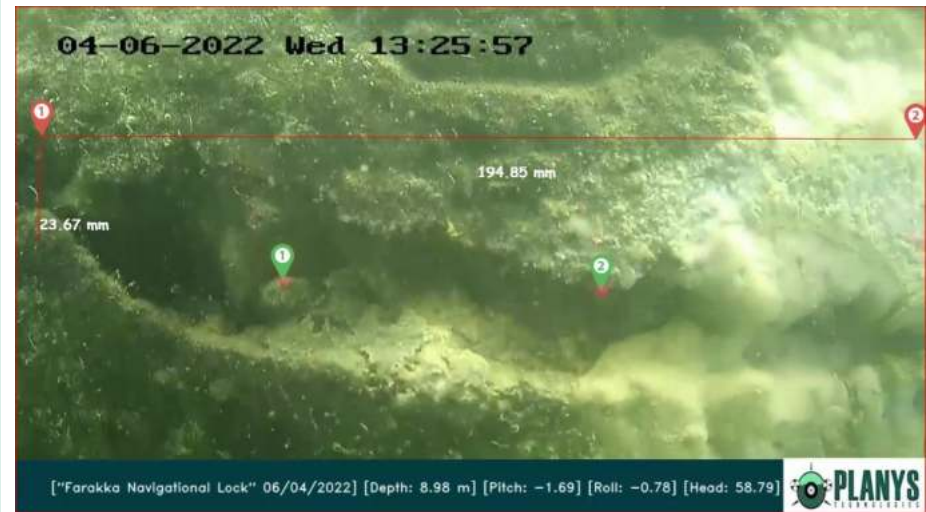
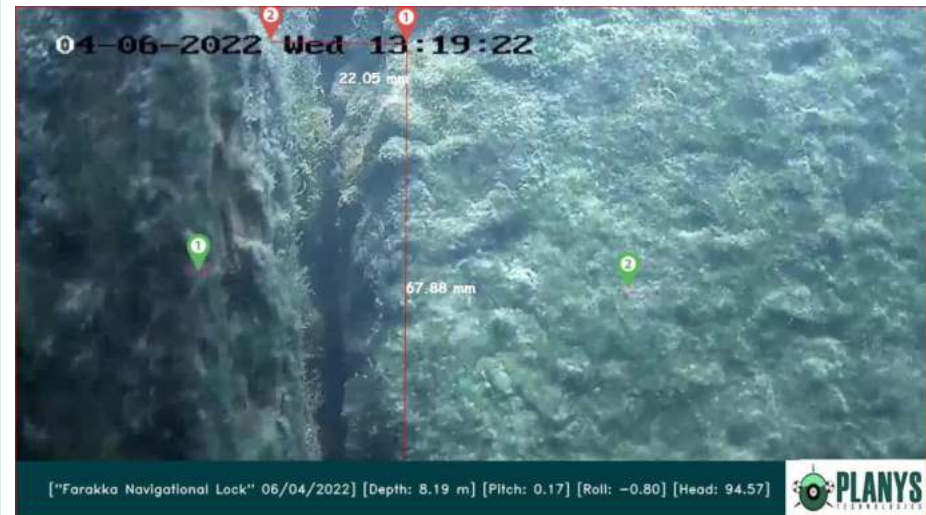
<p><b>O50</b></p>	<p>Cavity/Major</p>	<p>Wall East 3 &amp; 8.98</p>	<p>194.85 X 23.67</p>
<p><b>O51</b></p>	<p>Debonding Between Two Layers/Minor</p>	<p>Wall East 5 &amp; 8.19</p>	<p>67.88 X 22.05</p>

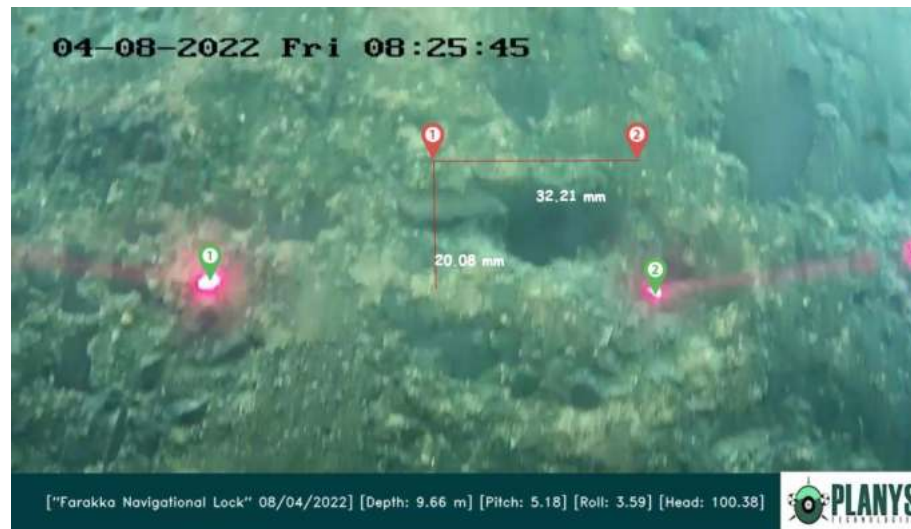
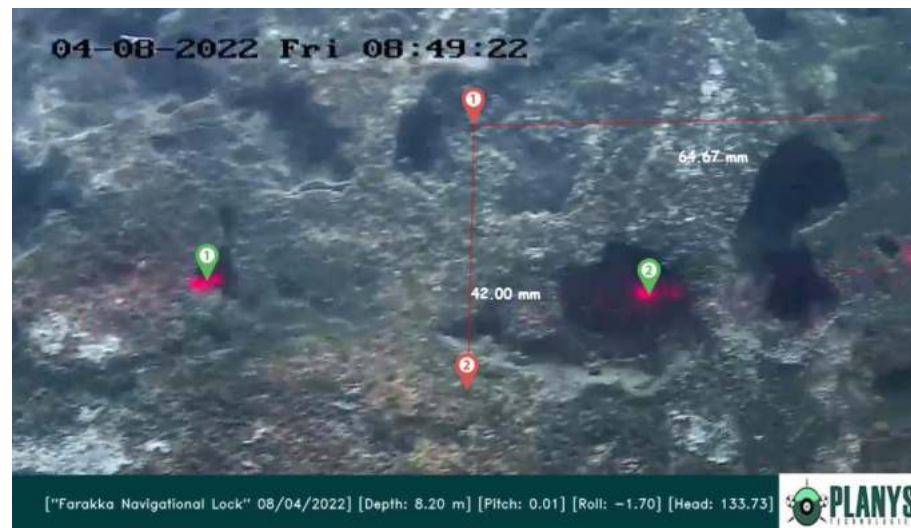
O80	Cavity/Minor	Wall West50 East50 & 9.66	32.21 X 20.08
O81	Cavity/Minor	Wall West52 East52 & 8.20	64.67 X 42.00

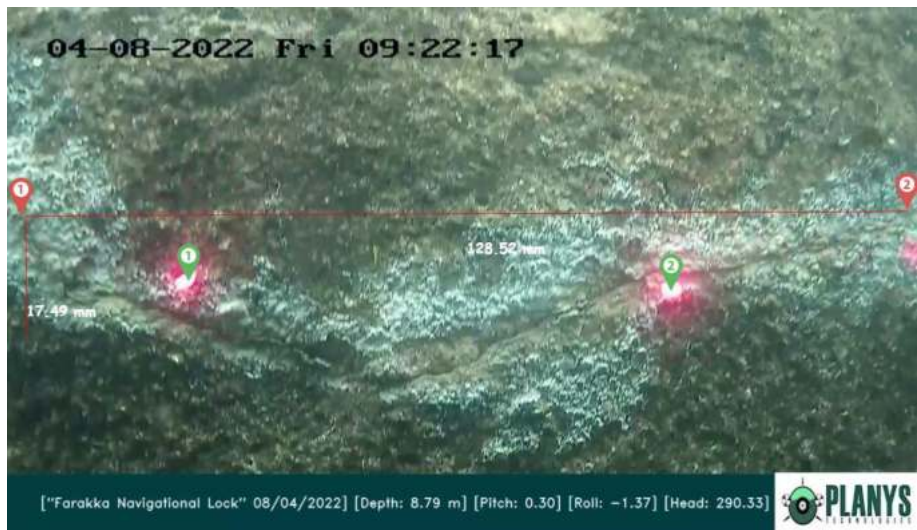
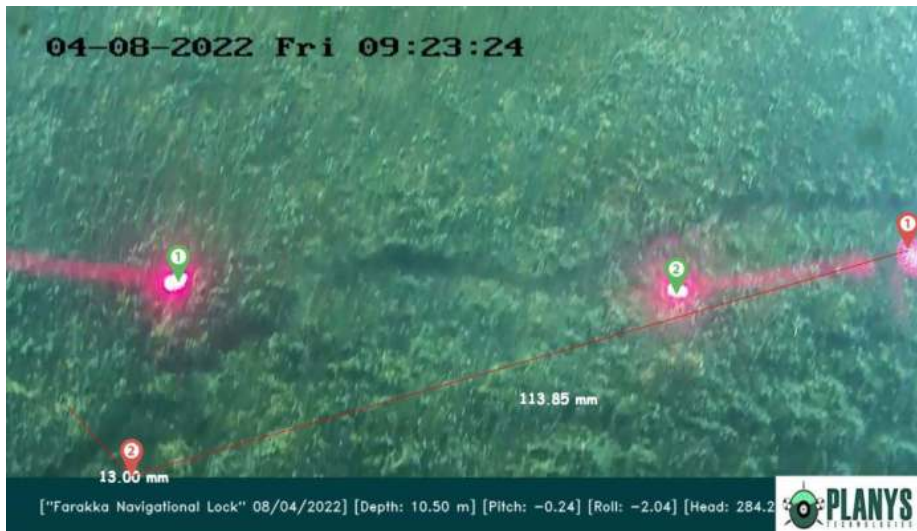
<p><b>O82</b></p>	<p>Crack/Moderate</p>	<p>Wall East55 West55 &amp; 8.79</p>	<p>128.52 X 17.49</p>
<p><b>O83</b></p>	<p>Crack/Moderate</p>	<p>Wall East55 West55 &amp; 10.50</p>	<p>113.85 X 13.00</p>

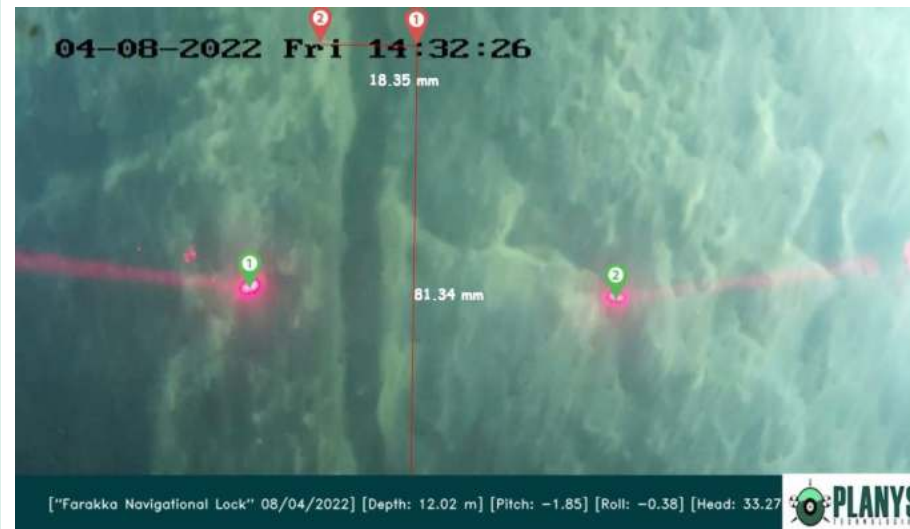
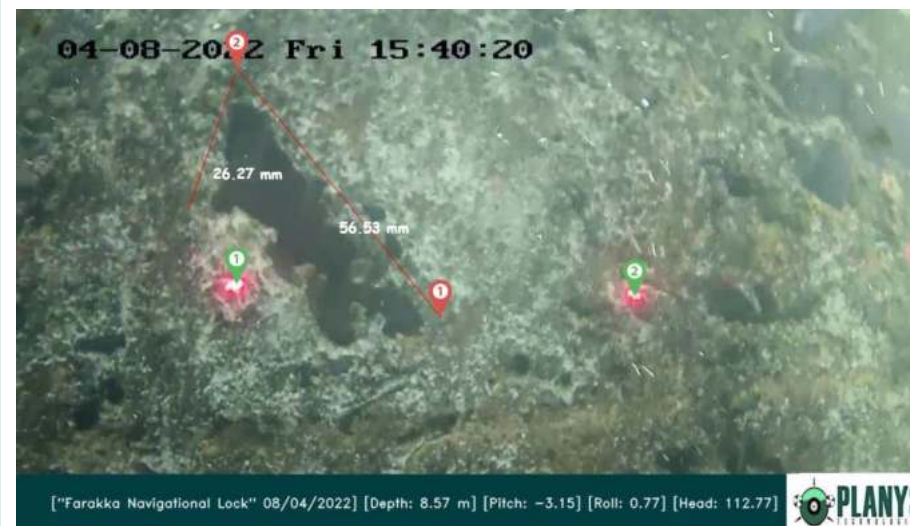
O90	Debonding Between Two Layers/Moderate	Wall East66 West66 & 12.02	81.34 X 18.35
O91	Cavity/Minor	Wall West67 East67 & 8.57	56.53 X 26.27

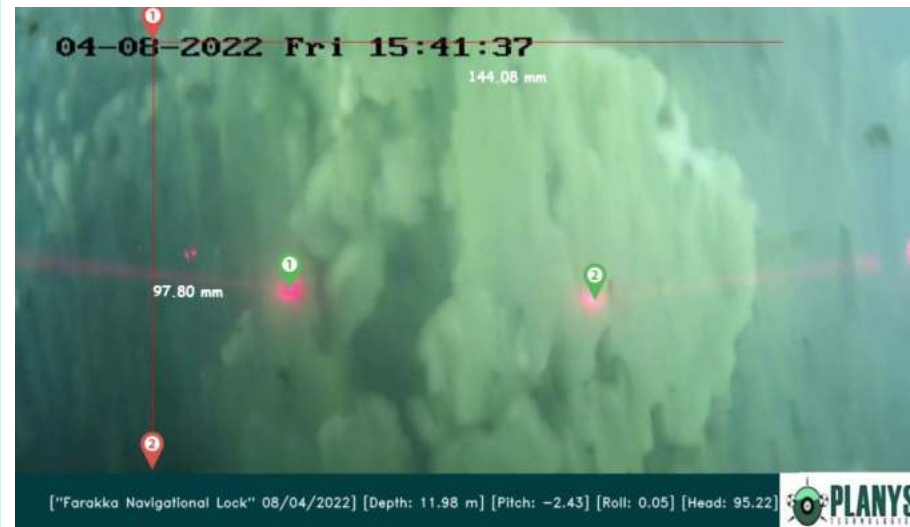
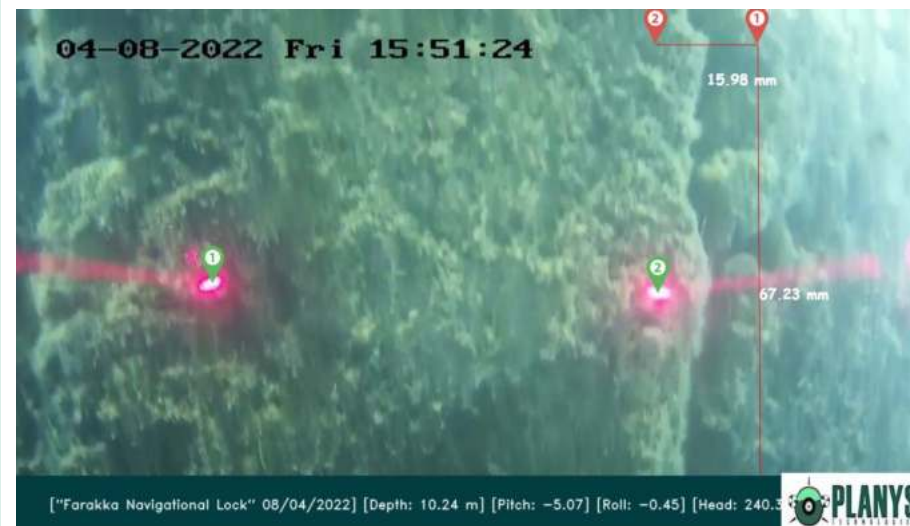
<p><b>O92</b></p>	<p>Surface Deformation/Moderate</p>	<p>Wall West67 East67 &amp; 11.98</p>	<p>114.08 X 97.8</p>
<p><b>O93</b></p>	<p>Crack/Minor</p>	<p>Wall West67 East67 &amp; 10.24</p>	<p>67.23 X 15.98</p>

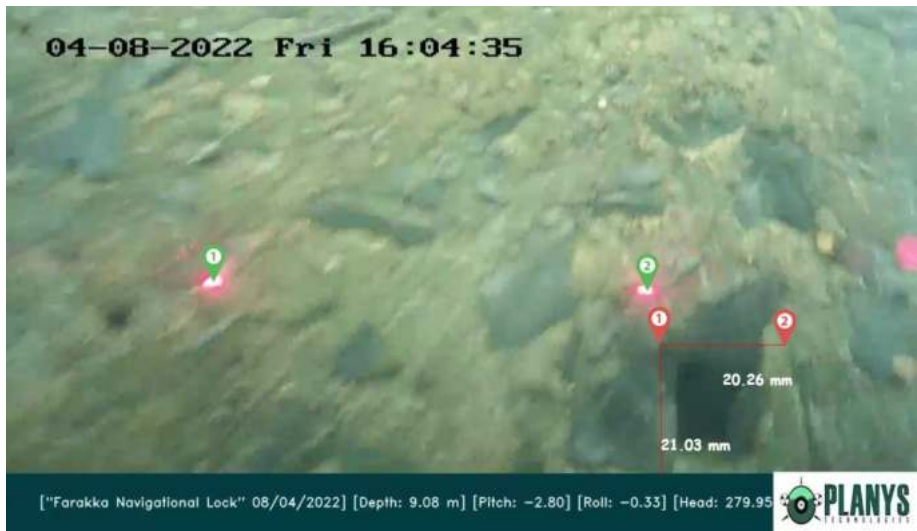
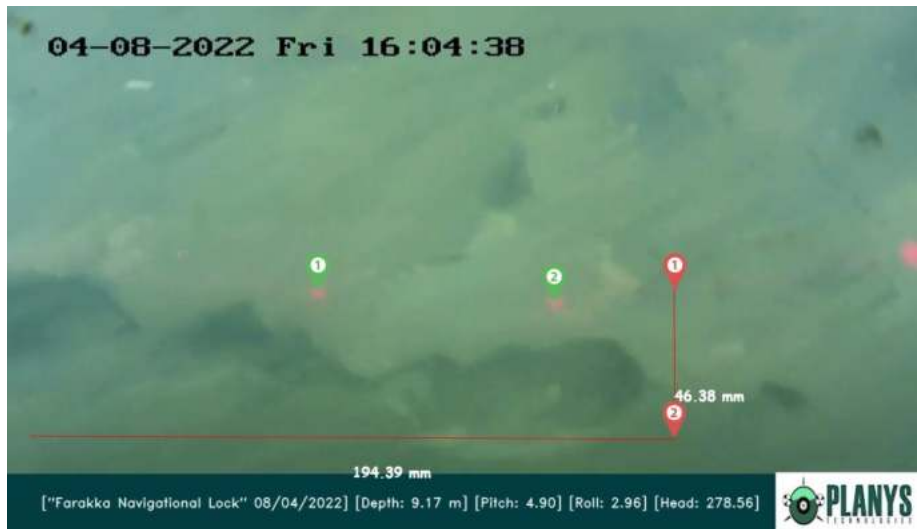
<p><b>O94</b></p>	<p>Cavity/Minor</p>	<p>Wall East68 West68 &amp; 9.08</p>	<p>21.03 X 20.26</p>
<p><b>O95</b></p>	<p>Cavity/Major</p>	<p>Wall East68 West68 &amp; 9.17</p>	<p>194.39 X 46.38</p>

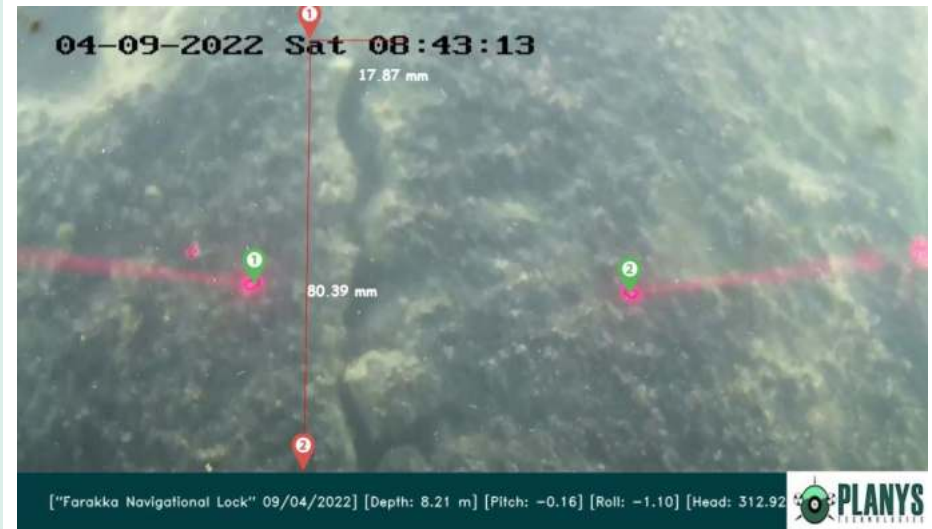
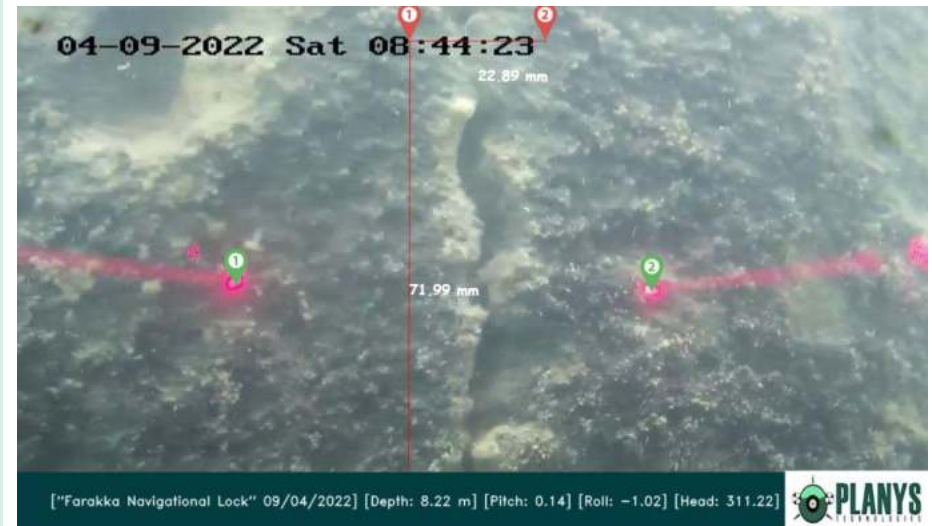
<p><b>O96</b></p>	<p>Crack/Moderate</p>	<p>Wall East70 West70 &amp; 8.21</p>	<p>80.39 X 17.87</p>
<p><b>O97</b></p>	<p>Cavity/Moderate</p>	<p>Wall East70 West70 &amp; 8.22</p>	<p>71.99 X 22.89</p>

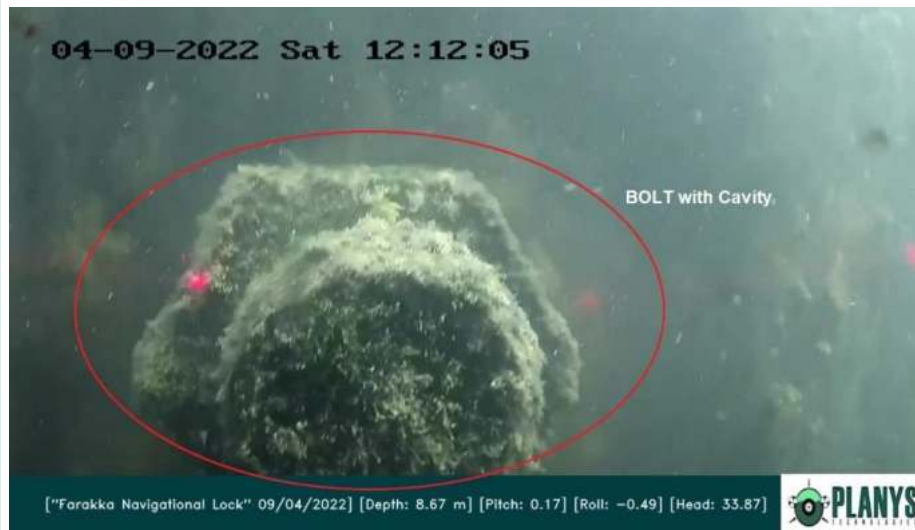
<p><b>O108</b></p>	<p>Debris/Minor</p>	<p>Wall East77 &amp; 8.67</p>	<p>NA X NA</p>
--------------------	---------------------	---------------------------------------	----------------

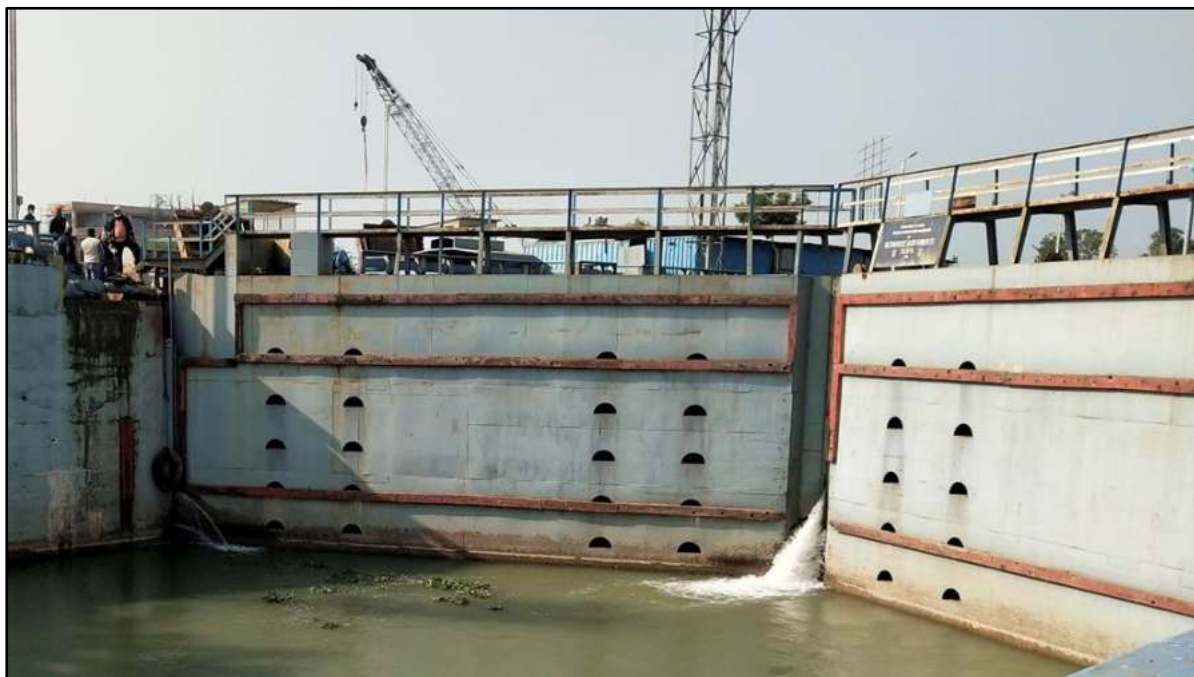
During visual survey it was observed that the submerged portion of gates have significant leakages from bottom and front portion and structural components of these portion were found to be severally corroded (Figure 47). The wooden and rubber seals were found to be damaged and not effectively sealing openings/gaps between the structure and skin plates from both ends (b/w gates and b/w gate and corners (Figure 48)

Figure 47: Mitre Gates of Farakka Lock

- Replacement of the underwater portion of the skin plate of the mitre gates and repair for the above water gate leaf portion. Complete replacement of the operating system of the mitre gates.

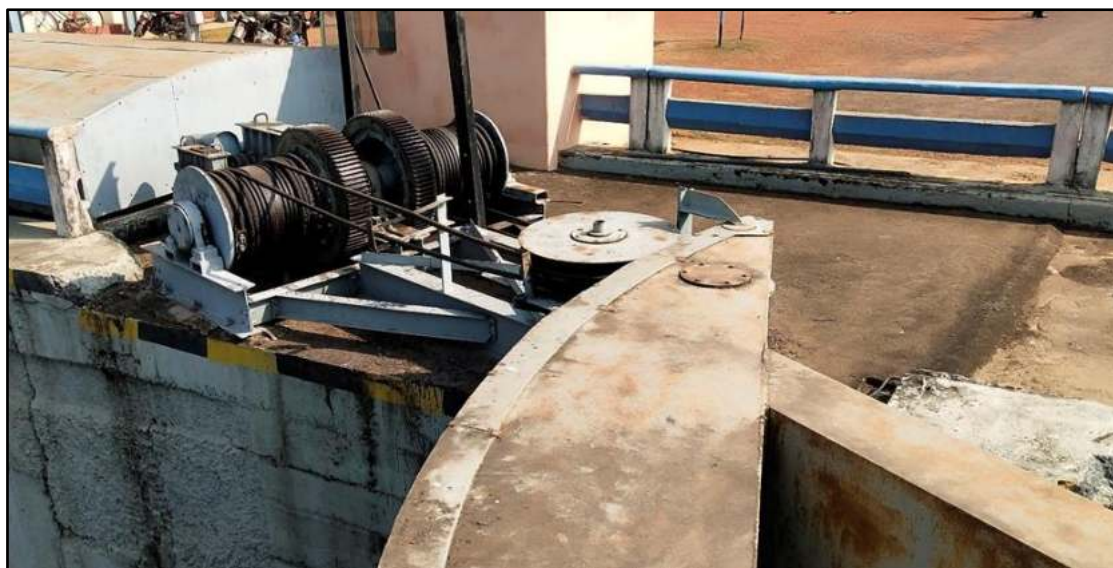
These timings are quite high compared to the proposed Opening/Closing Time of 3-5 min for new lock's Mitre Gates and the operational capability and reliability of present mechanism is doubtful in future if the traffic across the Lock is further increased. During the operation of the gates, it was noted that top hinges of both gates are almost in the end period of their use and significant part of them is corroded with noise being observed for some period of operations from top bearings (Figure 49). It was noted that the greasing arrangement for the bearing is abandoned and has never been used. Hinges of one of the gate was damaged and subsequently replaced in 2020.

**Figure 50: Operating Mechanism of Mitre Gates of Farakka Lock**

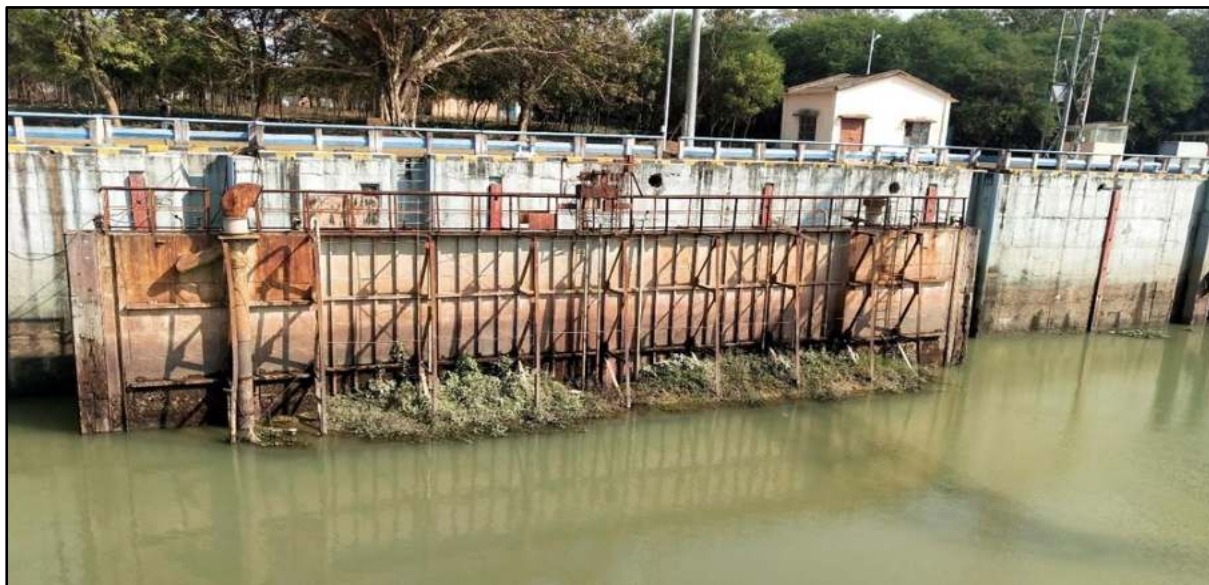
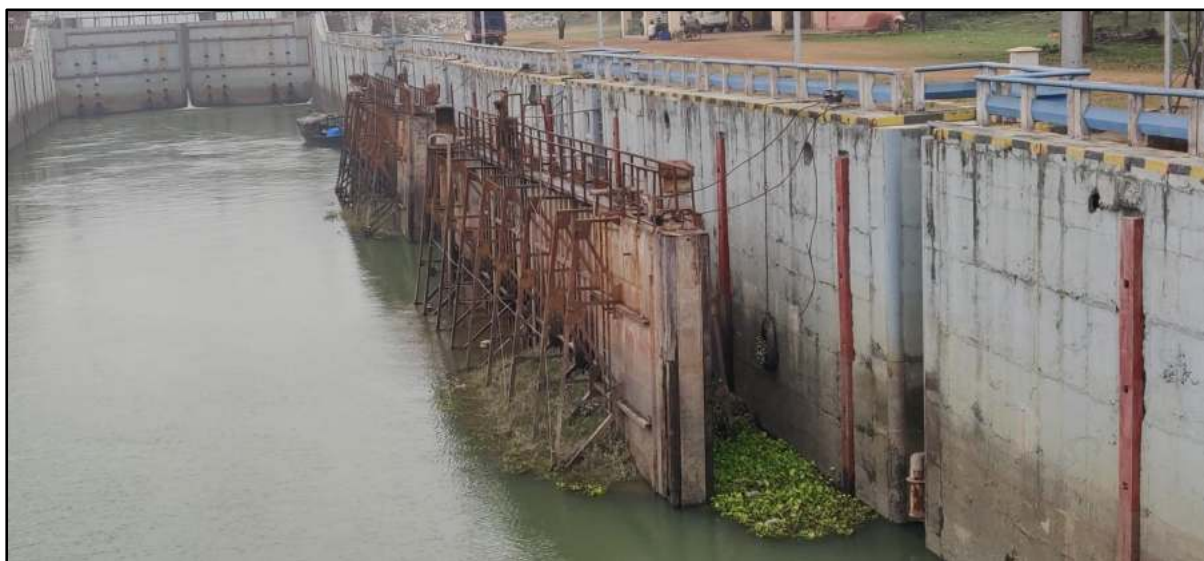
and they cannot be lowered in position to stop water. Also, the current position of gates is not right and suitable parking mechanisms and structure needs to be created at site.

**Figure 51: Cassion Gates for Mitre Gate Maintenance at Farakka Lock**

- Complete replacement of the 2 cassion gates along with operating system.

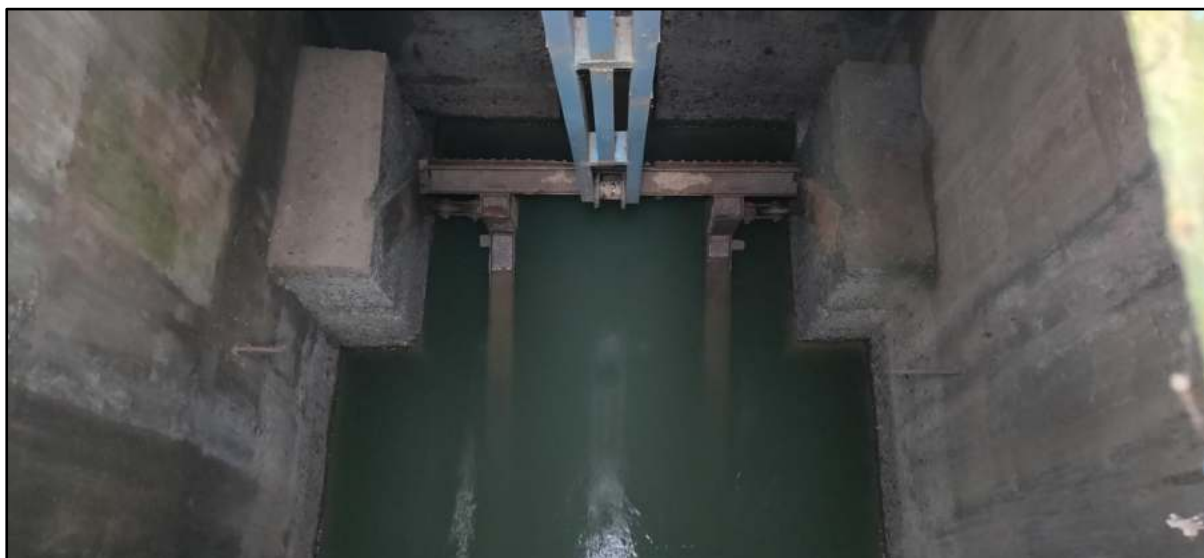
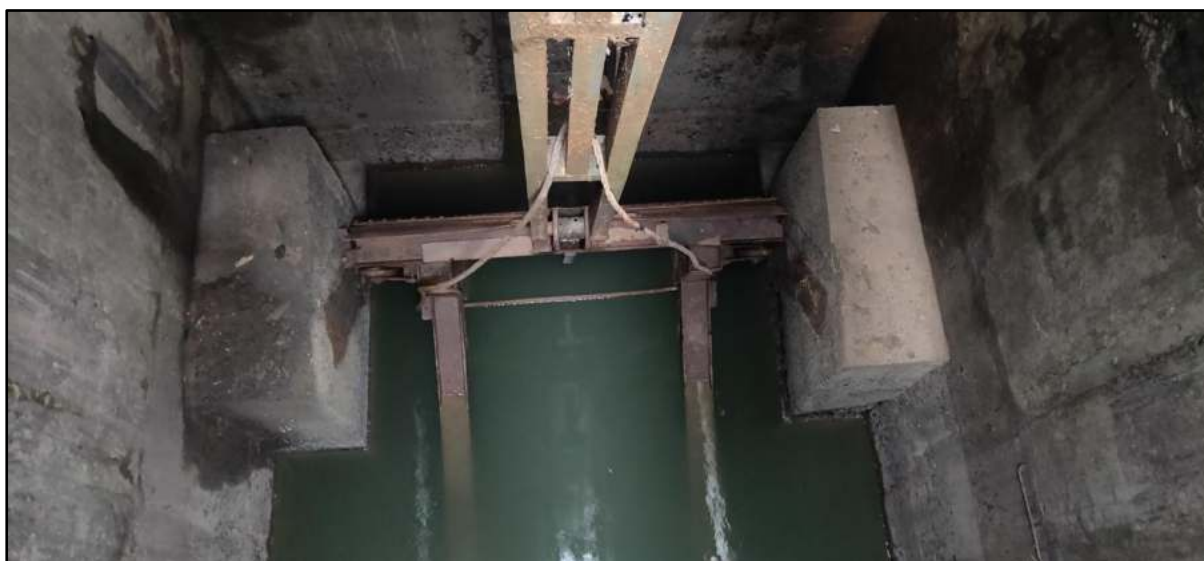
Some structural members are found to be corroded and misaligned. Due to misalignment in the trunnions, it has caused the gate structure to rub against the piers causing some damage to both. The seals of most of the gates are not functioning properly and are worn out due to normal use and not having been replaced since long time. Radial Gates of Farakka Lock and Lifting brackets and limb arms of radial Gates are shown in Figure 52.

**Figure 52: Lifting brackets and limb arms of Radial Gates**
