**Subject:** Revised Condition Survey Report of Consultancy Services for Preparation of Detailed Project Report (DPR) for the work of Renovation/Modernization of Existing Navigation Lock at Farakka.

## CONSULTANCY SERVICES FOR PREPARATION OF DETAILED PROJECT REPORT (DPR) FOR THE WORK OF RENOVATION/MODERNIZATION OF EXISTING NAVIGATION LOCK AT FARAKKA

## Condition Survey Report

August 2022

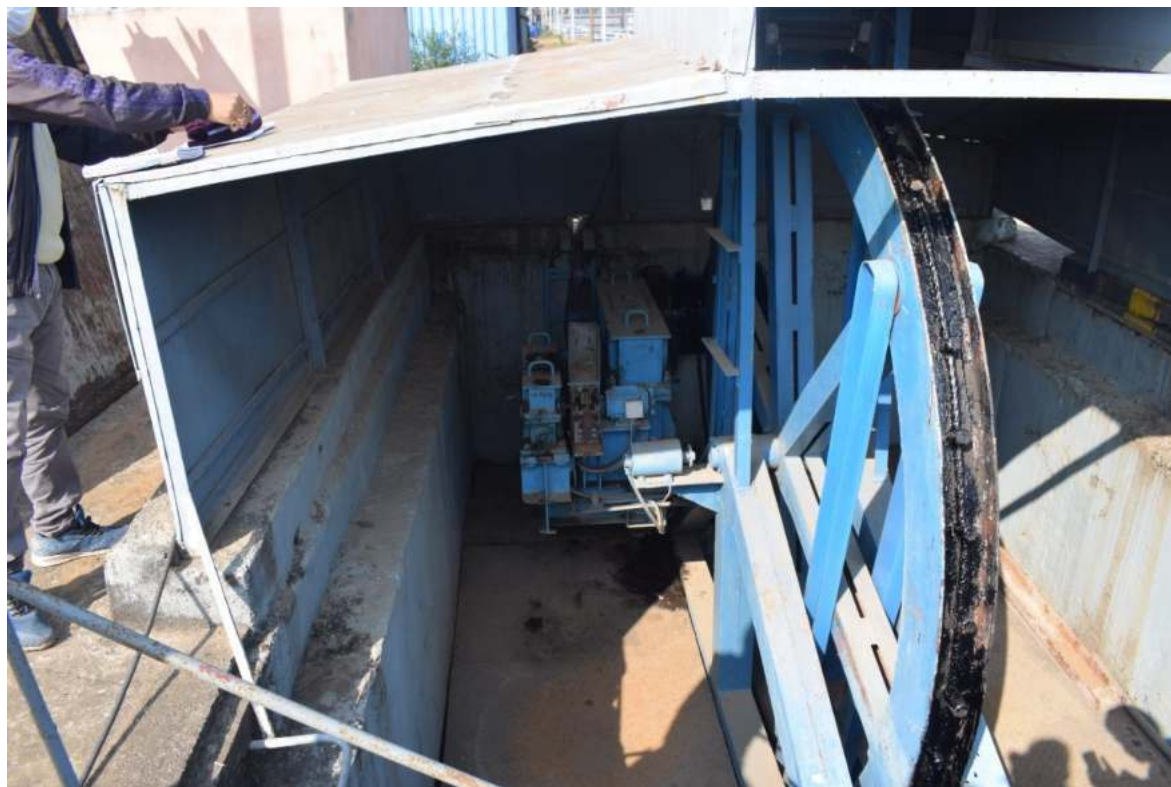
These durations are considered to be on higher side compared to the proposed Opening/Closing Time of 1 min for New Lock's radial gates. The operating mechanism of these gates is electrically operated rope drum hoist of old technology. Also, the operating equipment i.e., hoists, motors, ropes are found to be in poor condition and the system has not been properly maintained (Figure 53).

**Figure 53: Operating System of Radial Gates**

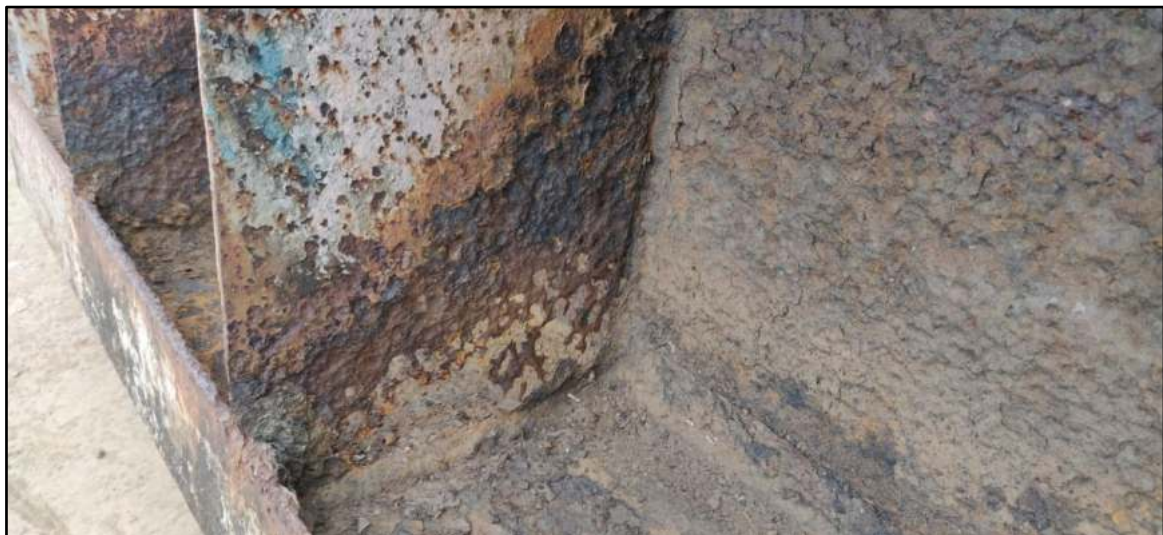
and 55). The filling valve arrangement of gates are also in dilapidated state with corrosion on all sides (Figure 56). The Wheels are jammed and not rotating freely, greasing system was not functioning and bearings need to be replaced. The lifting assembly is shown in Figure 57.

**Figure 55: Heavy corrosion in Bulkhead Gates**

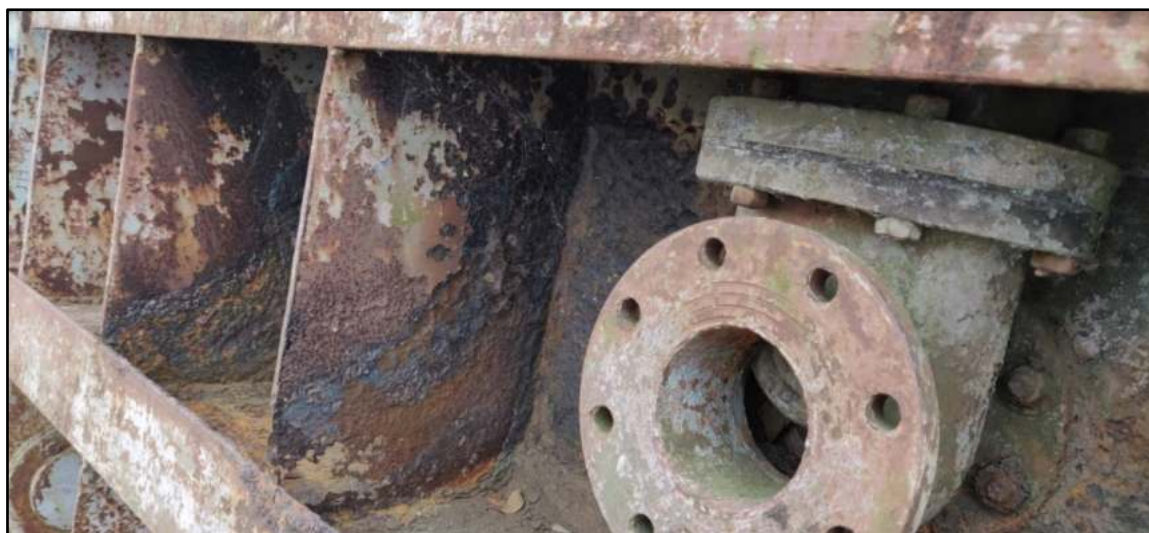
Figure 56: Deteriorated equalizing valve of Bulkhead Gates

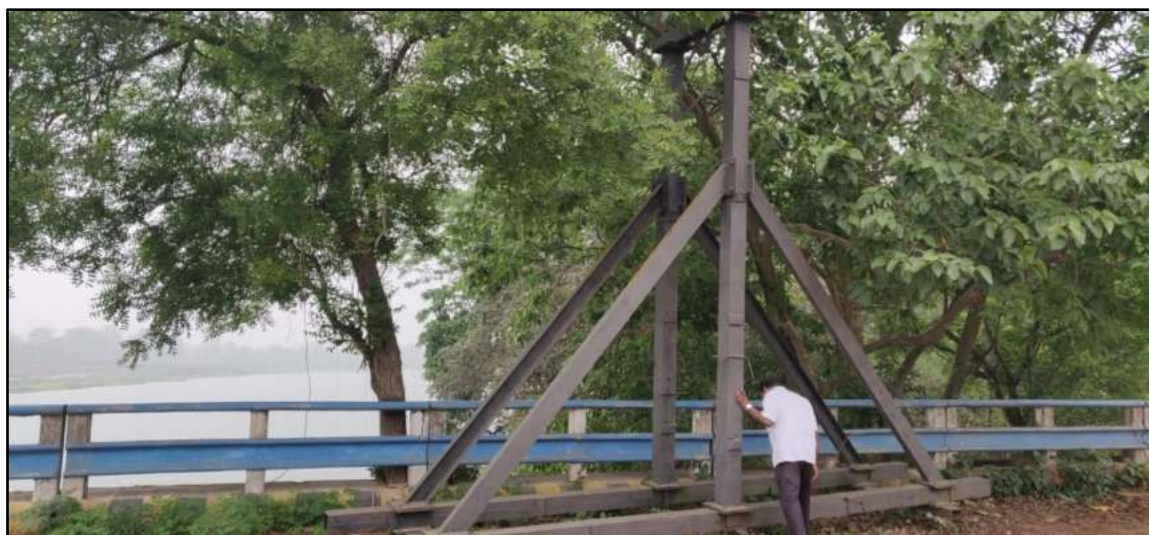
Figure 57: Lifting Assembly of Bulkhead Gates

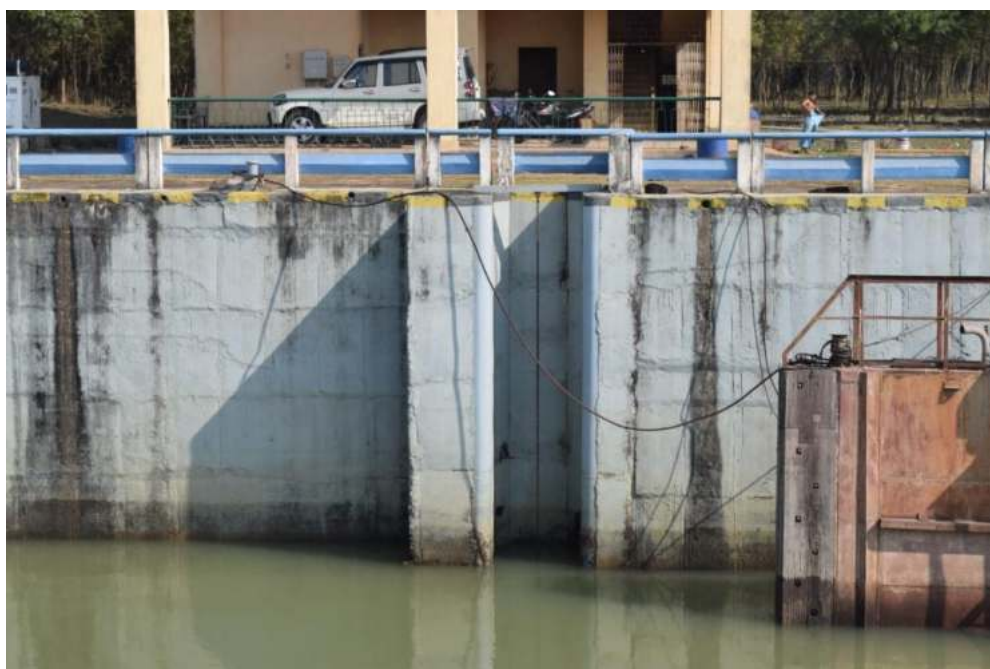
Conventional moorings systems viz. floating and fixed bollards are in place in the navigational lock. There are Bollards – eight (8) numbers floating type (four (4) on each bank) and fourteen (14) numbers fixed type (seven (7) on each bank). Most of the floating bollards are non-functional and even few of the fixed type bollards are damaged.

Figure 61: Damaged Fixed Type Bollard

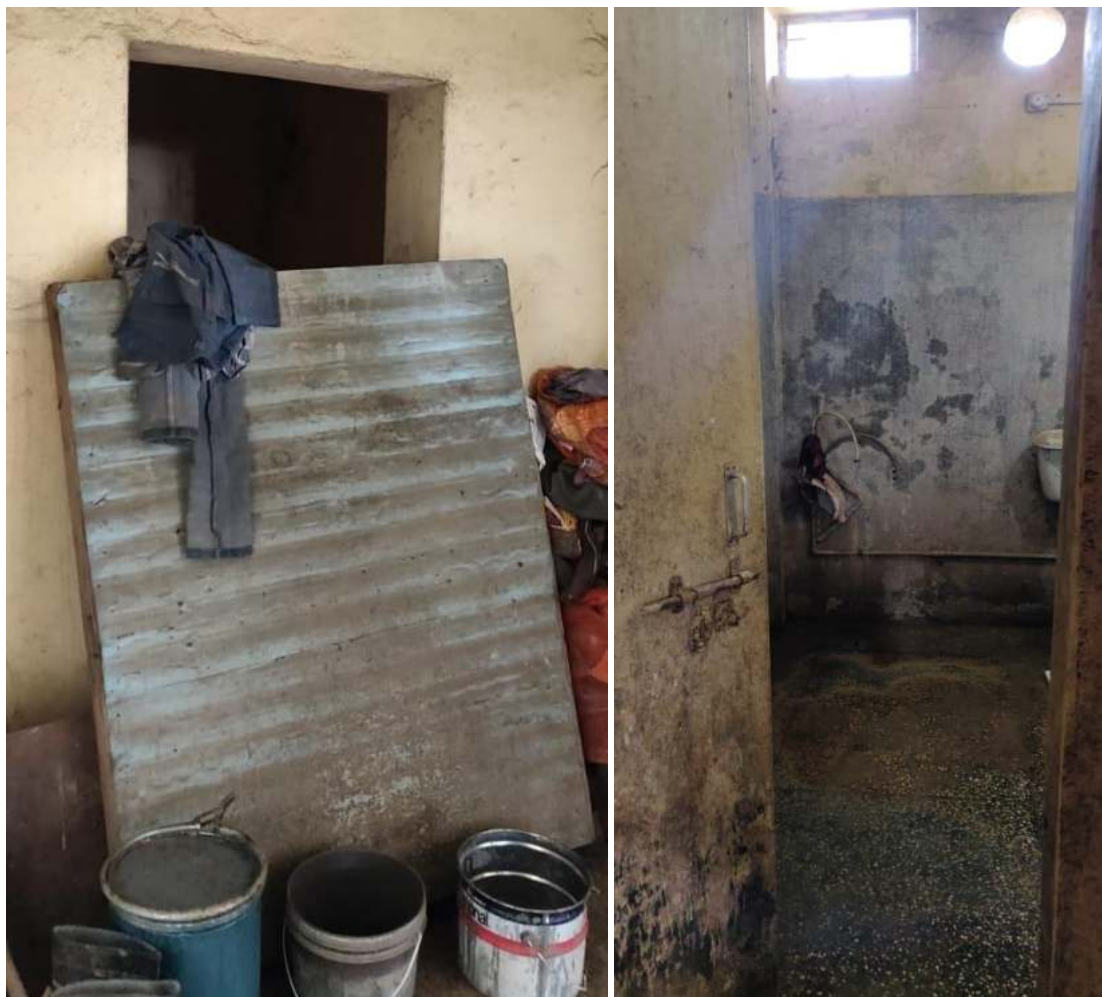
**Figure 64: Present Condition of interiors of Control room building**

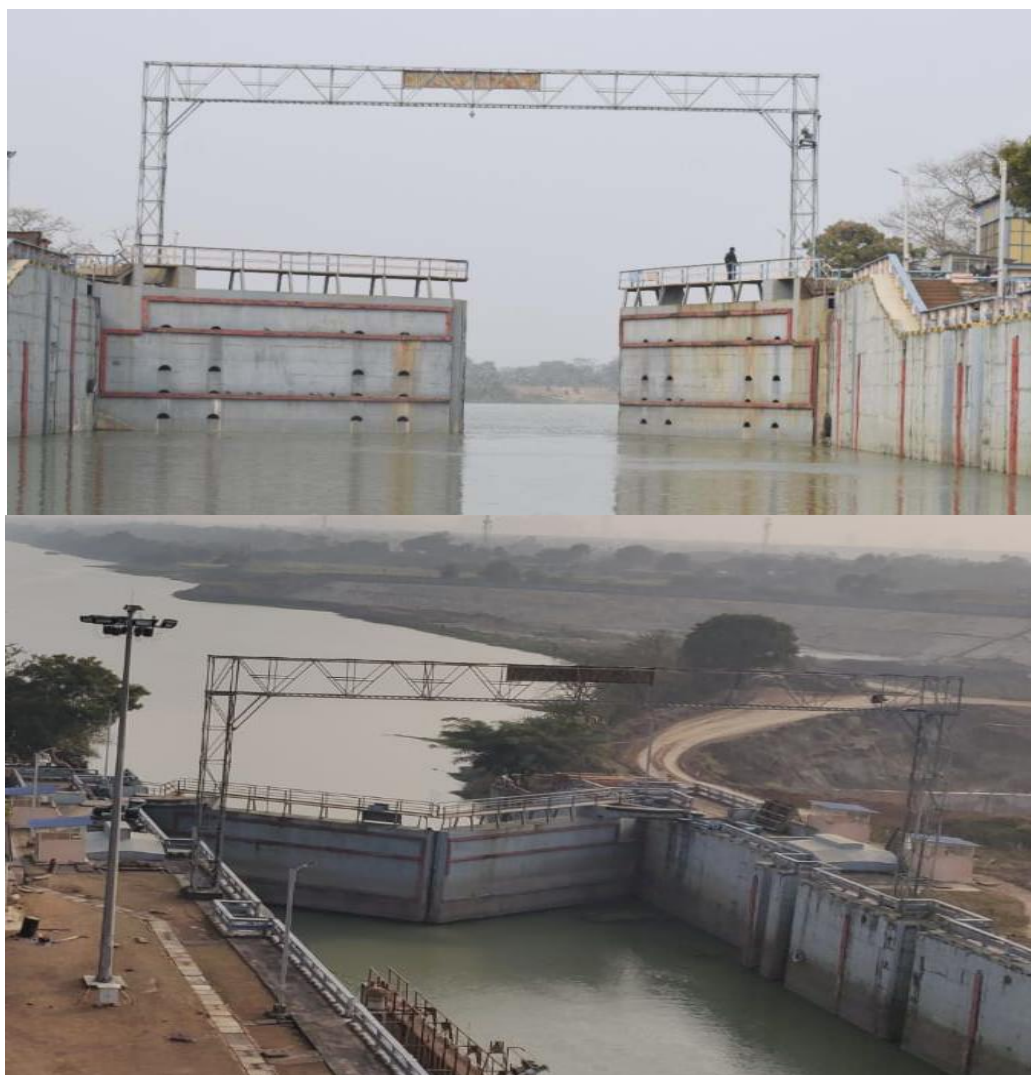
The earlier arrangement of power supply was using underground electrical ducts. But the overall electrical power and control system failed to work at some point of time which led to abandoning it. Subsequently a new direct power supply was separately taken to each electric motor drive contactor. This new arrangement did not use the existing underground electrical ducts and instead used two over-ground steel lattice cable bridges (one each at u/s and d/s mitre gate) through which the electrical cables were dragged and supported (Figure 65). Both the cable bridges are corroded and are also vulnerable to collision.

**Figure 65: Steel lattice type cable bridges**

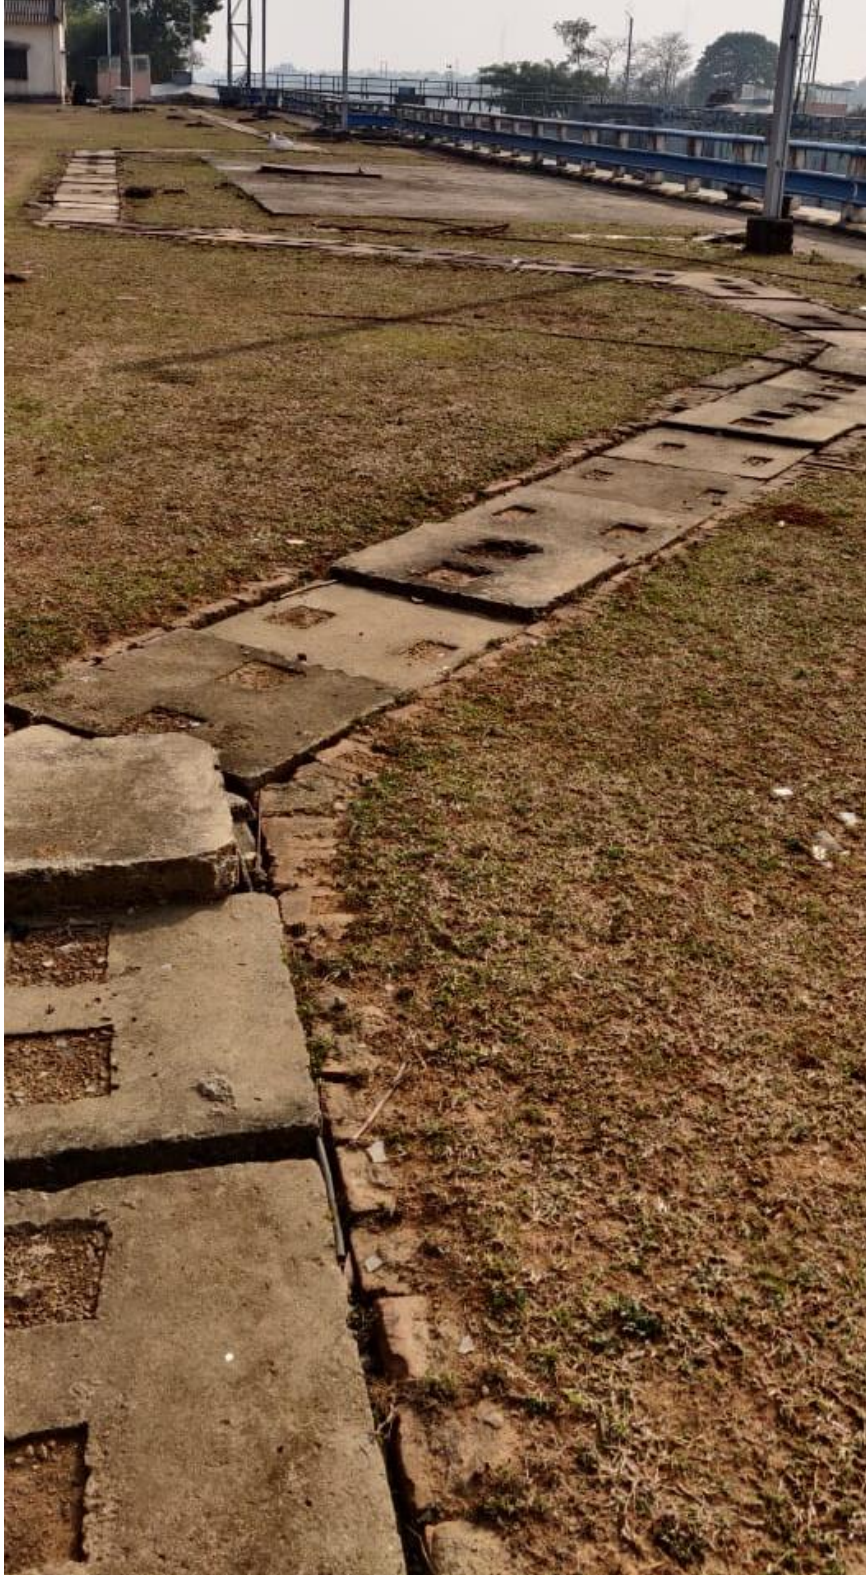
The electrical arrangements on the left side of the navigational lock are through the cable trench as shown in Figure 66. The trenches look essentially intact, but clearly need cleaning out. Some concrete covers are missing, or broken.

**Figure 66: Cable trench for power cables**

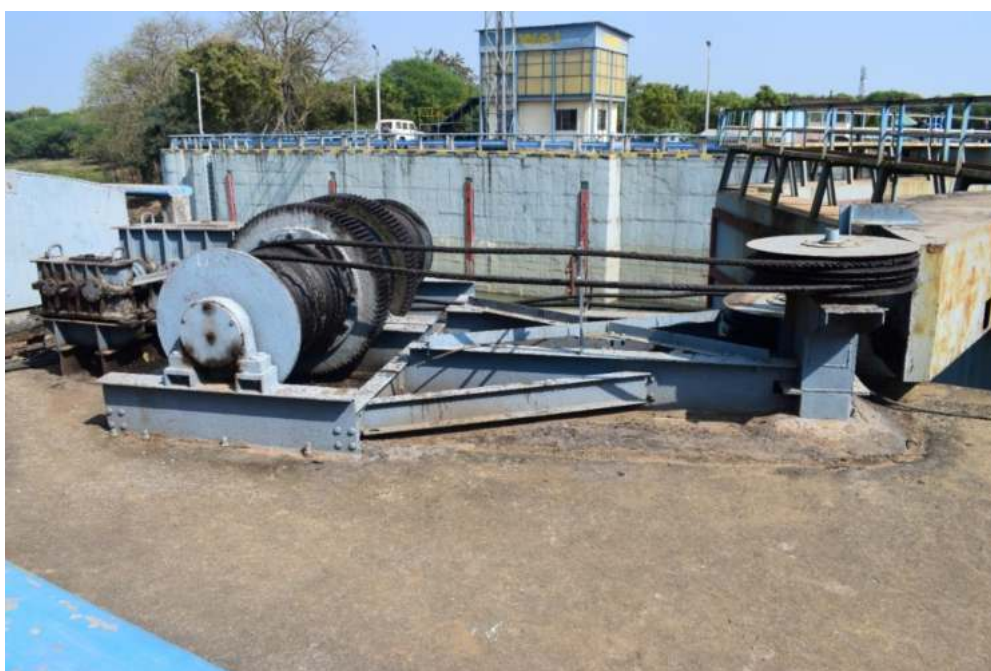
There are no working limit-switches for end of travel shut down and a series of stones are placed which are being used to indicate end of gate travel positions to the operators (Figure 67).

**Figure 67: Temporary position indicator used to control gate opening**

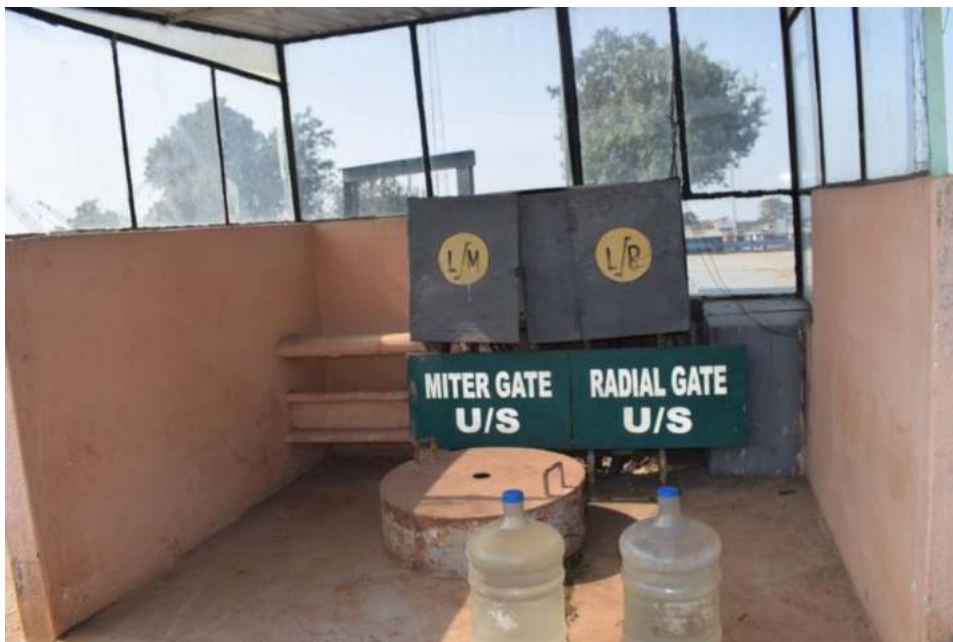
The gates were originally fitted with a push-button control system complete with end of travel limit switches and safety devices. This system has completely failed and the gates are now operated by persons directly closing the respective motor starter contactors (by placing their hands into a live electrical control box and using a stick) while somebody else manually over-rides the brake (Figure 68). This practice is dangerous as it exposes people to potentially fatal voltages.

**Figure 68: Local control system of u/s Mitre and Radial Gate**

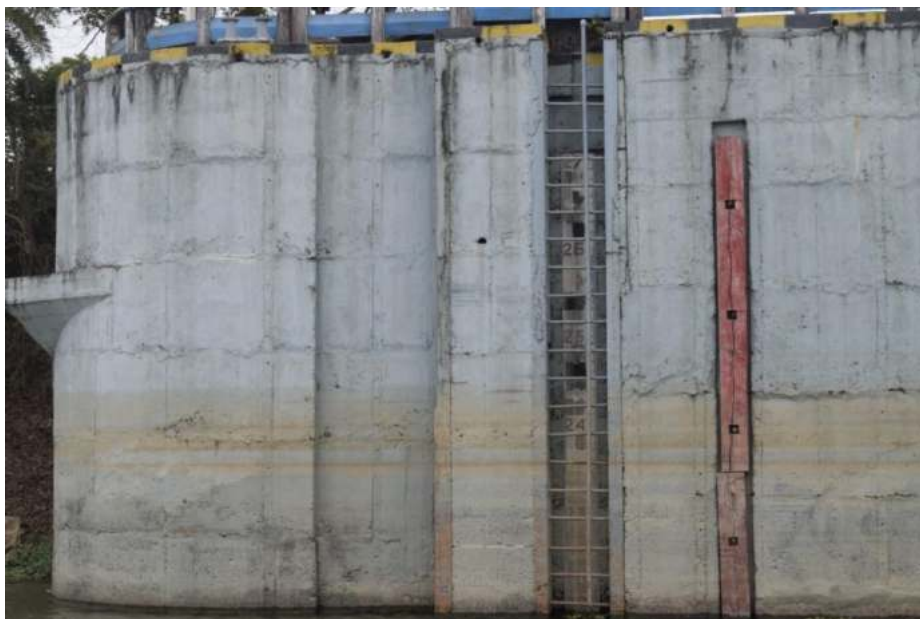
There are no instrumentation systems for water levels or head differences across the gates or flow monitoring in the lock. Fixed water level gauge boards exist at locations upstream and downstream of each of the sets of mitre gates, but these are in the ladder recesses and are not readily visible to the lock operators. Some of the gauge boards have been damaged and do not cover all operating water levels (Figure 69).

**Figure 69: Fixed water level gauge in ladder recess**
