**Subject:** Submission of Revised Inception Report of Consultancy Services for Preparation of Detailed Project Report (DPR) for the work of Renovation/Modernization of Existing Navigation Lock at Farakka.

## CONSULTANCY SERVICES FOR PREPARATION OF DETAILED PROJECT REPORT (DPR) FOR THE WORK OF RENOVATION/MODERNIZATION OF EXISTING NAVIGATION LOCK AT FARAKKA

## Inception Report

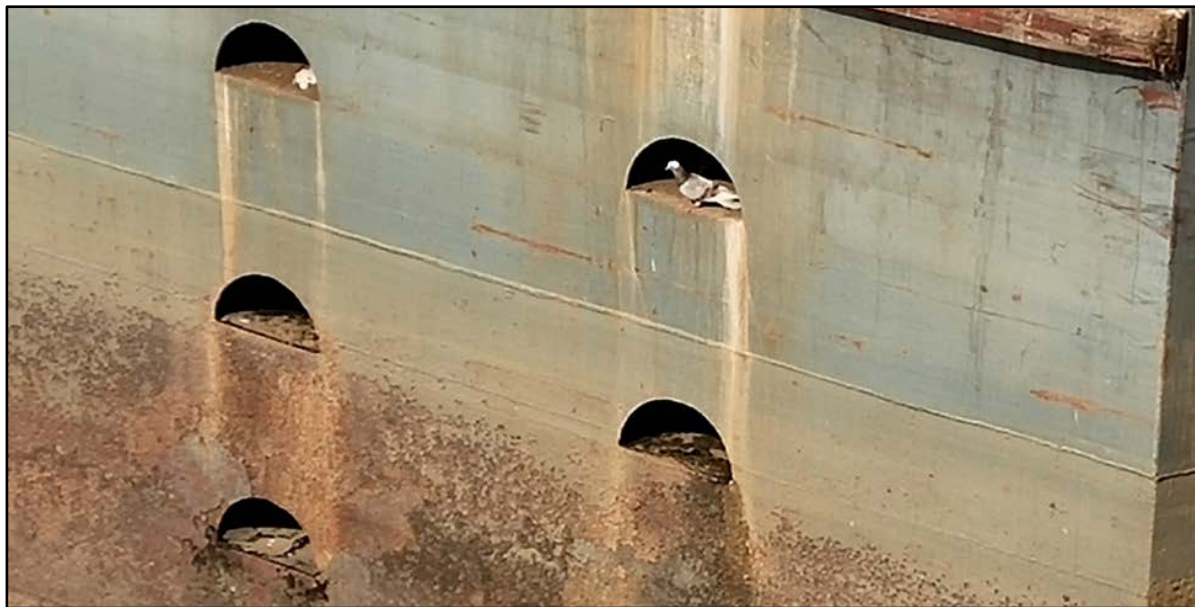
During visual survey it was observed that the submerged portion of gates have significant leakages from bottom and front portion and structural components of these portion were found to be severally corroded (Figure 4.4). The wooden & rubber

**Figure 4.4 Corrosion of Submerged Section of Mitre Gates of Farakka Lock**

After these preliminary assessments and background data study it is suggested that both mitre gates should to be replaced which will be further firmed up after the detailed condition survey. The new set of gates should be designed as per the

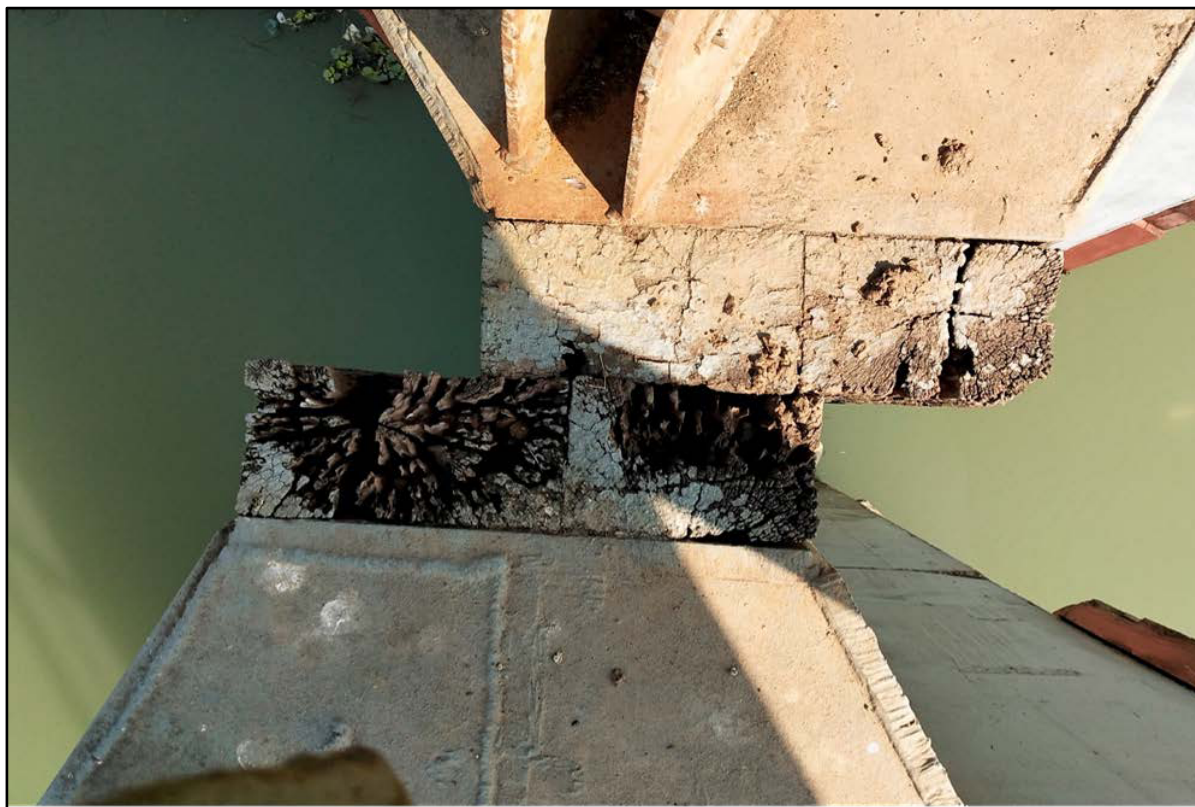
5. It has been observed that there was a profuse gap between the rubber seals provided along the nose of the Mitre Gate at both mouths of the existing navigation lock. The wooden pads provided on the base of the rubber seals got warped unevenly at different locations all along its vertical height of both the Mitre Gates.

seals were found to be damaged and to be not effectively sealing openings/gaps between the structure and skin plates from both ends (b/w gates and b/w gate and corner (Figure 4.5)

**Figure 4.5 Condition of Seals of Mitre Gate of Farakka Lock**

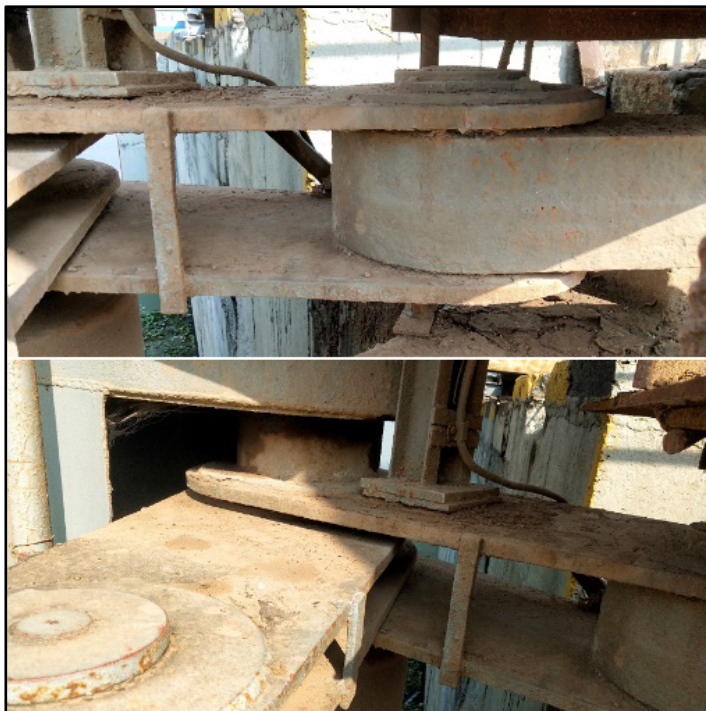
**Figure 4.6 Top Bearing of Mitre Gates of Farakka Lock**

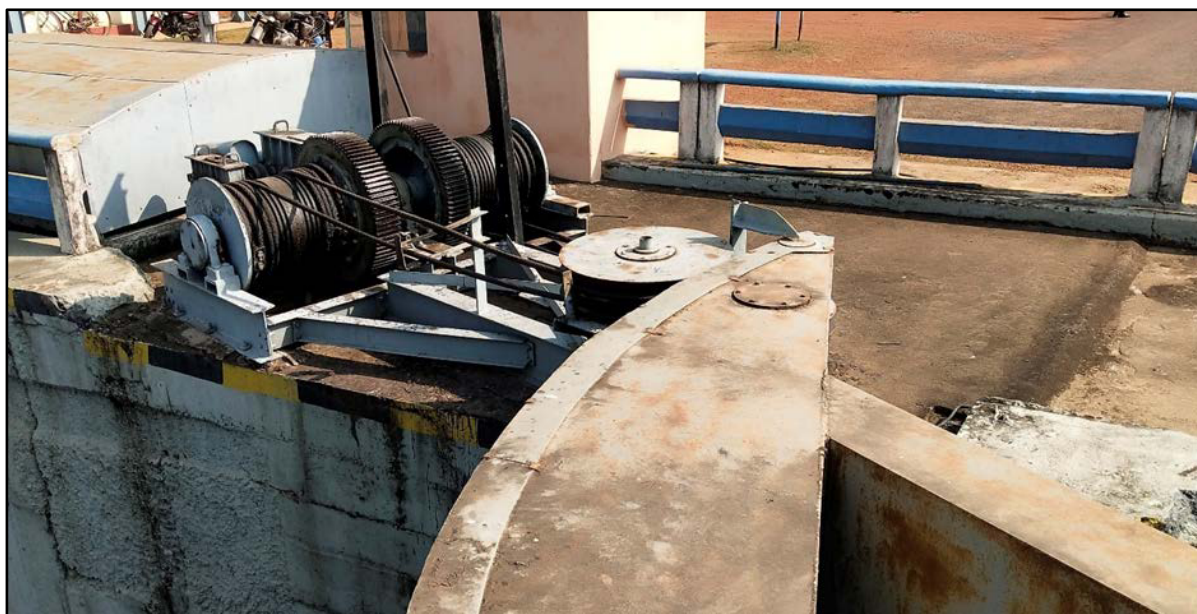
The operating mechanism (Figure 4.7) of the mitre gates is found to be based on incredibly old technology principles and the components and consumables are in dire need of replacement. The rope dismantles from the guides during operation and has to be put back on guides manually. The double rope guided pulley mechanism is not dependable and can create operation hazard/bottlenecks easily. There is no automatic supervisory control mechanism for mitre gate operation and human intervention/interpretation is required to assess the U/S and D/S water level at gate and to decide the right time for closing and opening operation.

**Figure 4.7 Operating Mechanism of Mitre Gates of Farakka Lock**

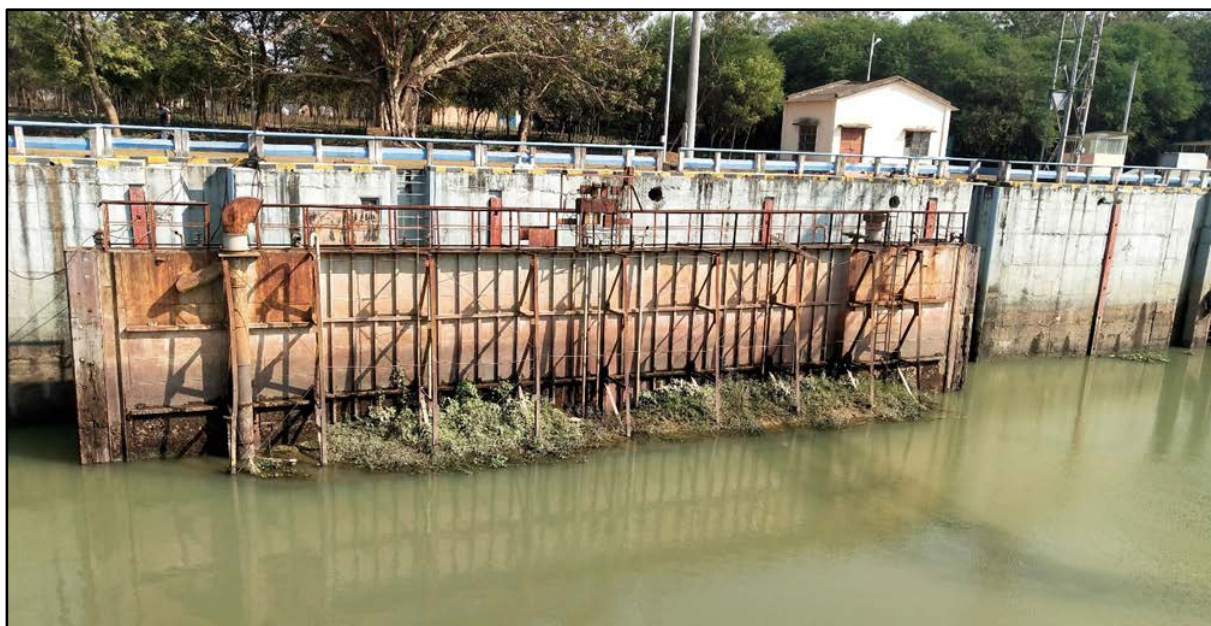
These gates cannot be used at any point in future keeping in mind the operational hazard they can create. Also, the current position of gates is not right and if these gates are to be used suitable parking mechanisms and structure needs to be created at site.

**Figure 4.8 Cassion Gates for Mitre Gate Maintenance at Farakka Lock**

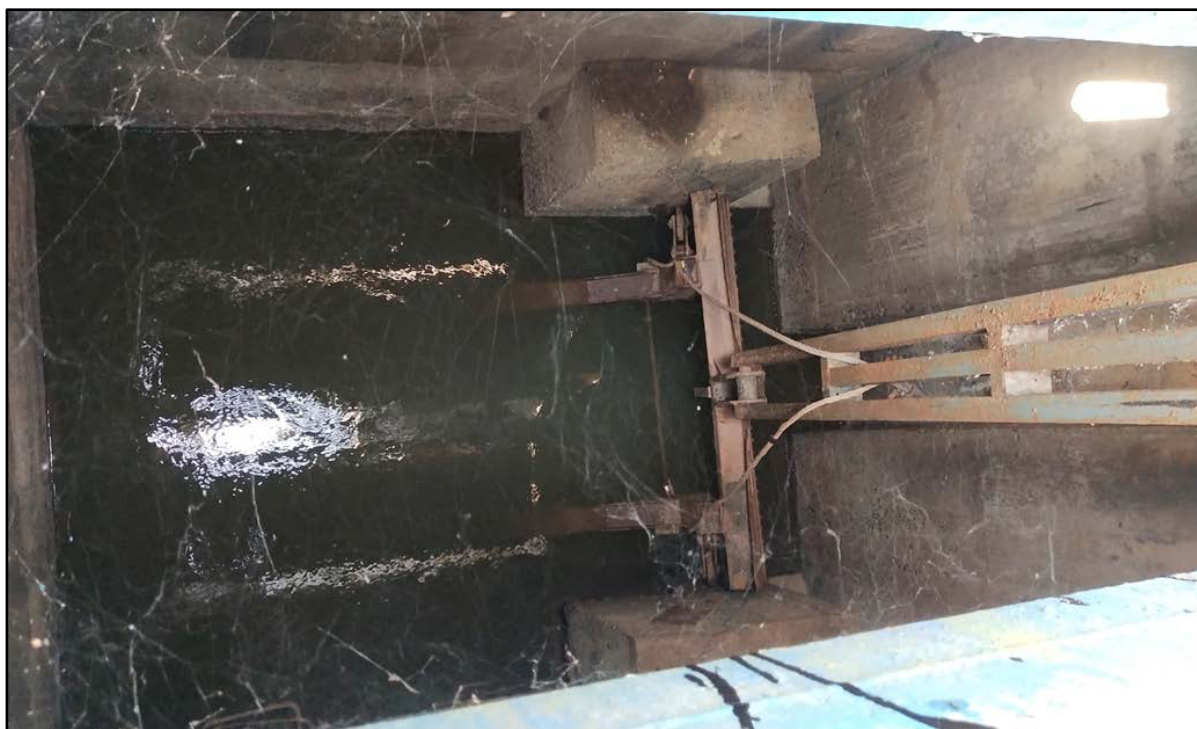
The structural members are mostly found to be corroded and misaligned. This has caused the gates to be inefficiently used for their functioning. Due to misalignment in most of the trunnions has caused the gates structure to rub against the piers causing further damage to both. The seals of most of the gates are not functioning and are damaged due to use in unaligned and inappropriate way. Sketch of Radial Gates in O&M Manual of Farakka Lock shown in Figure 4.9 and Lifting brackets and limb arms of Radial Gates of Farakka Lock Figure 4.10.

**Figure 4.10 Lifting brackets and limb arms of Radial Gates**

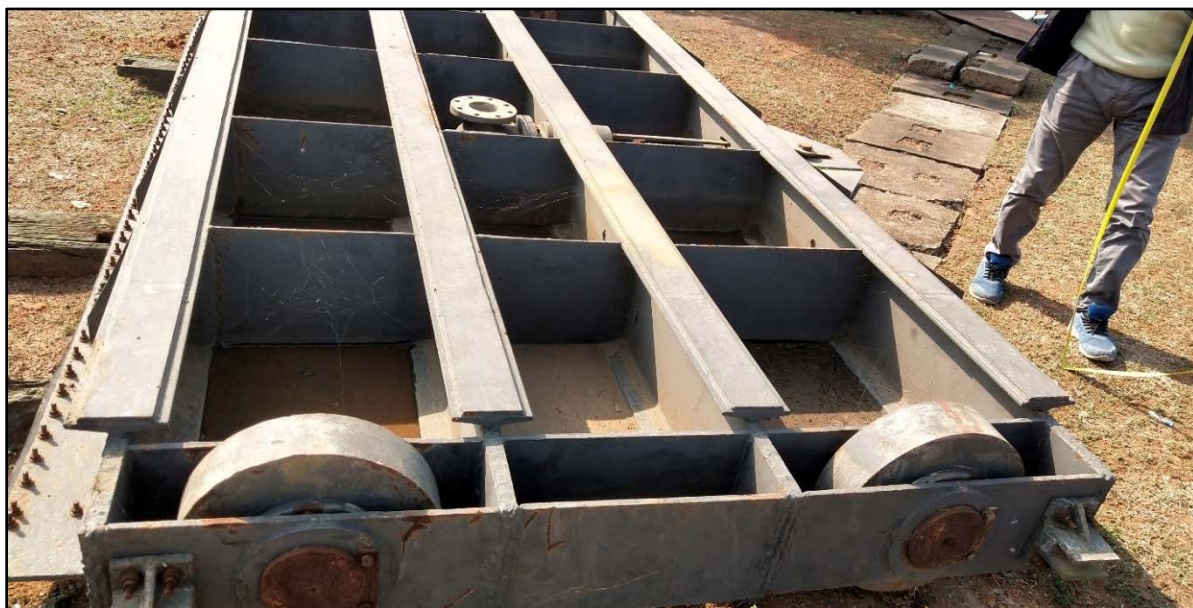
All structural members of loose bulkheads were inspected and were found to be heavily corroded and not in a position of rehabilitation. The seals of all gates are damaged conditions (Teflon cladding worn out) beyond any chances use in operation (Figure 4.13)

**Figure 4.11 Bulkhead Gates for Radial Gate Maintenance**

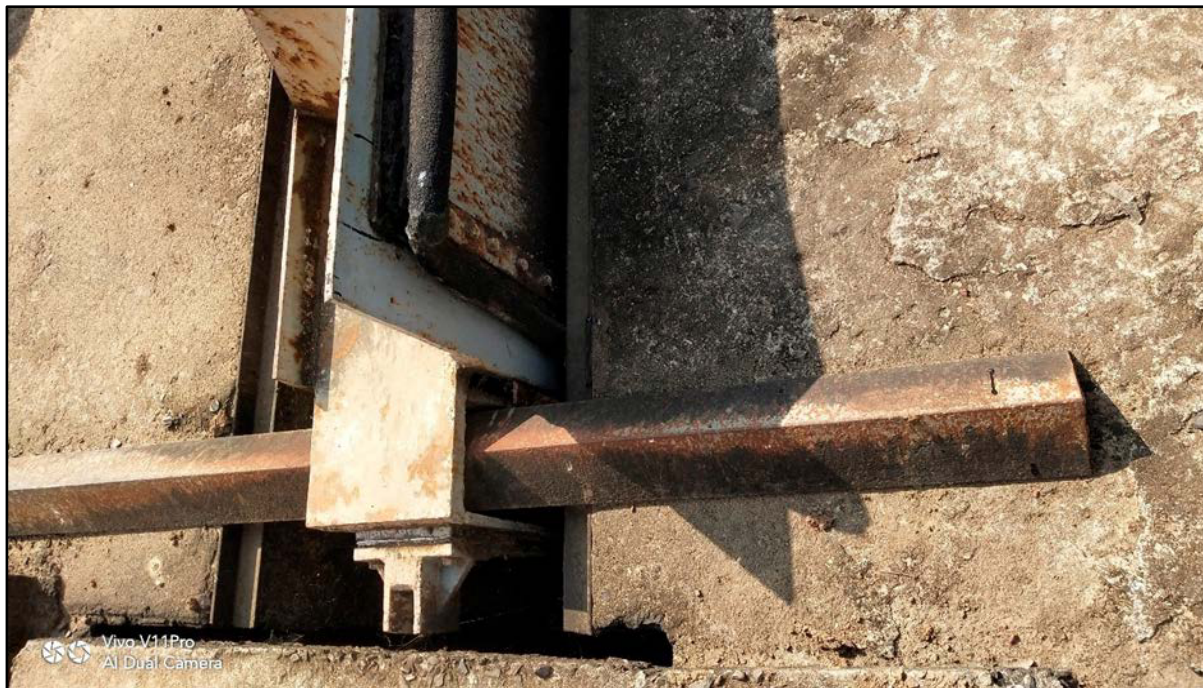
**Figure 4.23 Rubber Seals of Bulkhead Gates of Farakka Lock**

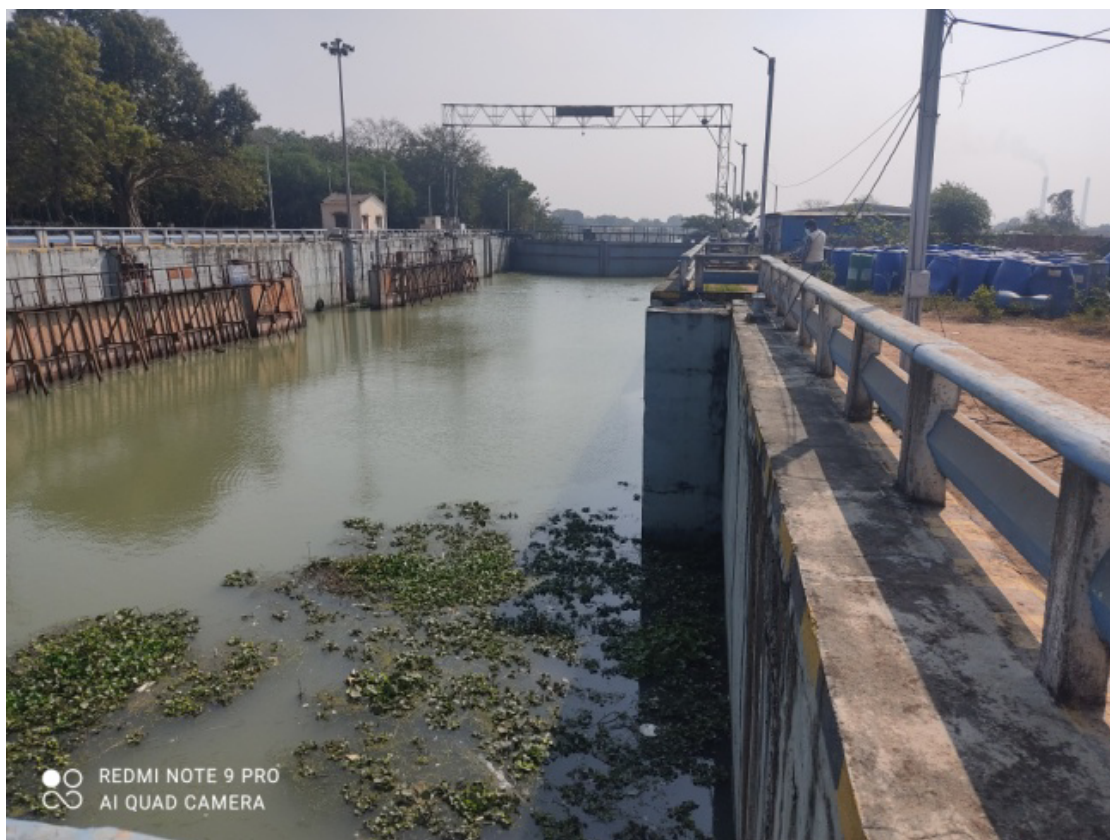
The condition of all of the concrete structures in the lock complex is poor. There were cracks, honey combing, spalling of concrete, and possible corrosion of reinforcement in underwater portions. Corrosion is typically worst in areas subject to wetting and drying, i.e. between the upper and lower water levels in the lock chamber. The lock chamber has never been emptied since its commissioning and the condition of the lock floor and the underwater parts of the lock walls is required to be observed by underwater investigated technologies.

**Figure 4.15 Vegetation in Lock Chamber**

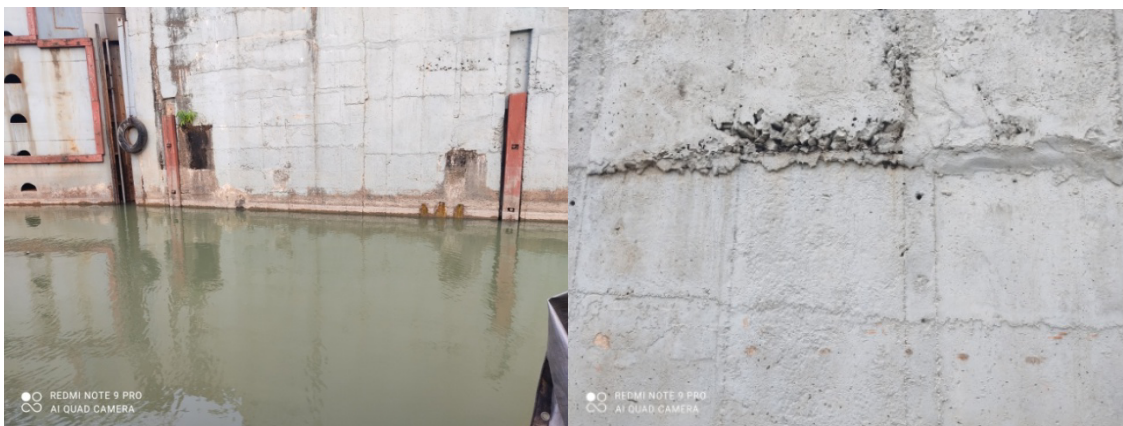
**Figure 4.46 Honey Combing in Lock Walls**

The condition of Retaining /Side Walls in the lock chamber is poor. There are patches of Honey Combing in concrete, cracks, gaps at different locations. Submerged portions require underwater investigations.

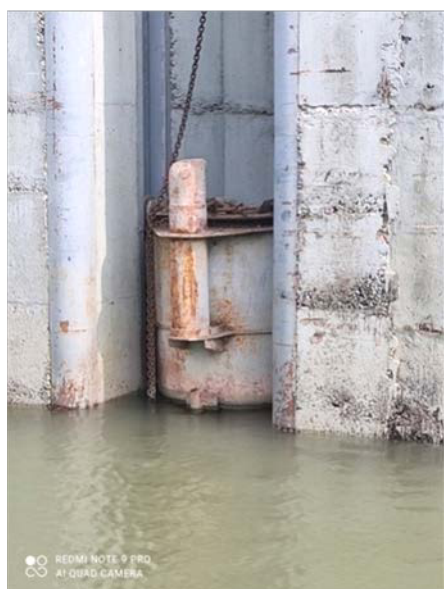
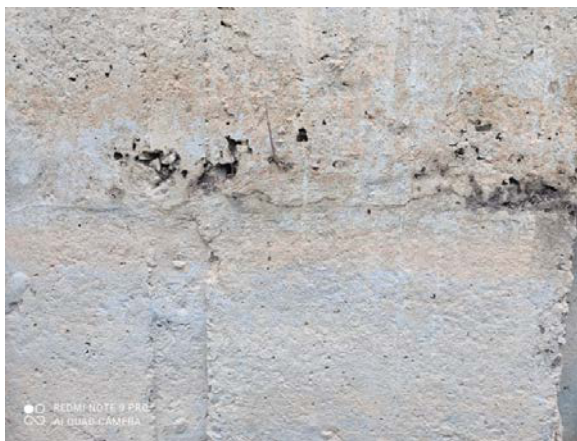
**Figure 4.57 Lock Chamber side walls damaged**

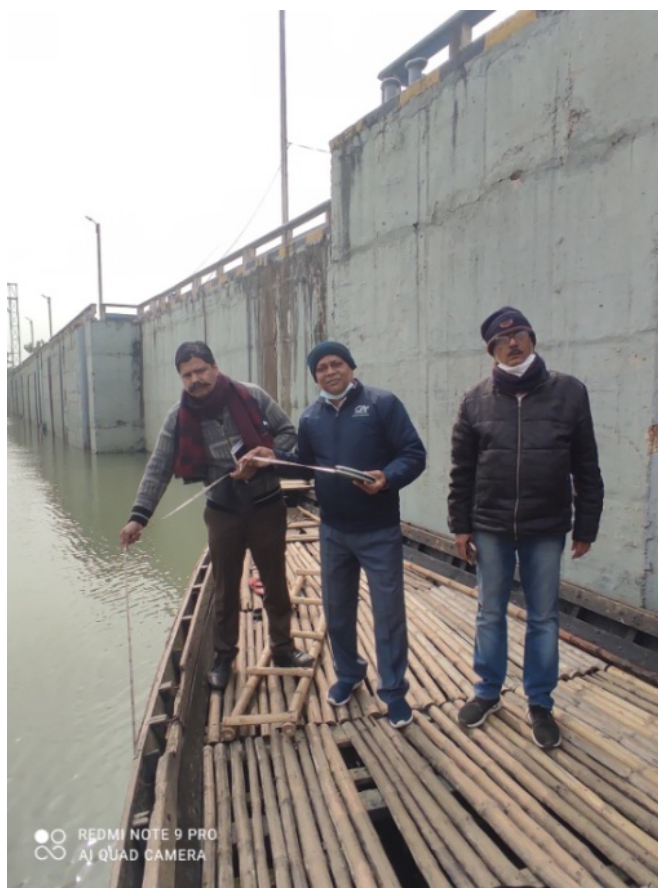
**Figure 4.68 Depth measurement in lock chamber for silt deposition over base slab**

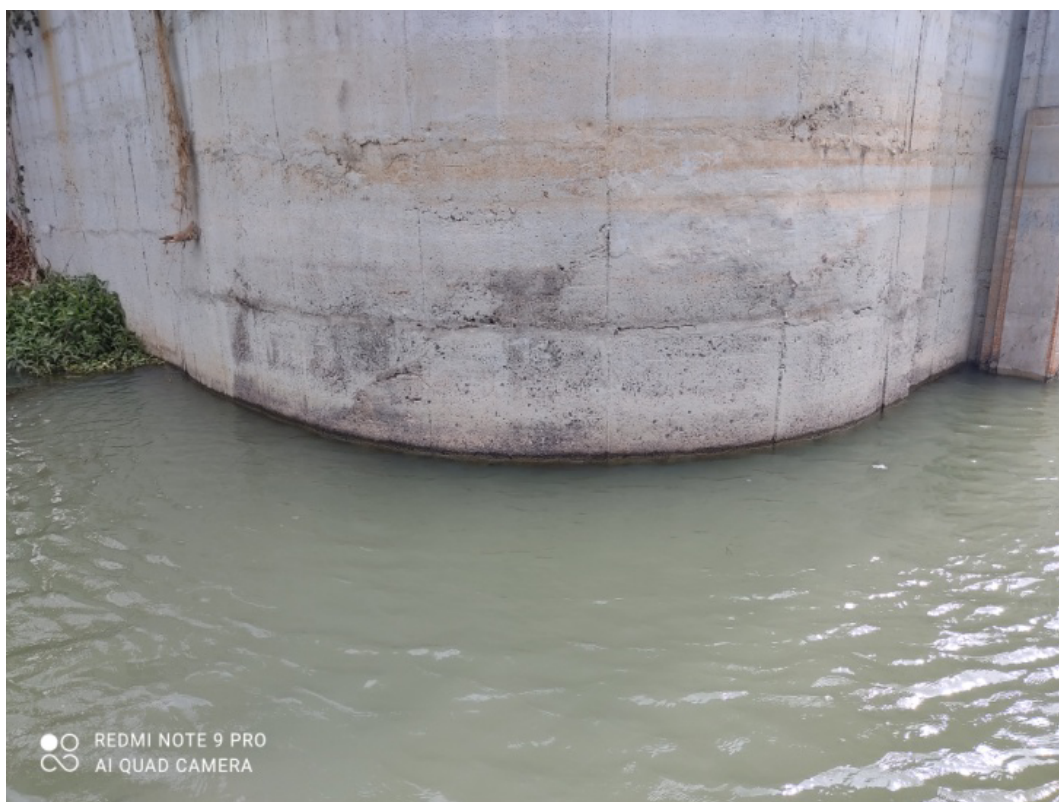
Guide Walls /Side Walls show patches of honey combing in concrete, cracks, and gaps in concrete. Presence of vegetation in adjacent portions is also visible. The lock approach structures require NDT investigations at different points to ascertain condition of concrete and corrosion.

**Figure 4.79 Guide Walls Damaged & Vegetation**

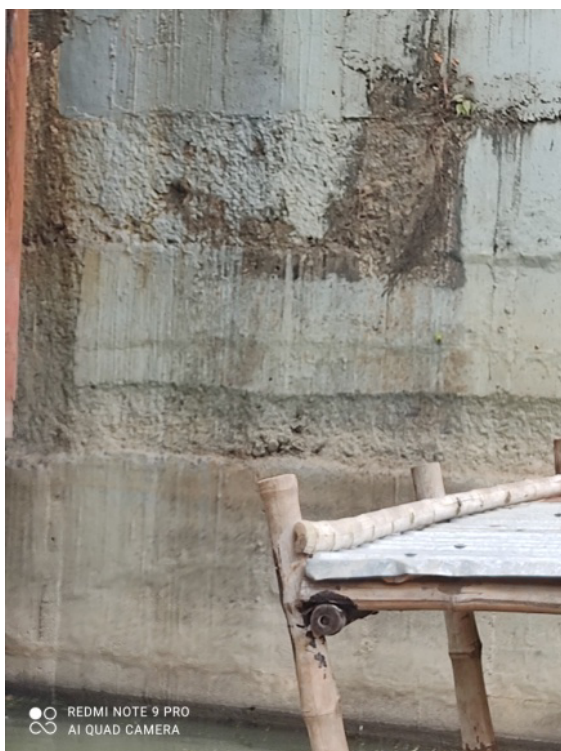
**Figure 4.20 Guide Walls Damaged – Honey Combing & Cracks**
