**Subject:** Revised Condition Survey Report of Consultancy Services for Preparation of Detailed Project Report (DPR) for the work of Renovation/Modernization of Existing Navigation Lock at Farakka.

## CONSULTANCY SERVICES FOR PREPARATION OF DETAILED PROJECT REPORT (DPR) FOR THE WORK OF RENOVATION/MODERNIZATION OF EXISTING NAVIGATION LOCK AT FARAKKA

## Condition Survey Report

August 2022

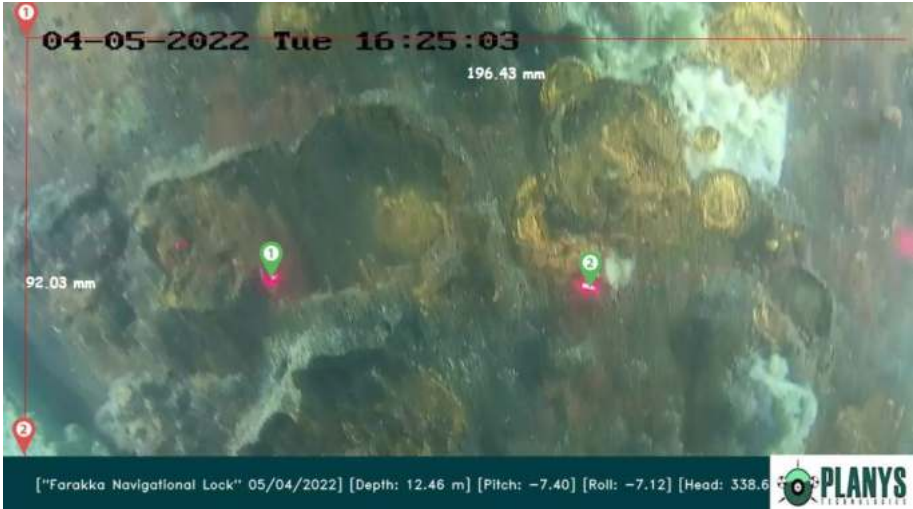
ID	Observation Type	Observation Details		Observations
		Location & Depth(m)	Dimension of Observations (L x W) (mm)	
O9	Corrosion/Major	Gate 1 West E & 12.46	196.43 X 92.03

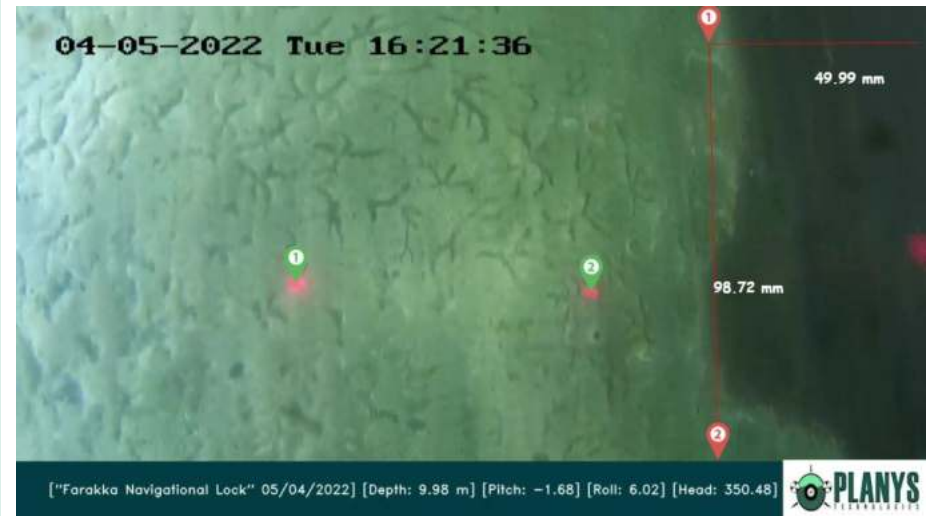
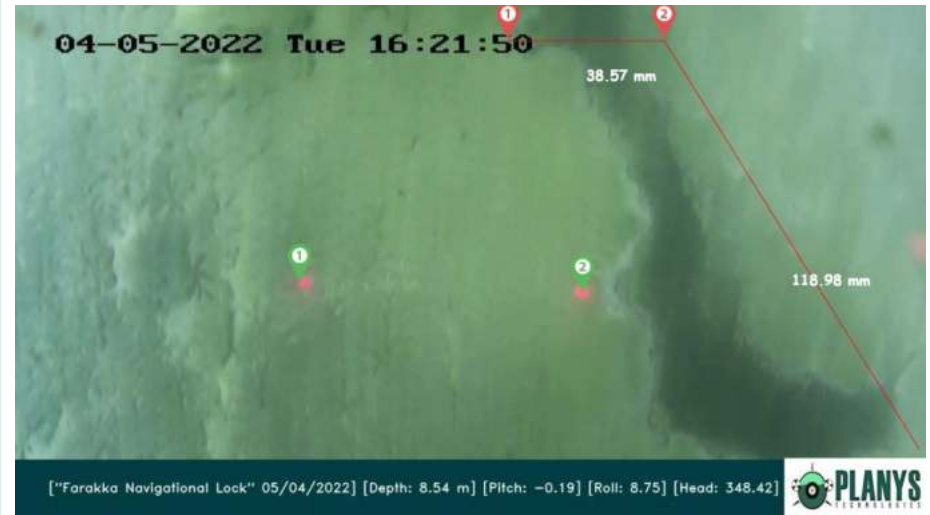
<p><b>O10</b></p>	<p>Cavity/Moderate</p>	<p>Gate 1 West F &amp; 9.98</p>	<p>98.72 X 49.99</p>
<p><b>O11</b></p>	<p>Cavity/Moderate</p>	<p>Gate 1 West F &amp; 8.54</p>	<p>118.98 X 38.57</p>

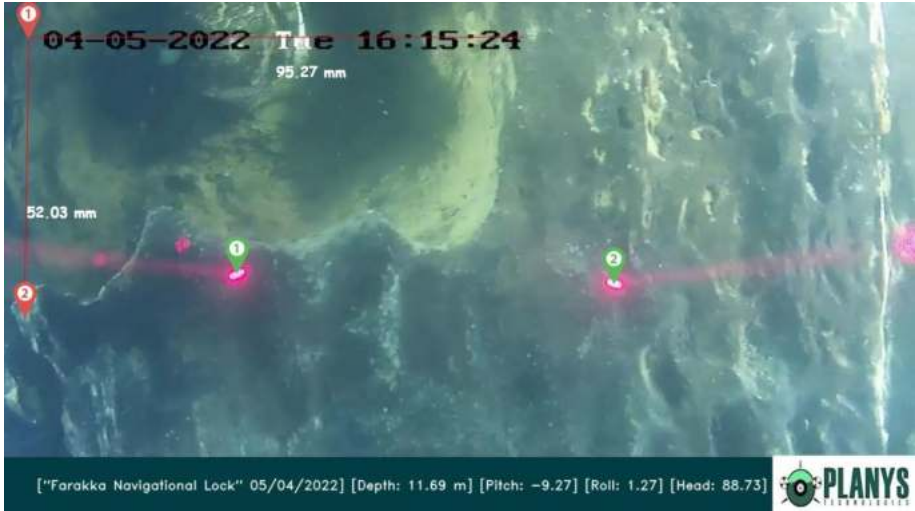
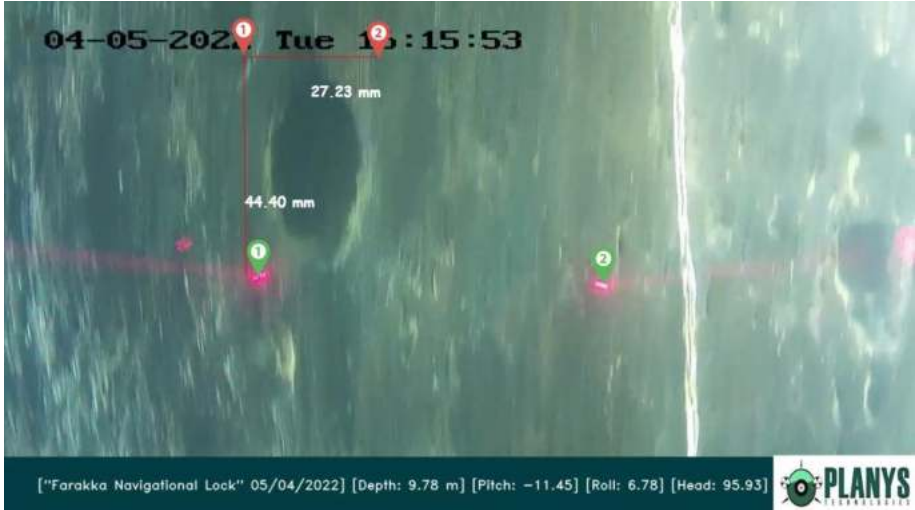
<p><b>O12</b></p>	<p>Cavity/Moderate</p>	<p>Gate 1 West H &amp; 11.69</p>	<p>95.27 X 52.03</p>
<p><b>O13</b></p>	<p>Cavity/Minor</p>	<p>Gate 1 West H &amp; 9.78</p>	<p>44.40 X 27.23</p>

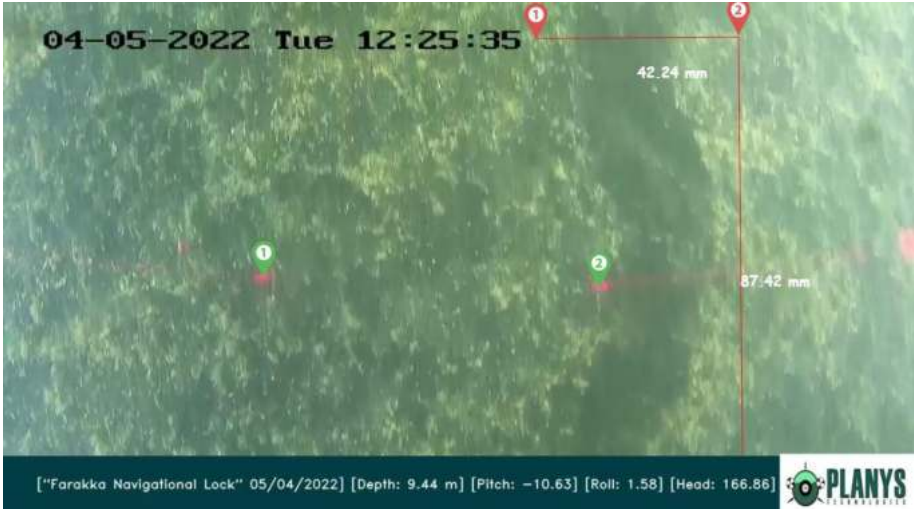
O21	Cavity/Moderate	Gate 2 East J & 9.44	87.42 X 42.24
-----	-----------------	----------------------------	---------------

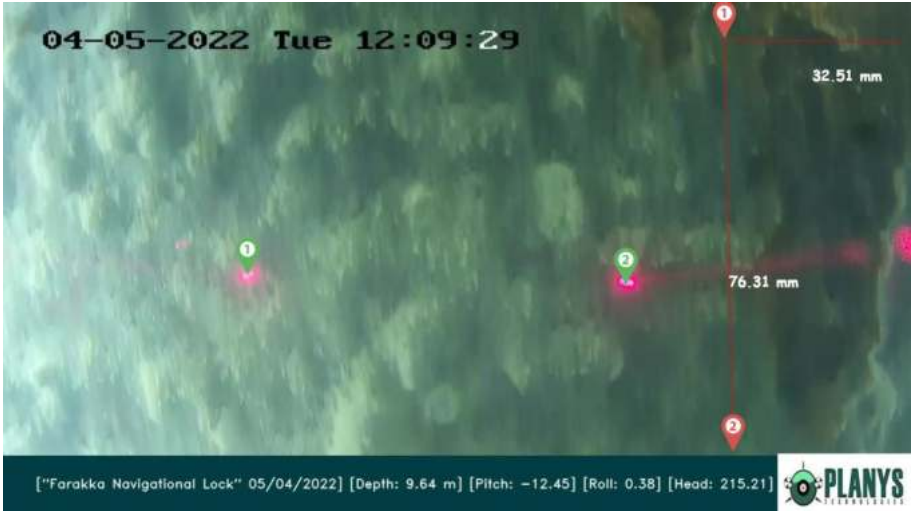
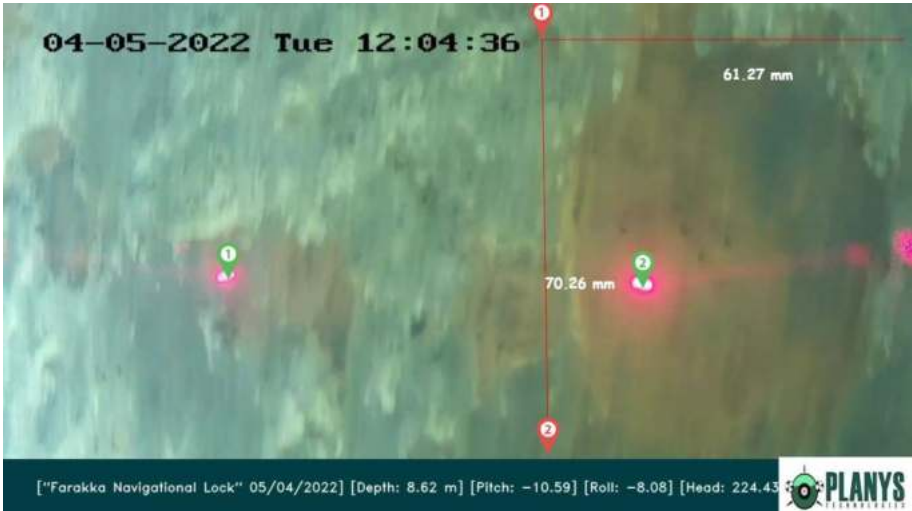
<p><b>O23</b></p>	<p>Cavity/Moderate</p>	<p>Gate 2 West B &amp; 9.64</p>	<p>76.31 X 32.51</p>
<p><b>O24</b></p>	<p>Corrosion/Moderate</p>	<p>Gate 2 West F &amp; 8.62</p>	<p>70.26 X 61.27</p>

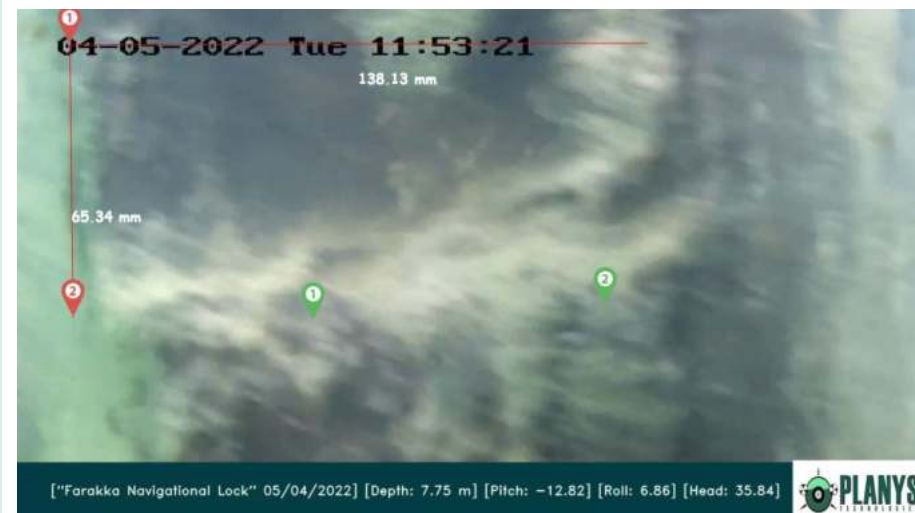
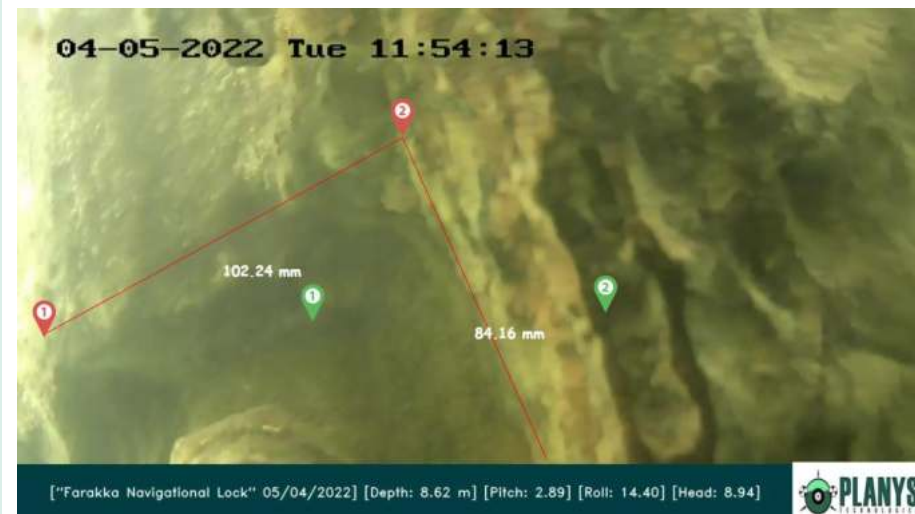
<p><b>O25</b></p>	<p>Cavity/Moderate</p>	<p>Gate 2 West H &amp; 7.75</p>	<p>138.13 X 65.34</p>
<p><b>O26</b></p>	<p>Cavity/Moderate</p>	<p>Gate 2 West H &amp; 8.62</p>	<p>102.24 X 84.16</p>

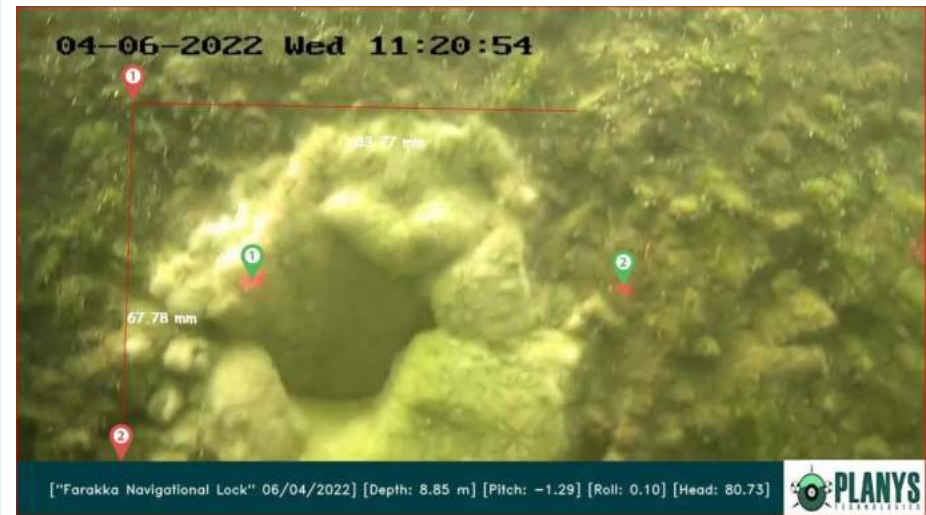
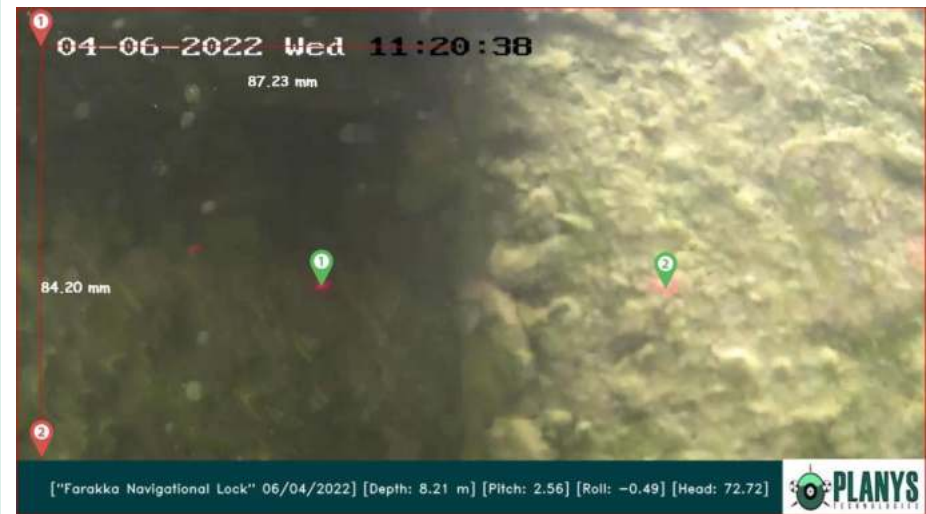
<p><b>O32</b></p>	<p>Cavity/Moderate</p>	<p>Wall West 2 &amp; 8.85</p>	<p>83.77 X 67.78</p>
<p><b>O33</b></p>	<p>Cavity/Moderate</p>	<p>Wall West 2 &amp; 8.21</p>	<p>87.23 X 84.20</p>

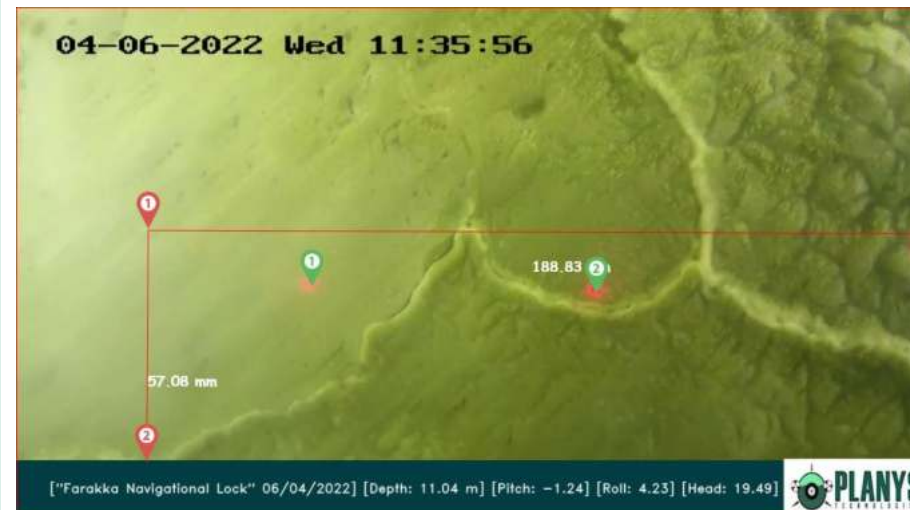
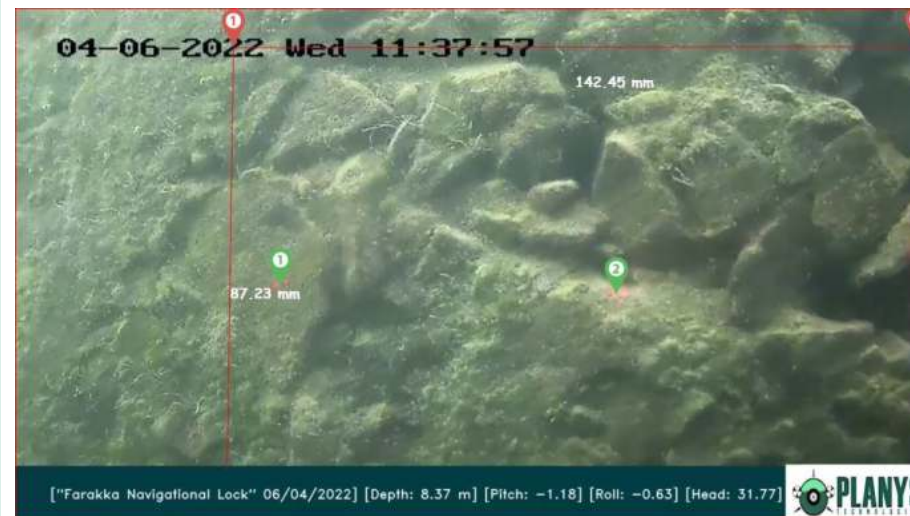
<p><b>O38</b></p>	<p>Crack/Major</p>	<p>Wall West 5 &amp; 11.04</p>	<p>188.83 X 57.08</p>
<p><b>O39</b></p>	<p>Honeycomb Formation/Moderate</p>	<p>Wall West 6 &amp; 8.37</p>	<p>142.45 X 87.23</p>

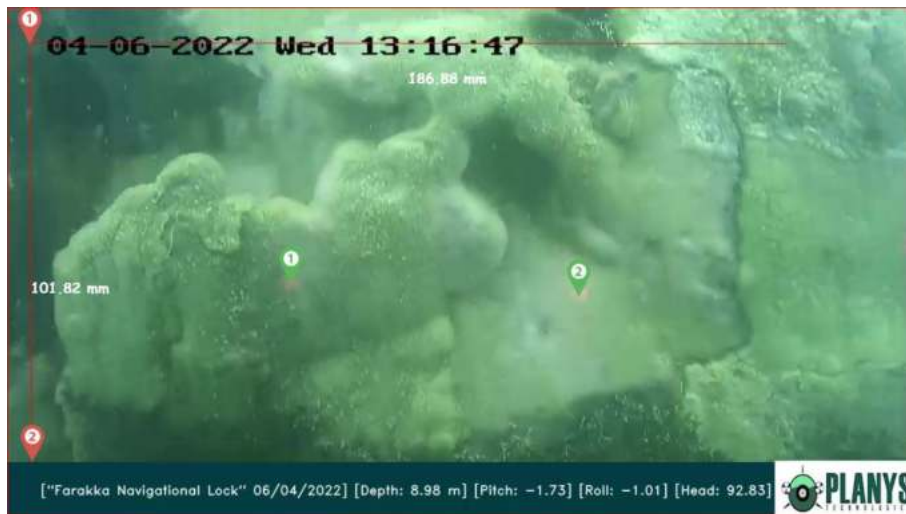
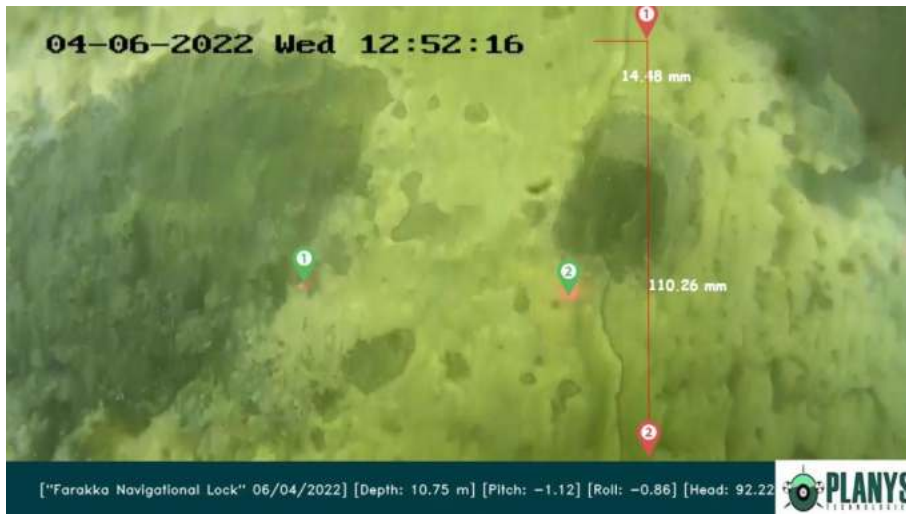
<p><b>O52</b></p>	<p>Cavity/Major</p>	<p>Wall East 6 &amp; 8.98</p>	<p>186.88 X 101.82</p>
<p><b>O53</b></p>	<p>Crack/Moderate</p>	<p>Wall East 11 &amp; 10.75</p>	<p>110.26 X 14.48</p>

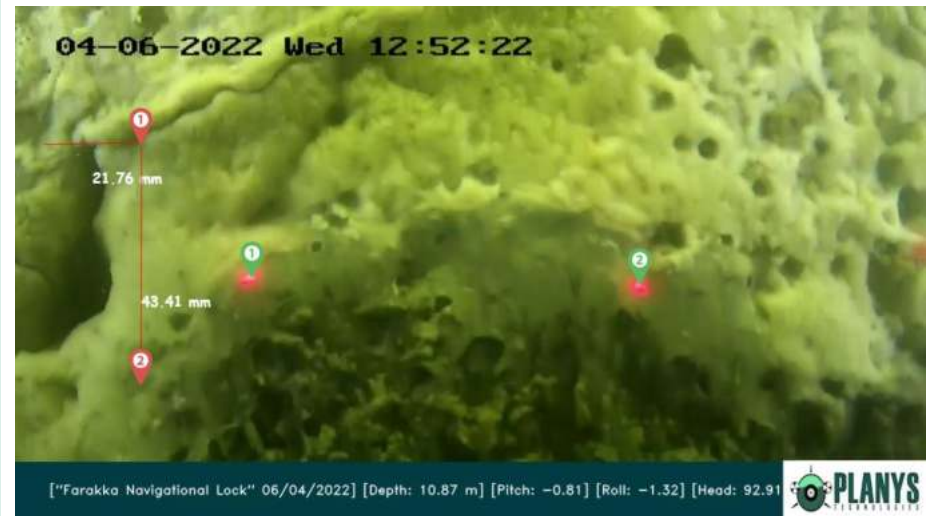
O54	Cavity/Minor	Wall East 11 & 10.87	43.41 X 21.76
-----	--------------	----------------------------	---------------

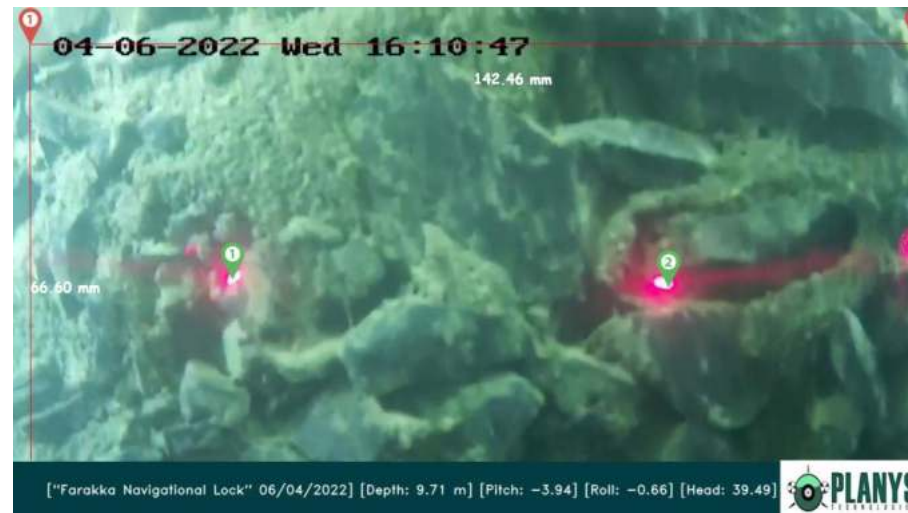
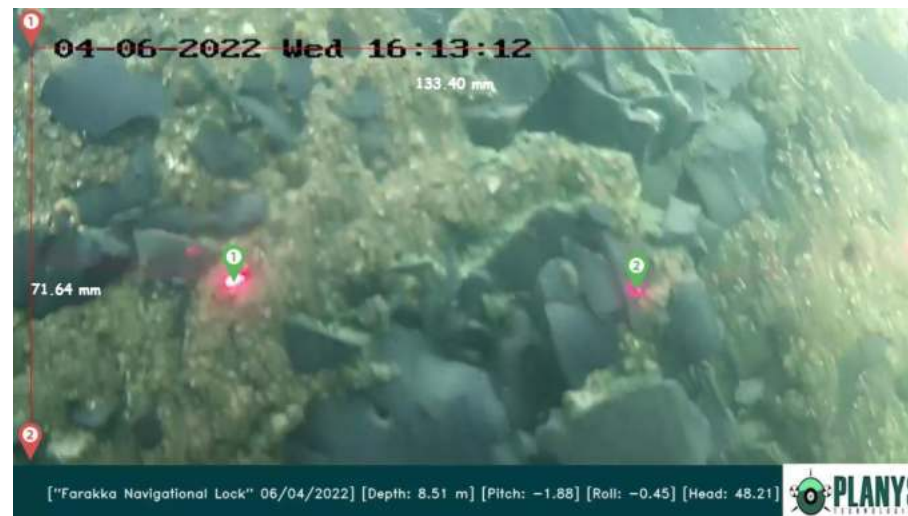
<p><b>O56</b></p>	<p>Cavity and Honeycomb Formation/Moderate</p>	<p>Wall East 19 West 19 &amp; 9.71</p>	<p>142.46 X 66.60</p>
<p><b>O57</b></p>	<p>Honeycomb Formation/Moderate</p>	<p>Wall West 20 East 20 &amp; 8.51</p>	<p>133.40 X 71.64</p>

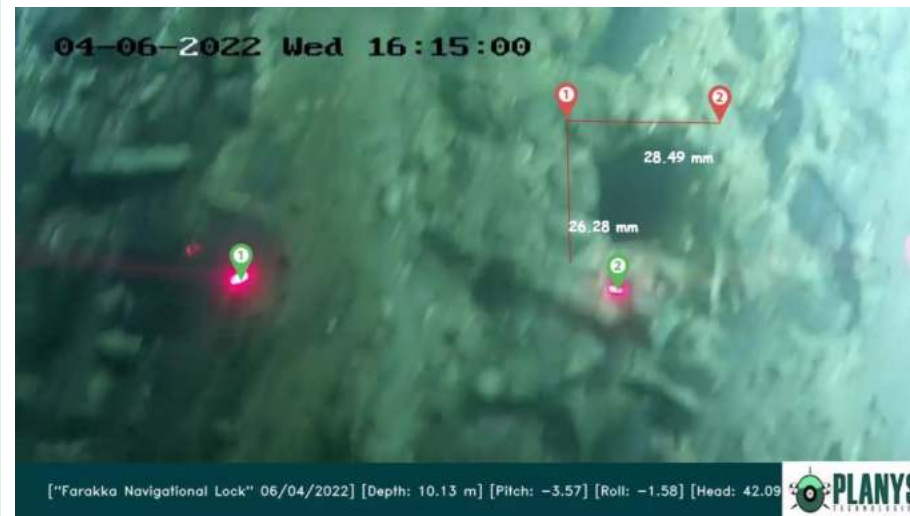
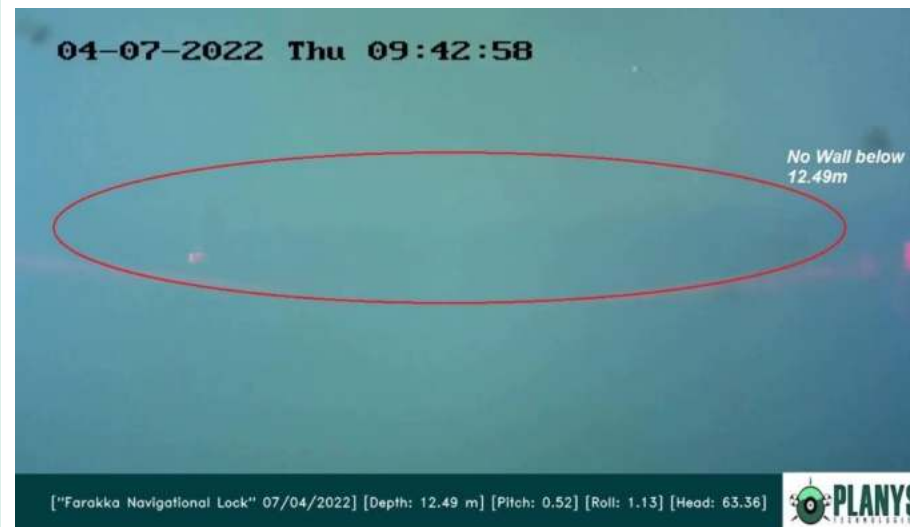
058	Cavity/Minor	Wall West 20 East 20 & 10.13	28.49 X 26.28
059	No Wall/Major	Wall West 23 East 23 & 12.49	NA X NA

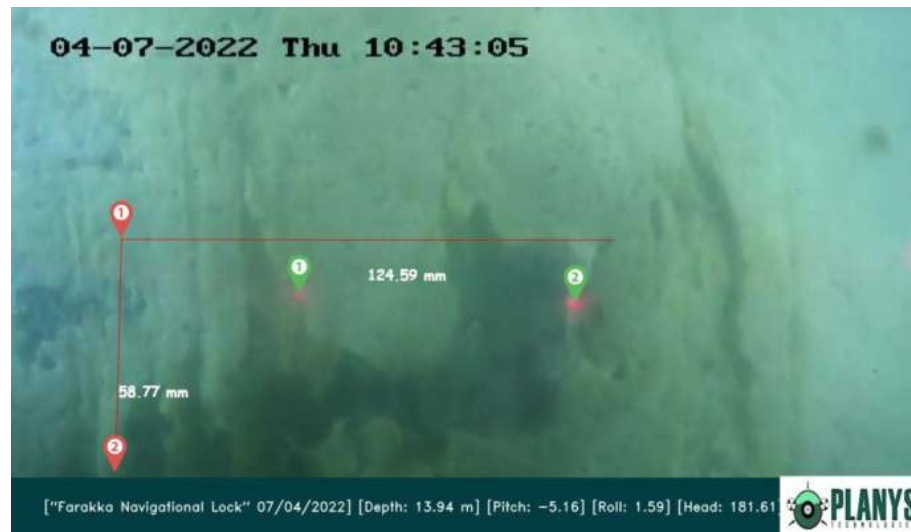
<p><b>060</b></p>	<p>Surface Deformation/Moderate</p>	<p>Wall West 25 East 25 &amp; 13.94</p>	<p>124.59 X 58.77</p>
<p><b>061</b></p>	<p>Cavity/Moderate</p>	<p>Wall West 27 East 27 &amp; 8.98</p>	<p>78.62 X 45.07</p>

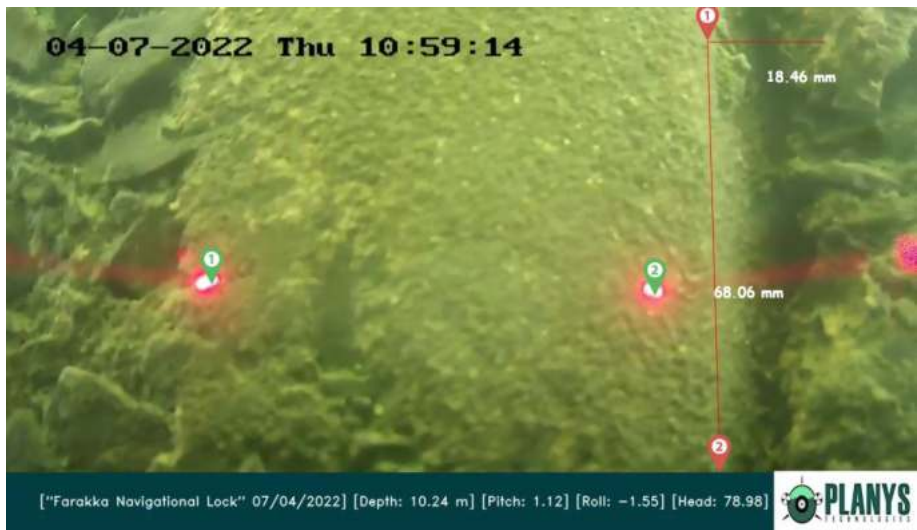
<p><b>O62</b></p>	<p>Cavity/Minor</p>	<p>Wall West 27 East 27 &amp; 10.24</p>	<p>68.06 X 18.46</p>
<p><b>O63</b></p>	<p>Cavity and Honeycomb Formation/Major</p>	<p>Wall West 27 East 27 &amp; 8.20</p>	<p>292.21 X 141.25</p>

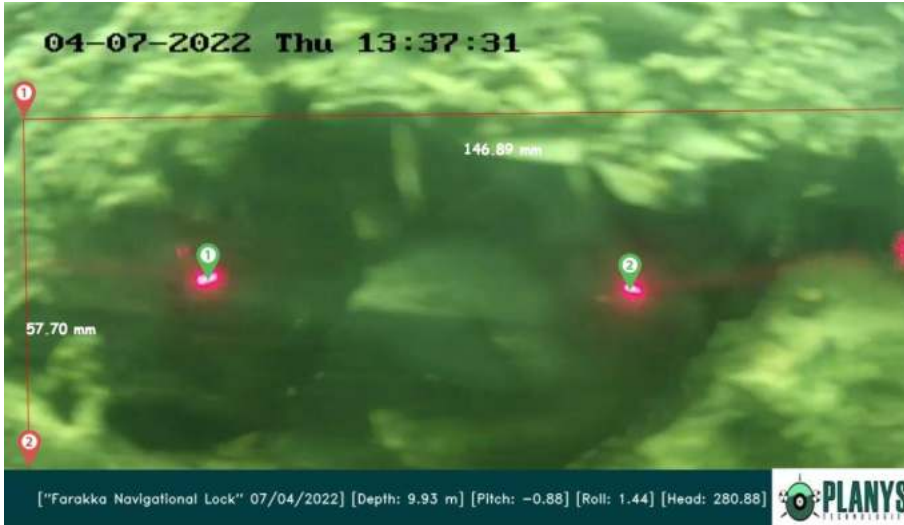
ID	Observation Type	Observation Details		Observations
		Location & Depth(m)	Dimension of Observations (L x W) (mm)	
O65	Cavity/Moderate	Wall West 34 East 34 & 9.93	146.89 X 57.70

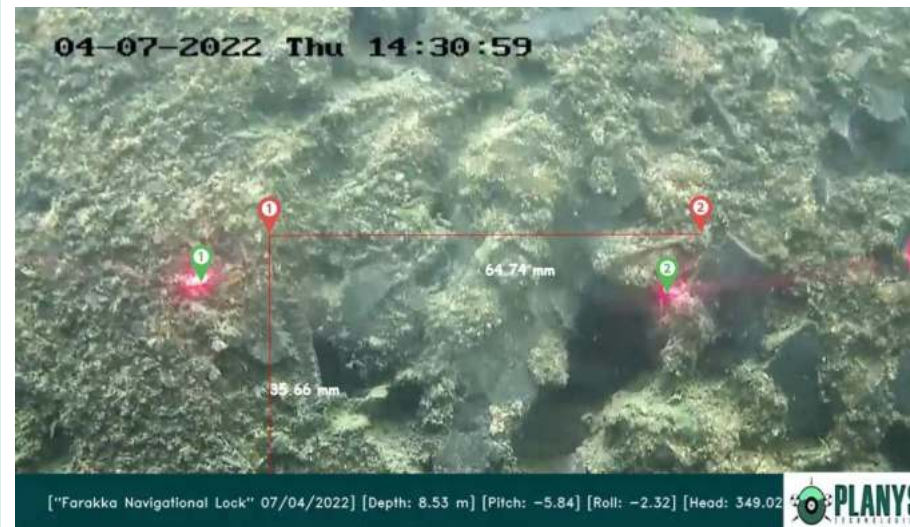
<p><b>O68</b></p>	<p>Cavity/Minor</p>	<p>Wall West 38 East 38 &amp; 8.53</p>	<p>64.74 X 35.66</p>
<p><b>O69</b></p>	<p>Surface Deformation/Moderate</p>	<p>Wall East 41 West 41 &amp; 9.06</p>	<p>150.63 X 55.24</p>

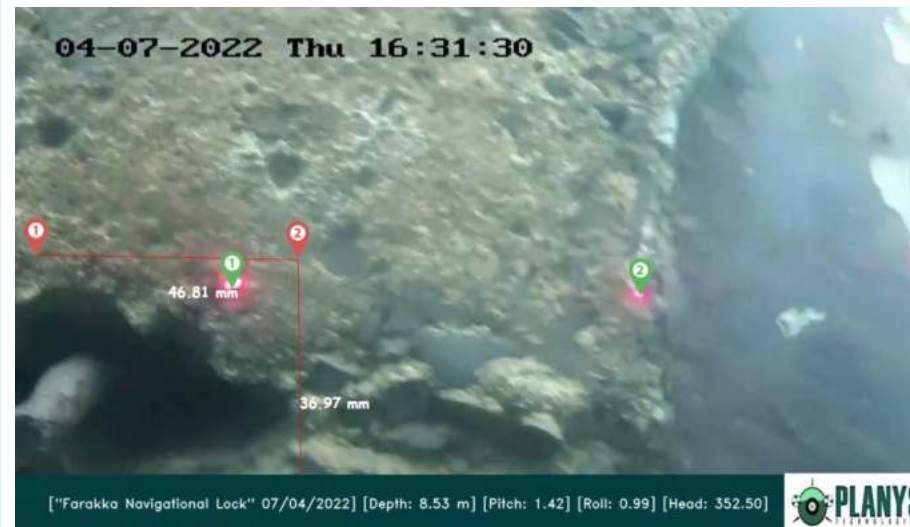
<p><b>O70</b></p>	<p>Cavity/Minor</p>	<p>Wall East 43 West 43 &amp; 8.53</p>	<p>46.81 X 36.97</p>
<p><b>O71</b></p>	<p>Debris/Minor</p>	<p>Wall West 44 East 44 &amp; 13.51</p>	<p>NA X NA</p>

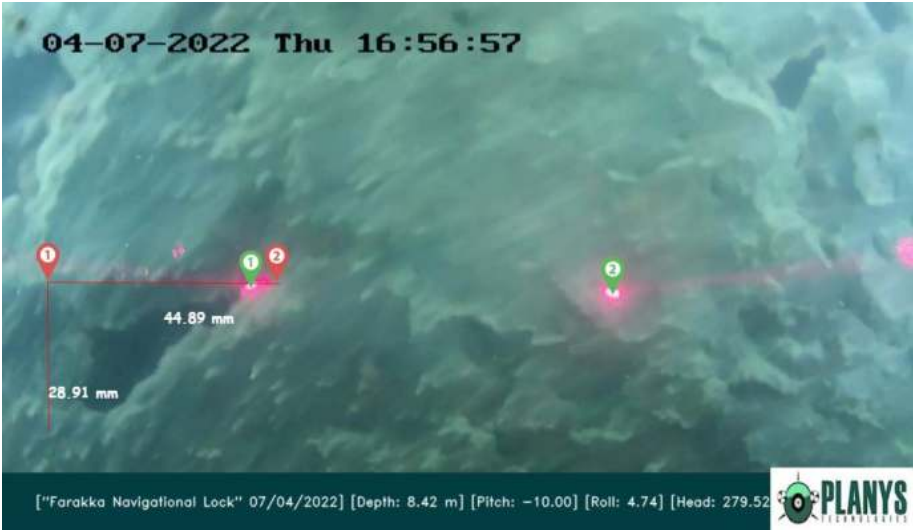
O72	Cavity/Minor	Wall West 44 East 44 & 8.42	44.89 X 28.91
-----	--------------	-----------------------------------	---------------

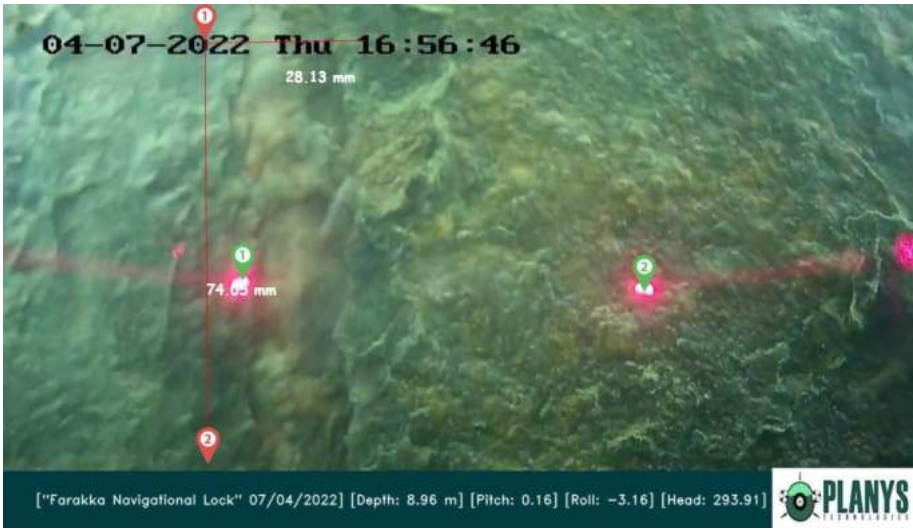
O73	Surface Deformation/Minor	Wall West 44 East 44 & 8.96	74.05 X 28.13
-----	---------------------------	-----------------------------------	---------------

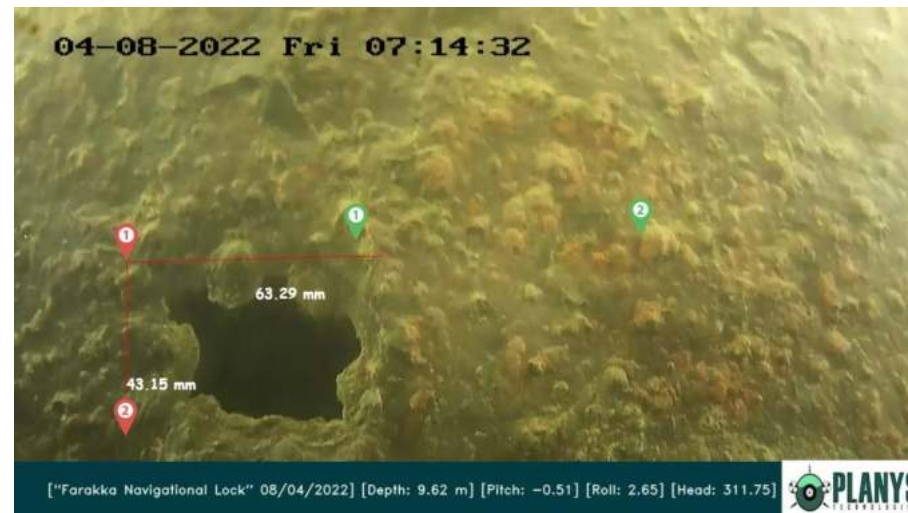
<p><b>O74</b></p>	<p>Cavity/Minor</p>	<p>Wall East 45 West 45 &amp; 9.62</p>	<p>63.29 X 43.15</p>
<p><b>O75</b></p>	<p>Cavity/Moderate</p>	<p>Wall East 45 West 45 &amp; 10.18</p>	<p>118.00 X 73.12</p>

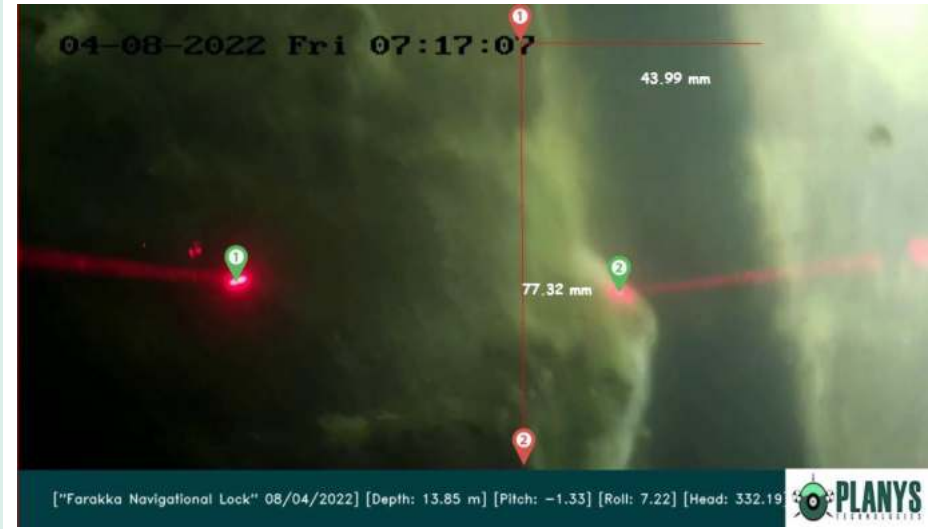
O76	Debonding Between Two Layers/Moderate	Wall East 45 West 45 & 13.85	77.32 X 43.99
-----	---------------------------------------	------------------------------------	---------------

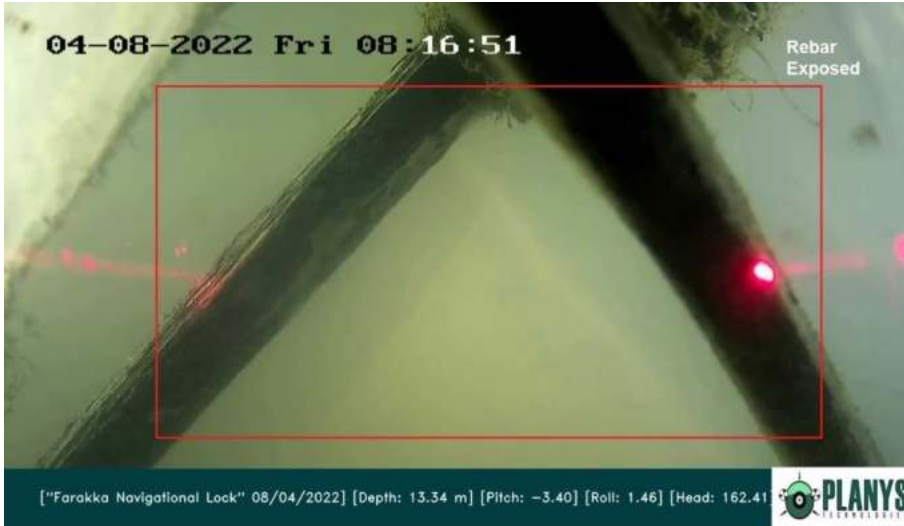
ID	Observation Type	Observation Details		Observations
		Location & Depth(m)	Dimension of Observations (L x W) (mm)	
O77	Rebar Protruding/Minor	Wall East49 West49 & 13.34	NA X NA

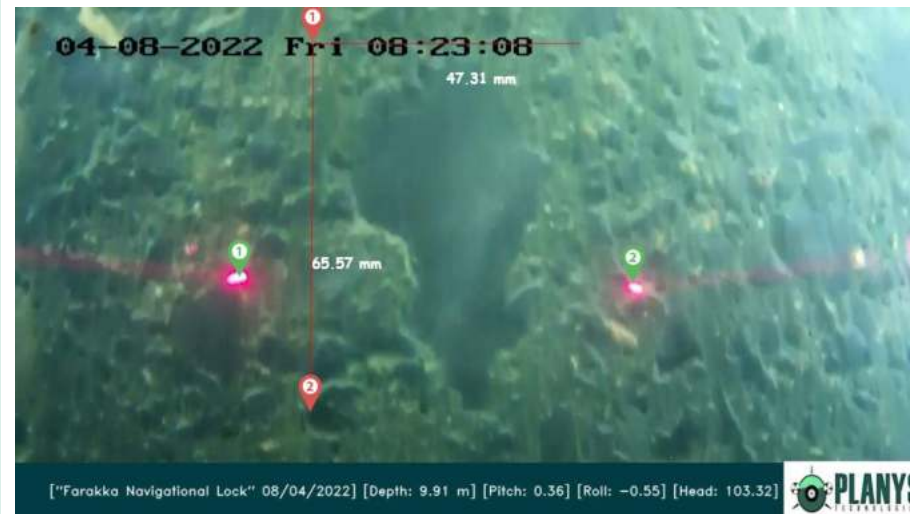
O78	Pin Holes/Minor	Wall East49 West49 & 9.91	65.57 X 47.31
-----	-----------------	---------------------------------	---------------

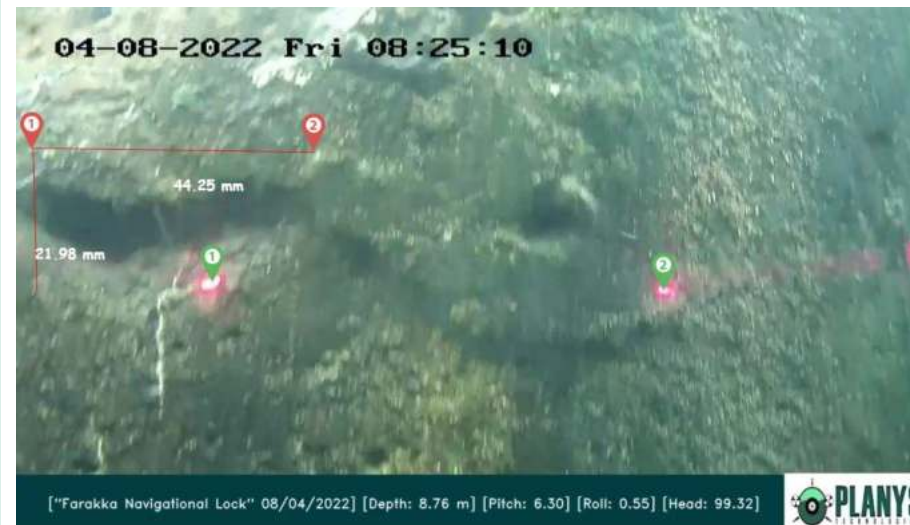
O79	Cavity/Minor	Wall West50 East50 & 8.76	44.25 X 21.98
-----	--------------	---------------------------------	---------------

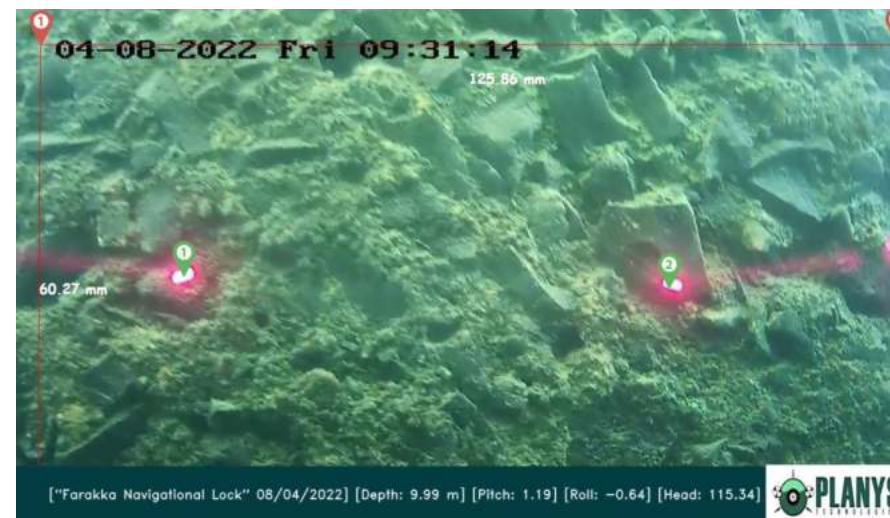
<p><b>O84</b></p>	<p>Honeycomb Formation/Moderate</p>	<p>Wall East55 West55 &amp; 9.99</p>	<p>125.86 X 60.27</p>
<p><b>O85</b></p>	<p>Cavity and Honeycomb Formation/Moderate</p>	<p>Wall West60 East60 &amp; 9.68</p>	<p>135.78 X 65.8</p>

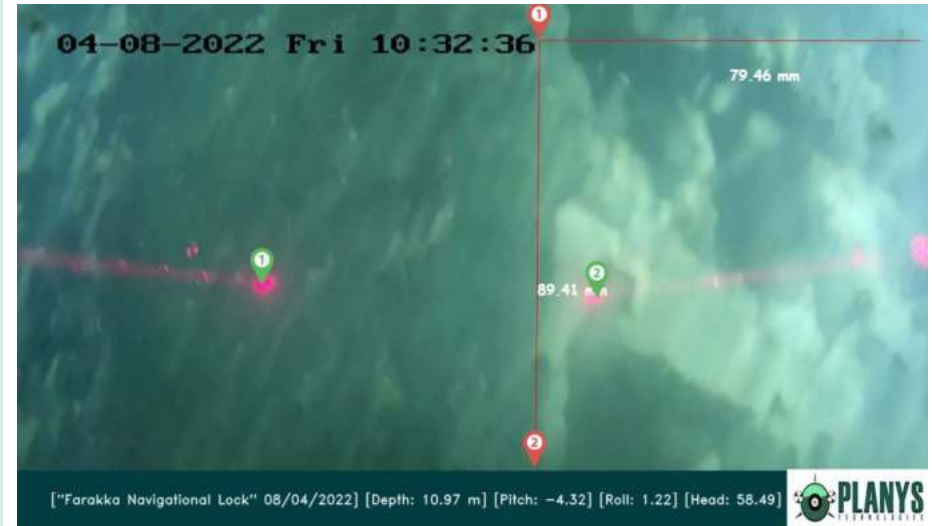
<b>O86</b>	Cavity/Moderate	Wall West60 East60 & 10.97	89.41 X 79.46
------------	-----------------	----------------------------------	---------------

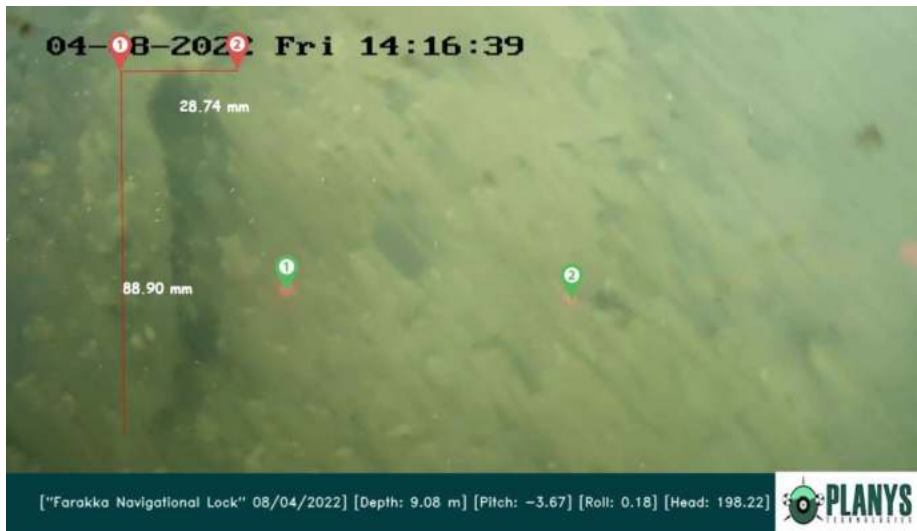
<p><b>O88</b></p>	<p>Cavity/Moderate</p>	<p>Wall East66 West66 &amp; 9.08</p>	<p>88.9 X 28.74</p>
<p><b>O89</b></p>	<p>Surface Deformation/Moderate</p>	<p>Wall East66 West66 &amp; 12.57</p>	<p>116.97 X 103.46</p>

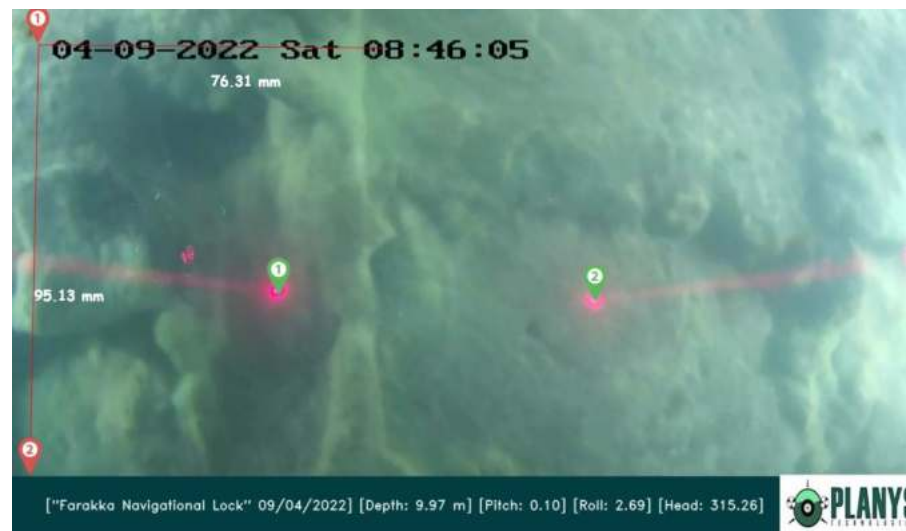
<p><b>O98</b></p>	<p>Surface Deformation/Minor</p>	<p>Wall East70 West70 &amp; 9.97</p>	<p>95.13 X 76.31</p>
<p><b>O99</b></p>	<p>Cavity/Minor</p>	<p>Wall East70 West70 &amp; 10.13</p>	<p>26.85 X 25.55</p>

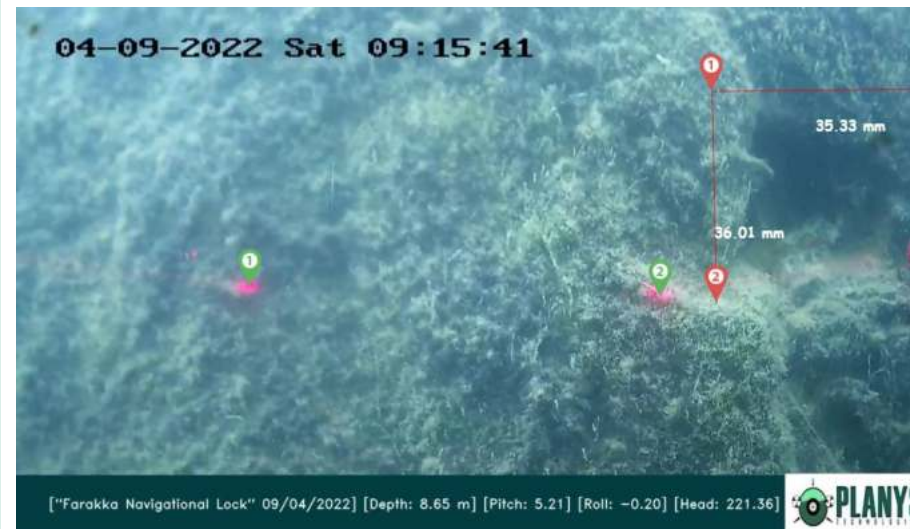
<p><b>O100</b></p>	<p>Cavity/Minor</p>	<p>Wall East71 West71 &amp; 8.65</p>	<p>36.01 X 35.33</p>
<p><b>O101</b></p>	<p>Cavity/Minor</p>	<p>Wall East72 West72 &amp; 10.01</p>	<p>30.72 X 19.09</p>

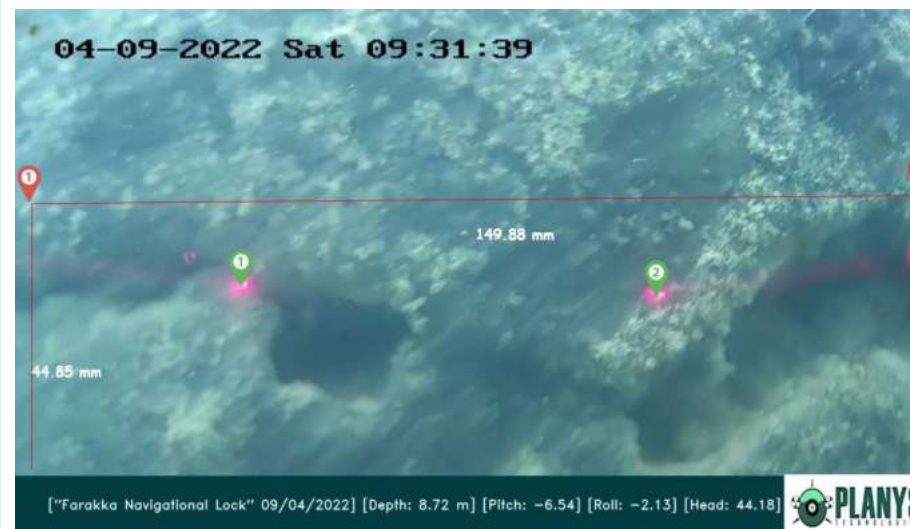
<p><b>O102</b></p>	<p>Cavity/Moderate</p>	<p>Wall East72 West72 &amp; 8.72</p>	<p>149.88 X 44.85</p>
<p><b>O103</b></p>	<p>Cavity/Moderate</p>	<p>Wall East73 West73 &amp; 8.73</p>	<p>143.90 X 20.70</p>

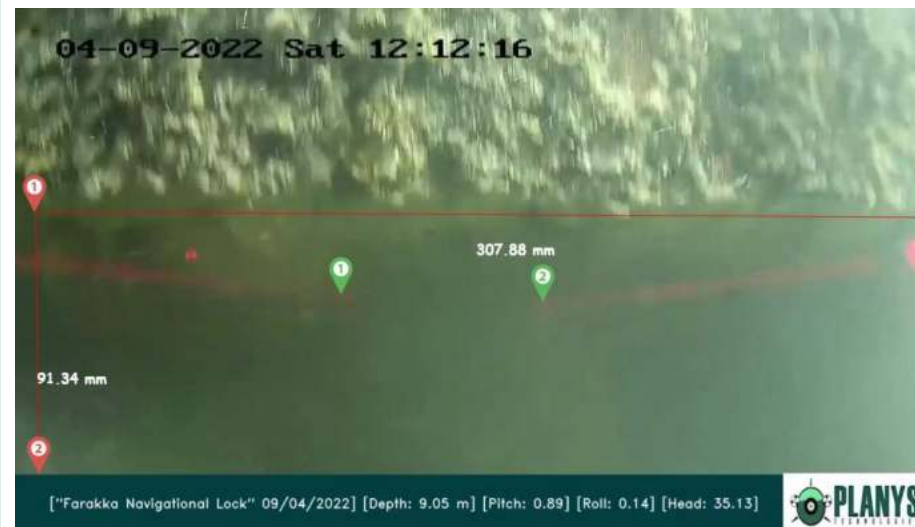
<p><b>O109</b></p>	<p>Cavity/Major</p>	<p>Wall East77 &amp; 9.05</p>	<p>307.88 X 91.34</p>
--------------------	---------------------	---------------------------------------	-----------------------

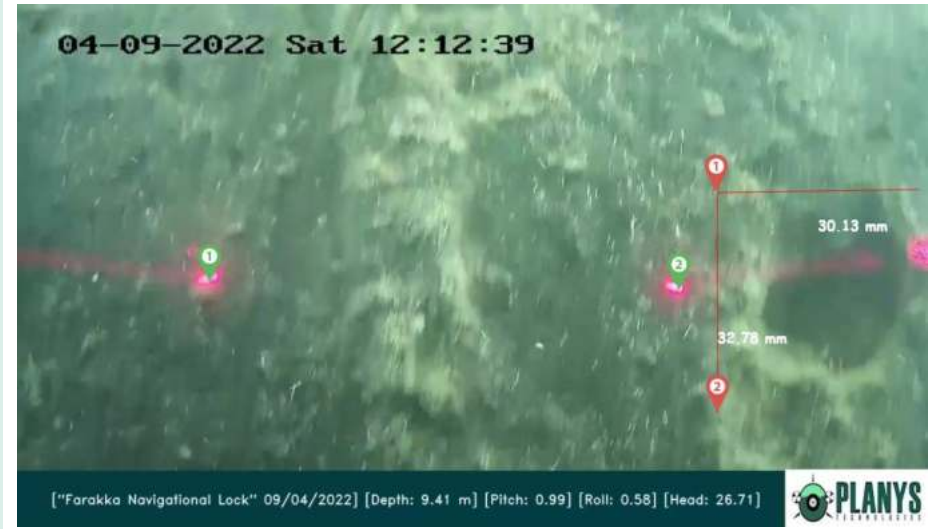
<p><b>O110</b></p>	<p>Cavity/Minor</p>	<p>Wall East77 &amp; 9.41</p>	<p>32.78 X 30.13</p>
<p><b>O111</b></p>	<p>Cavity/Major</p>	<p>Wall East77 &amp; 10.24</p>	<p>152.28 X 62.16</p>

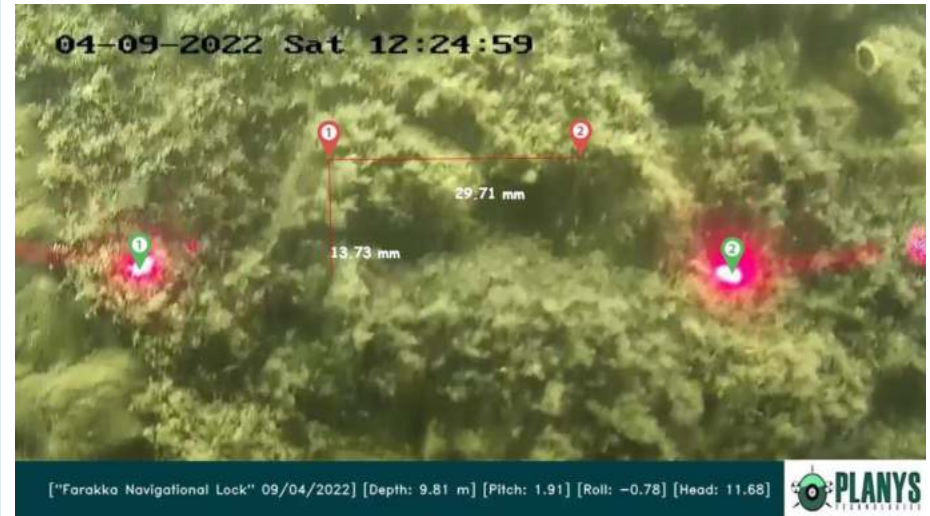
<p><b>O112</b></p>	<p>Pin Holes/Minor</p>	<p>Wall East80 &amp; 9.81</p>	<p>29.71 X 13.73</p>
<p><b>O113</b></p>	<p>Pin Holes/Minor</p>	<p>Wall East81 &amp; 8.64</p>	<p>24.55 X 20.61</p>

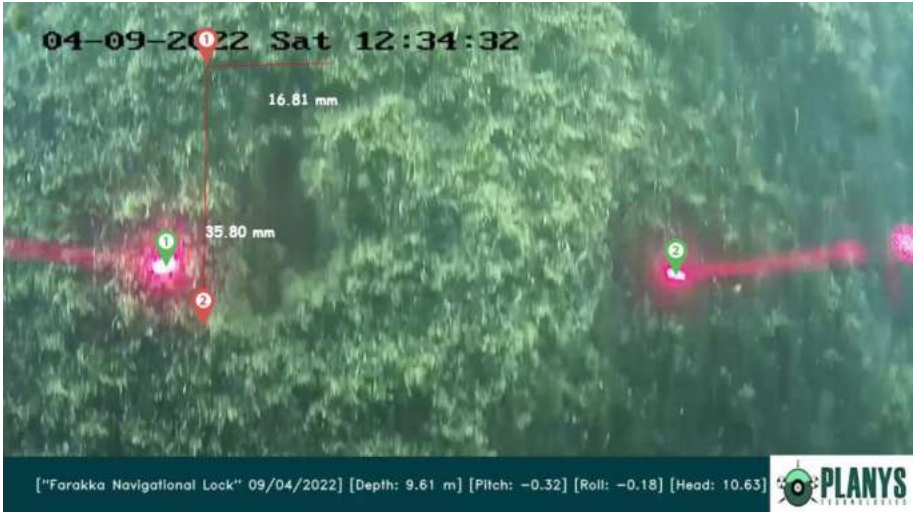
<b>O114</b>	Pin Holes/Minor	Wall East83 & 9.61	35.80 X 16.81
-------------	-----------------	--------------------------	---------------
