**Subject:** Revised Condition Survey Report of Consultancy Services for Preparation of Detailed Project Report (DPR) for the work of Renovation/Modernization of Existing Navigation Lock at Farakka.

## CONSULTANCY SERVICES FOR PREPARATION OF DETAILED PROJECT REPORT (DPR) FOR THE WORK OF RENOVATION/MODERNIZATION OF EXISTING NAVIGATION LOCK AT FARAKKA

## Condition Survey Report

August 2022

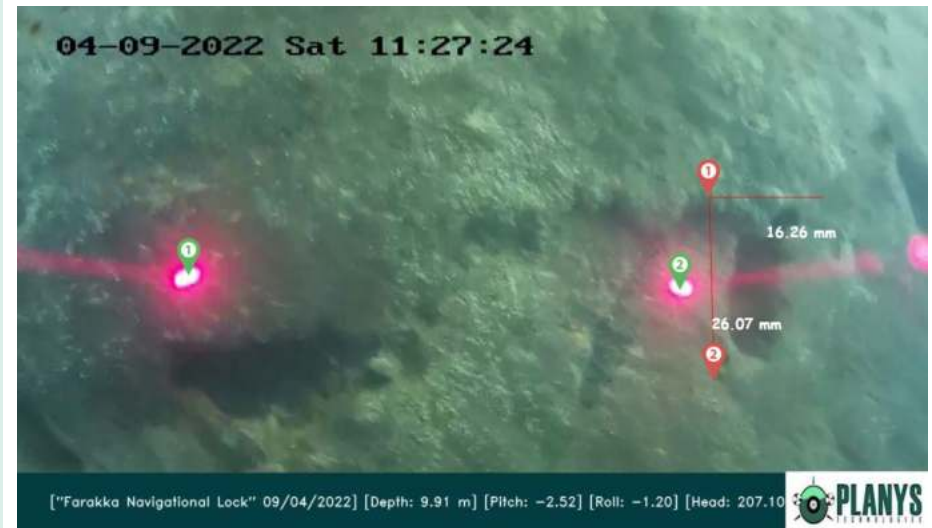
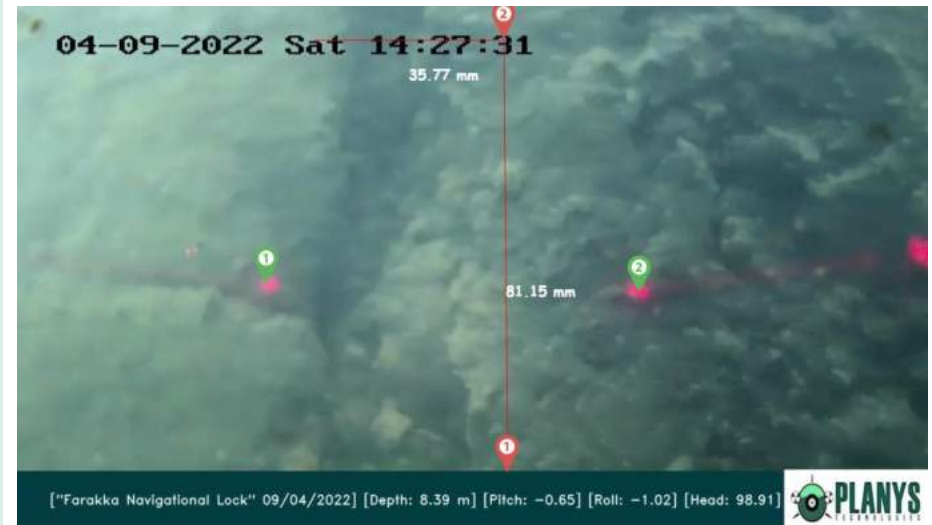
<p><b>O116</b></p>	<p>Cavity/Minor</p>	<p>Wall West76 &amp; 9.91</p>	<p>26.07 X 16.26</p>
<p><b>O117</b></p>	<p>Cavity/Moderate</p>	<p>Wall West79 &amp; 8.39</p>	<p>81.15 X 35.77</p>

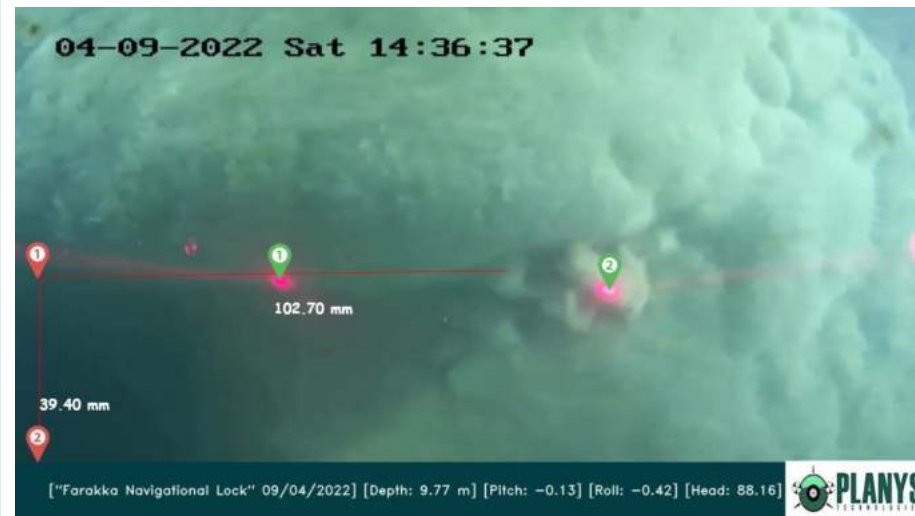
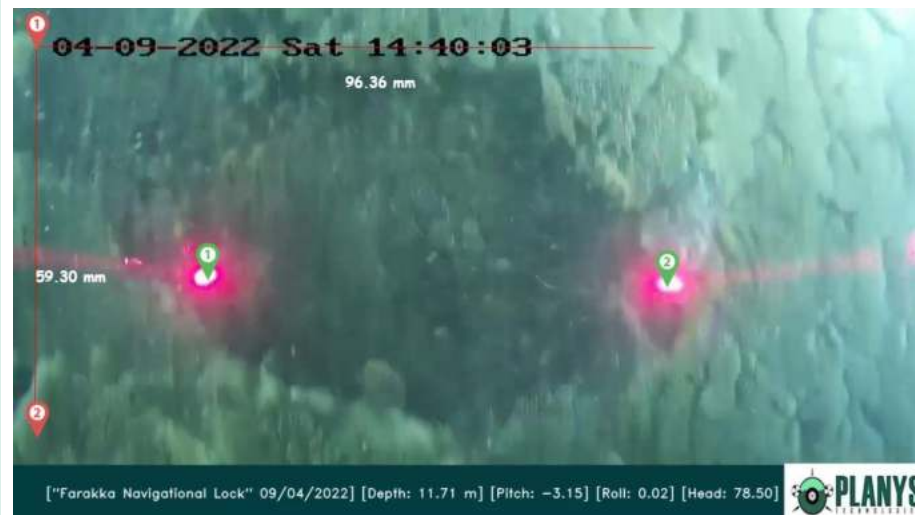
<p><b>O118</b></p>	<p>Cavity/Minor</p>	<p>Wall West79 &amp; 8.84</p>	<p>63.96 X 30.49</p>	
<p><b>O119</b></p>	<p>Cavity/Minor</p>	<p>Wall West80 &amp; 8.21</p>	<p>48.34 X 41.53</p>

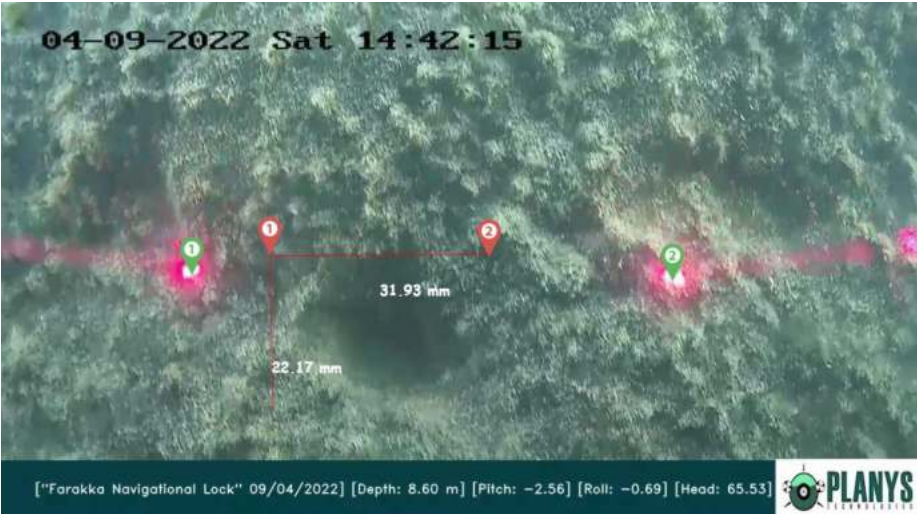
O122	Pin Holes/Minor	Wall West83 & 8.60	31.93 X 22.17
------	-----------------	--------------------------	---------------

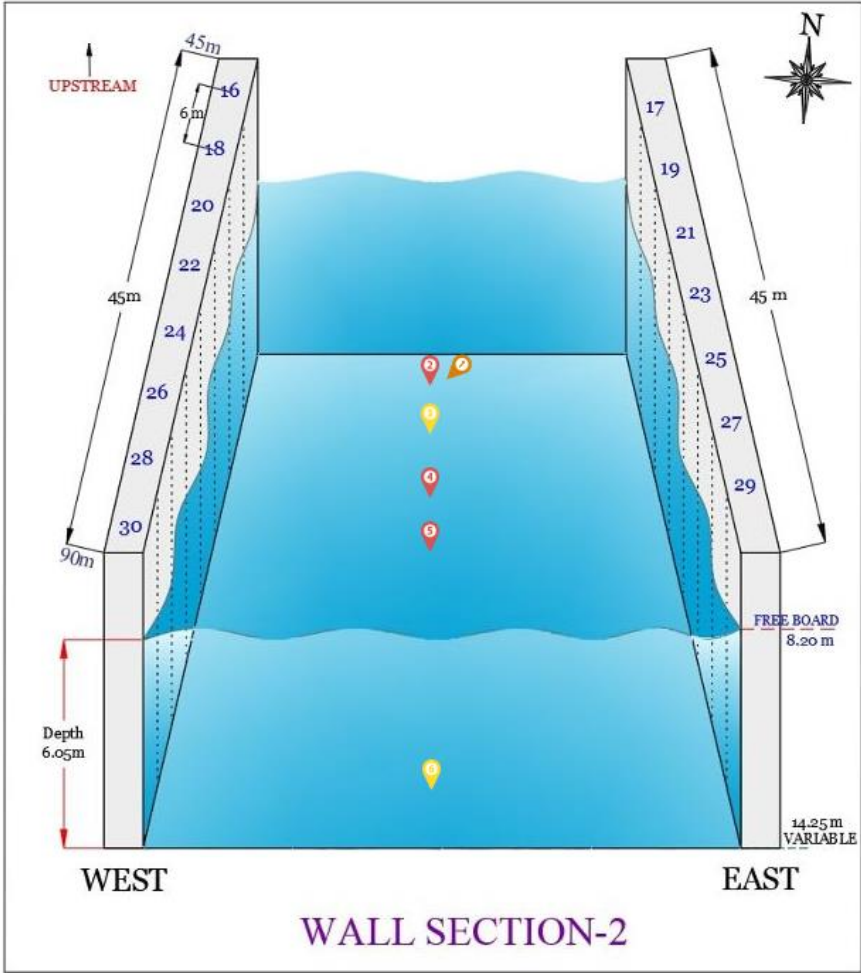
Figure 19: Heat map and Observations at Wall Bottom Section 16 - 30

ID	Observation Type	Observation Details		Observations
		Location & Depth(m)	Dimension of Observations (L x W) (mm)	
B1	Cavity/Moderate	Wall Bottom 16	106.51 X 48.93

<p><b>B2</b></p>	<p>Rebar Protruding/Major</p>	<p>Wall Bottom 16</p>	<p>NA X NA</p>
<p><b>B3</b></p>	<p>Surface Deformation/Minor</p>	<p>Wall Bottom 17</p>	<p>307.25 X 104.13</p>

<p><b>B4</b></p>	<p>Surface Deformation/Major</p>	<p>Wall Bottom 20</p>	<p>306.88 X 143.52</p>
<p><b>B5</b></p>	<p>Cavity/Major</p>	<p>Wall Bottom 22</p>	<p>195.05 X 142.98</p>

<p><b>B6</b></p>	<p>Construction Debris/Minor</p>	<p>Wall Bottom 29</p>	<p>NA X NA</p>	 
------------------	----------------------------------	-----------------------	----------------	---

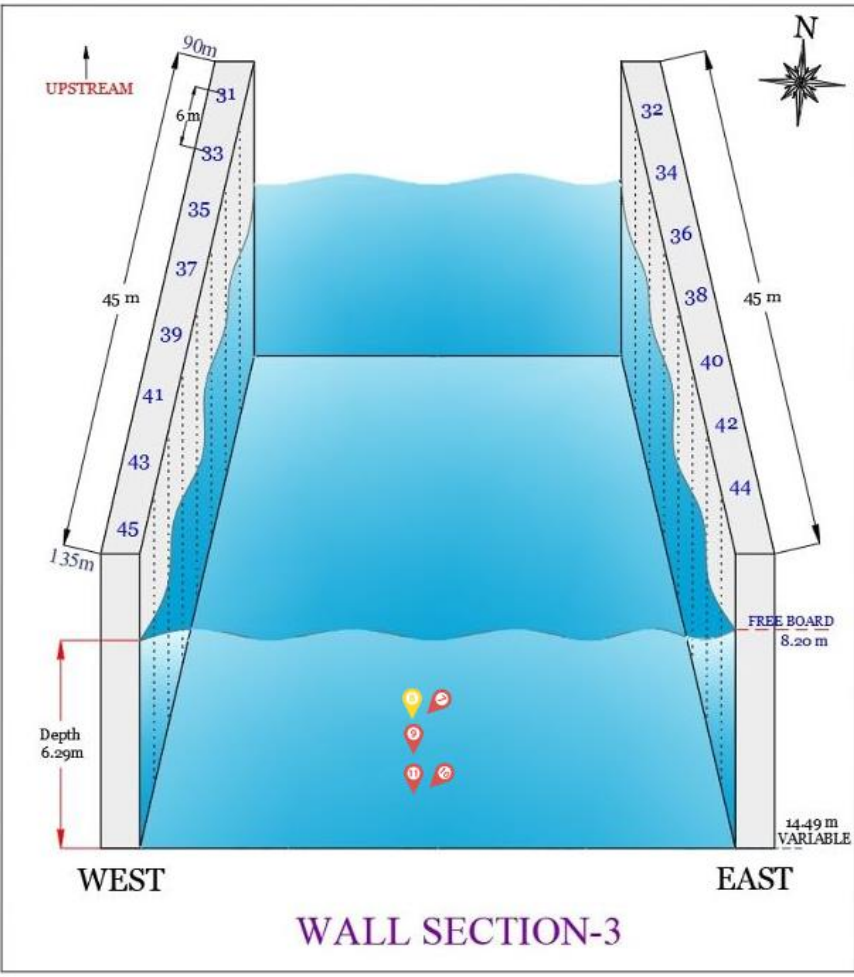
Figure 20: Heat map and Observations at Wall Bottom Section 31 - 45

ID	Observation Type	Observation Details		Observations
		Location & Depth(m)	Dimension of Observations (L x W) (mm)	
B7	Rebar Protruding/Major	Wall Bottom 41	NA X NA

<p><b>B8</b></p>	<p>Fishing Net/Minor</p>	<p>Wall Bottom 41</p>	<p>NA X NA</p>
<p><b>B9</b></p>	<p>Cavity/Major</p>	<p>Wall Bottom 42</p>	<p>379.86 X 178.09</p>

<p><b>B10</b></p>	<p>Cavity/Major</p>	<p>Wall Bottom 43</p>	<p>247.08 X 144.57</p>	
<p><b>B11</b></p>	<p>Cavity/Major</p>	<p>Wall Bottom 43</p>	<p>259.04 X 119.58</p>

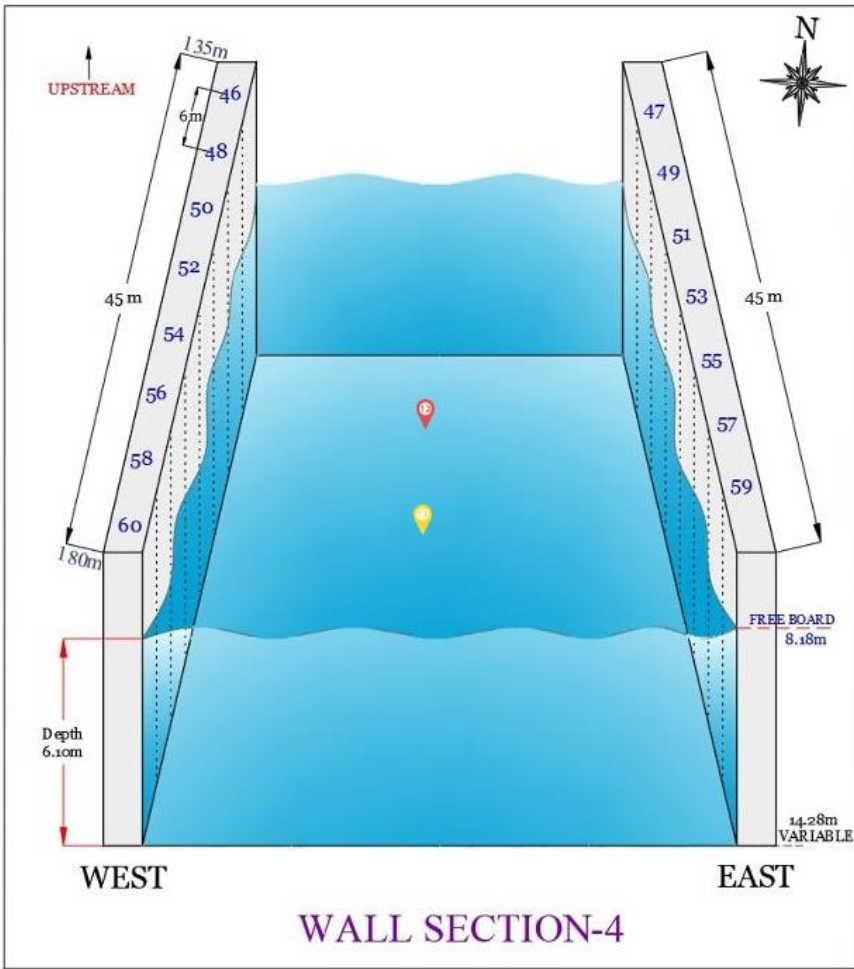
Figure 21: Heat map and Observations at Wall Bottom Section 46 - 60

ID	Observation Type	Observation Details		Observations
		Location & Depth(m)	Dimension of Observations (L x W) (mm)	
B12	Rebar Protruding/Major	Wall Bottom 49	NA X NA

<p><b>B13</b></p>	<p>Construction Debris/Minor</p>	<p>Wall Bottom 52</p>	<p>NA X NA</p>	
-------------------	----------------------------------	-----------------------	----------------	--

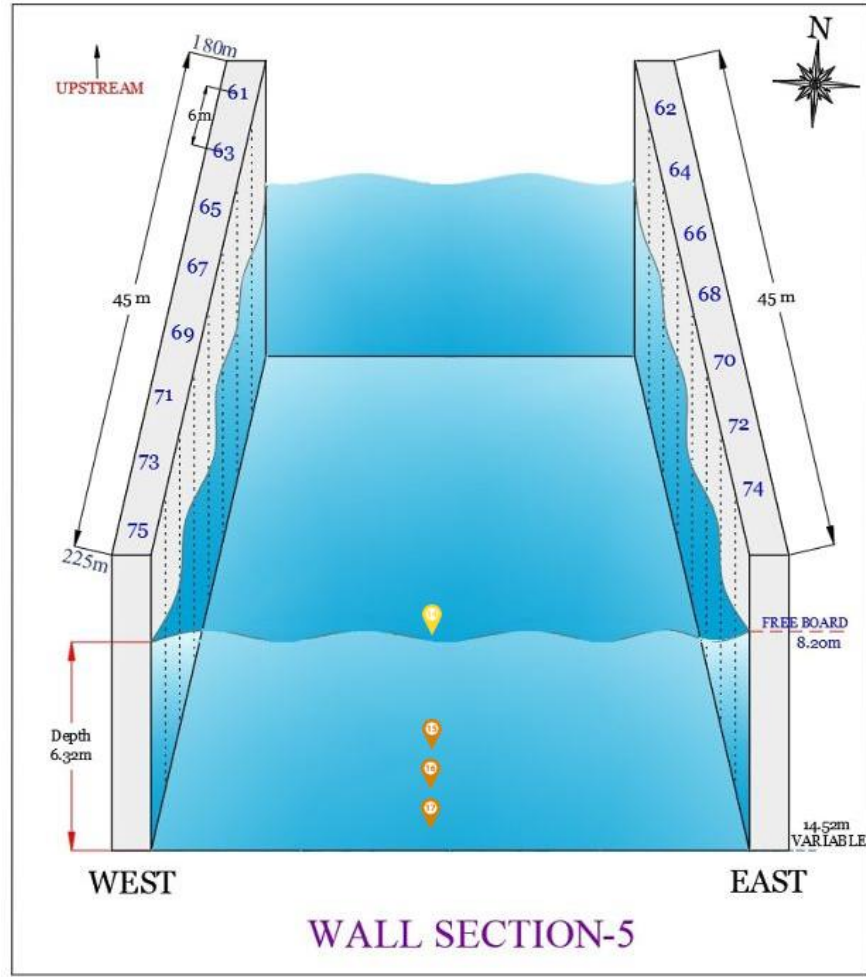
Figure 22: Heat map and Observations at Wall Bottom Section 61 - 75

ID	Observation Type	Observation Details		Observations
		Location & Depth(m)	Dimension of Observations (L x W) (mm)	
B14	Construction Debris/Minor	Wall Bottom 70	NA X NA

<p><b>B15</b></p>	<p>Cavity/Moderate</p>	<p>Wall Bottom 73</p>	<p>75.32 X 72.17</p>
<p><b>B16</b></p>	<p>Debonding Between Two Layers/Moderate</p>	<p>Wall Bottom 74</p>	<p>133.61 X 25.97</p>

B17	Cavity/Moderate	Wall Bottom 75	120.23 X 67.59
-----	-----------------	----------------	----------------

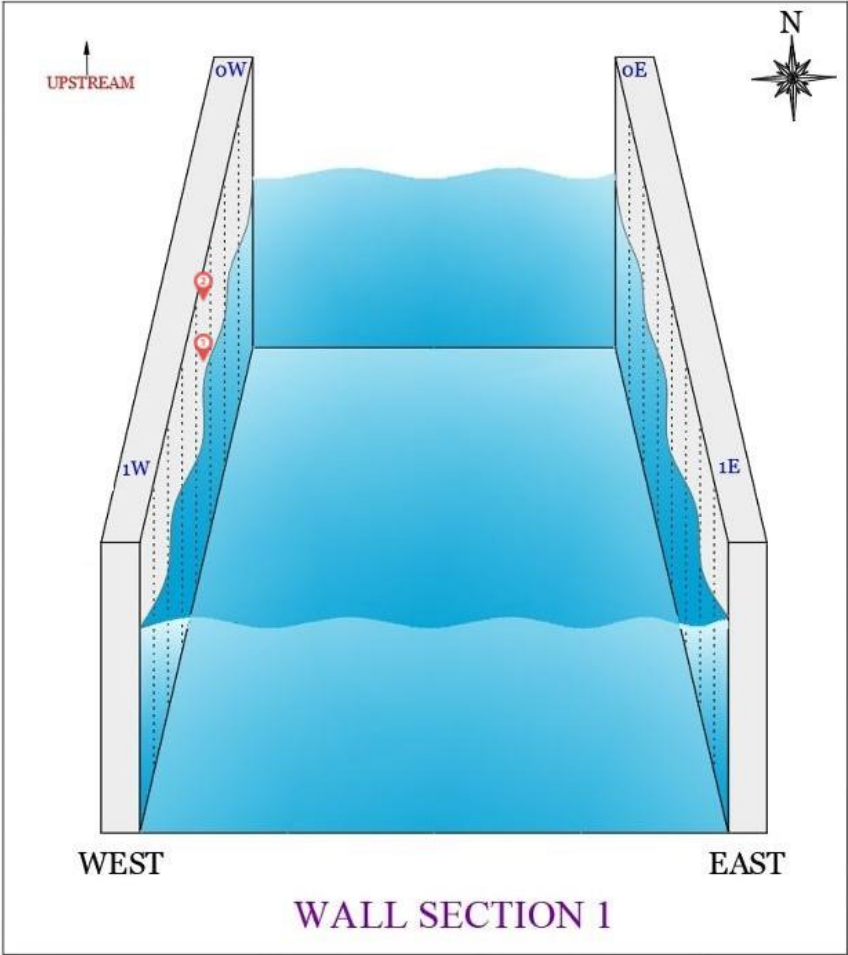
Figure 23: Heat map and Observations at Above water West 1 UPV

ID MARK	LOCATION	LOCATION	CORRECTED VELOCITY (km/s)	PROBING METHOD	REMARKS
1	Between 0 to 1W	Bottom	2.71	Indirect	Doubtful
2	Between 0 to 1W	Top	2.83	Indirect	Doubtful

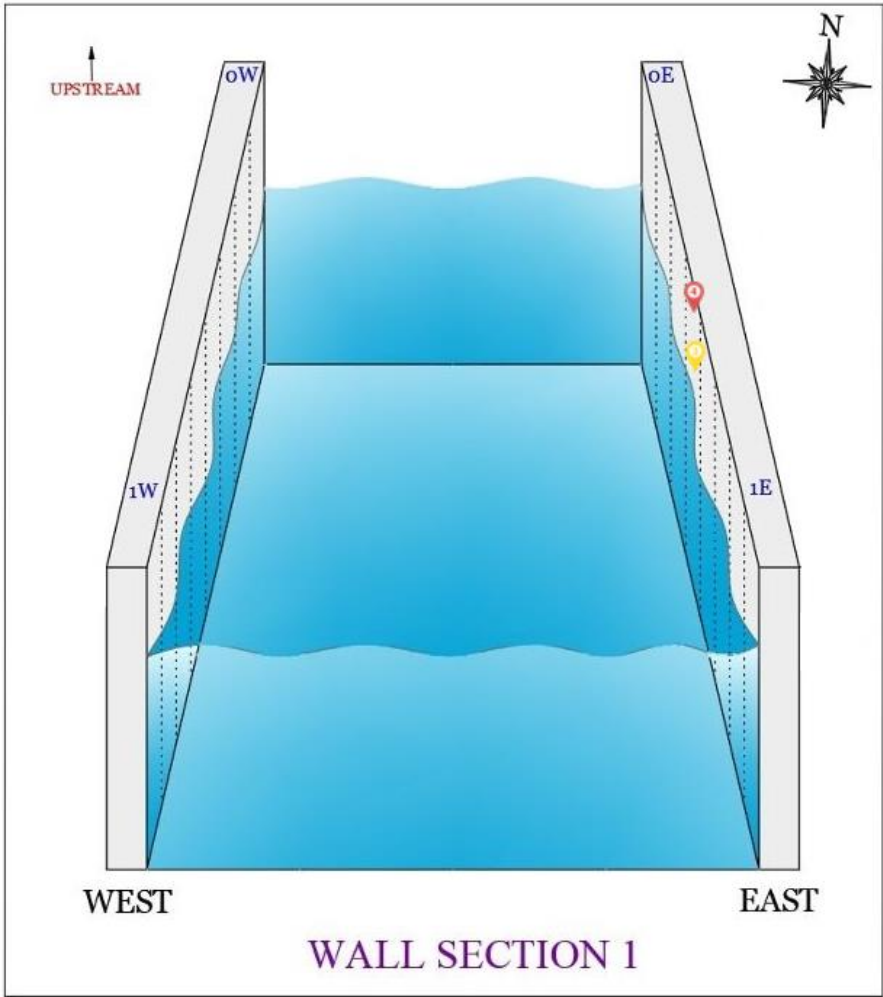
Figure 24: Heat map and Observations at Above water East 1 UPV

ID MARK	LOCATION	LOCATION	CORRECTED VELOCITY (km/s)	PROBING METHOD	REMARKS
3	Between 0 to 1E	Bottom	3.56	Indirect	Good
4	Between 0 to 1E	Top	2.65	Indirect	Doubtful

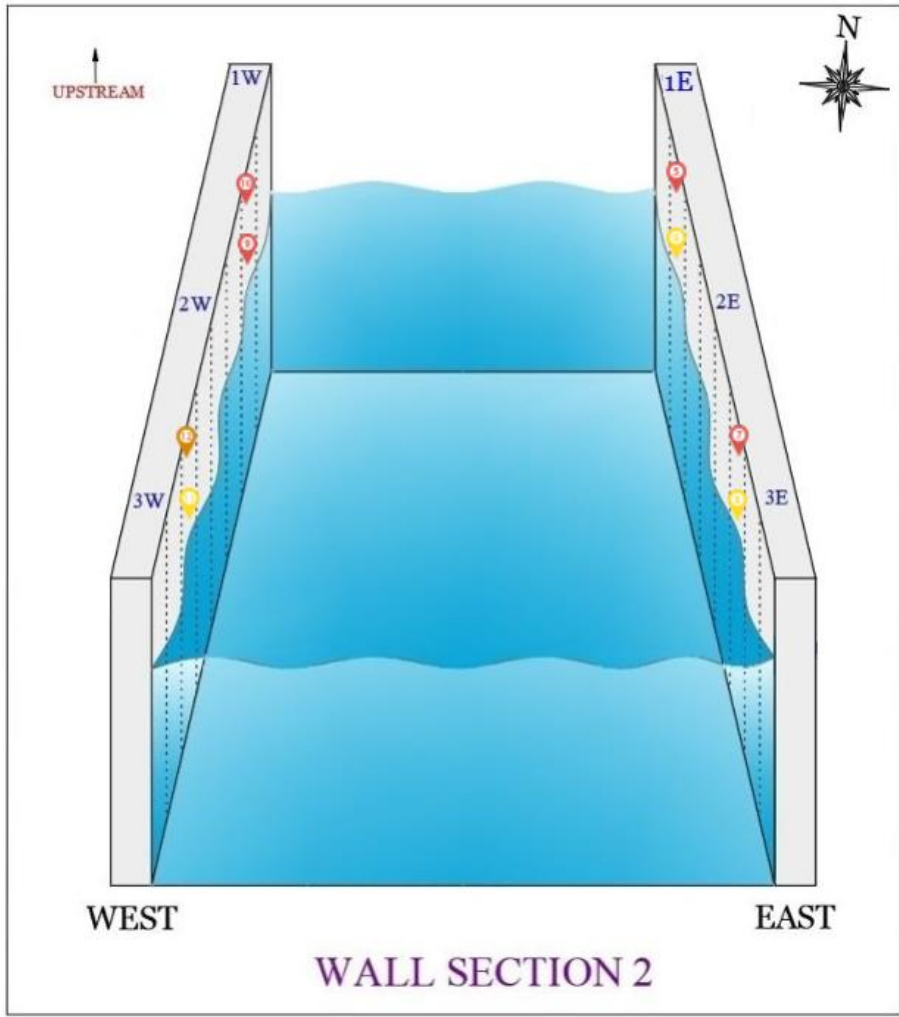
Figure 25: Heat map and Observations at Above water 1-2 UPV

ID MARK	LOCATION	LOCATION	CORRECTED VELOCITY (km/s)	PROBING METHOD	REMARKS
5	Between 1E to 2E	Top	2.63	Indirect	Doubtful
6	Between 1E to 2E	Bottom	3.50	Indirect	Good
7	Between 2E to 3E	Top	2.82	Indirect	Doubtful
8	Between 2E to 3E	Bottom	3.55	Indirect	Good
9	Between 1W to 200	Bottom	2.61	Indirect	Doubtful
10	Between 1W to 200	Top	2.64	Indirect	Doubtful
11	Between 2w to 3w	Bottom	4.02	Indirect	Good
12	Between 2w to 3w	Top	3.20	Indirect	Medium

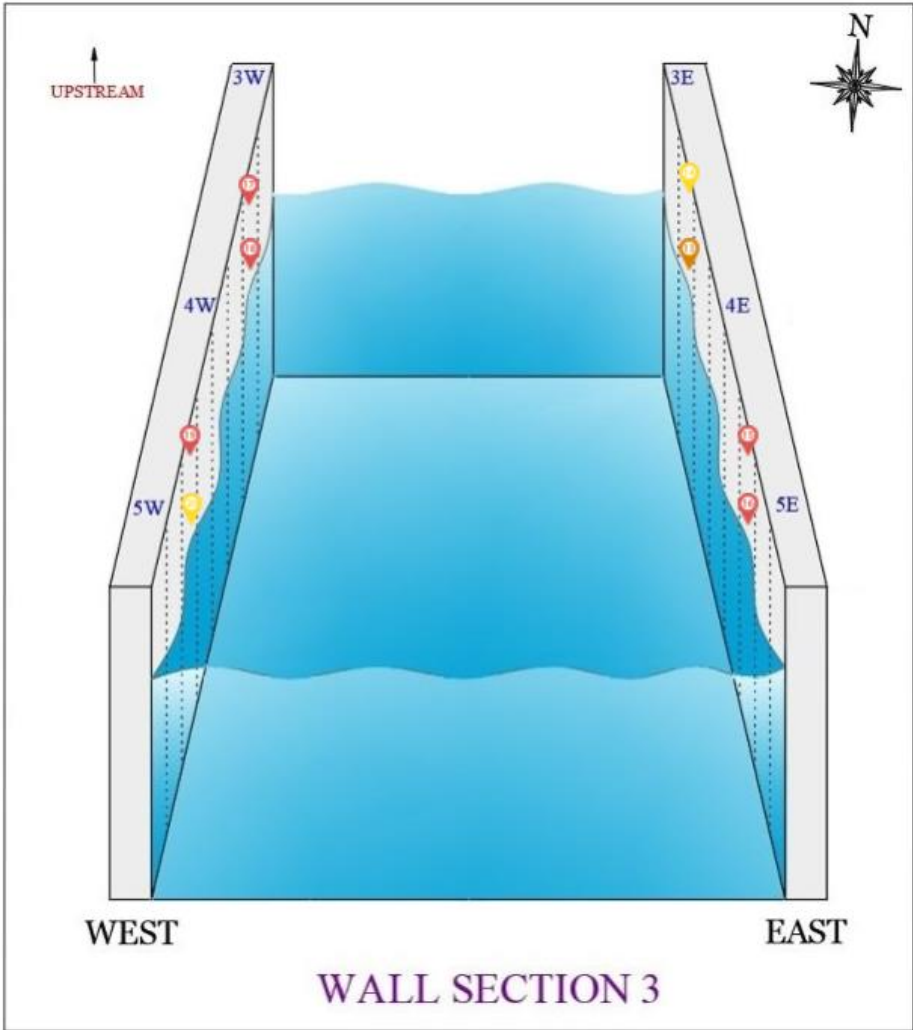
Figure 26: Heat map and Observations at Above water 3-4 UPV

ID MARK	LOCATION	LOCATION	CORRECTED VELOCITY (km/s)	PROBING METHOD	REMARKS
13	Between 3E to 4E	Bottom	3.26	Indirect	Medium
14	Between 3E to 4E	Top	3.91	Indirect	Good
15	Between 4E to 5E	Top	2.82	Indirect	Doubtful
16	Between 4E to 5E	Bottom	2.86	Indirect	Doubtful
17	Between 3w to 4w	Top	2.57	Indirect	Doubtful
18	Between 3w to 4w	Bottom	2.64	Indirect	Doubtful
19	Between 4w to 5w	Top	2.58	Indirect	Doubtful
20	Between 4w to 5w	Bottom	3.75	Indirect	Good

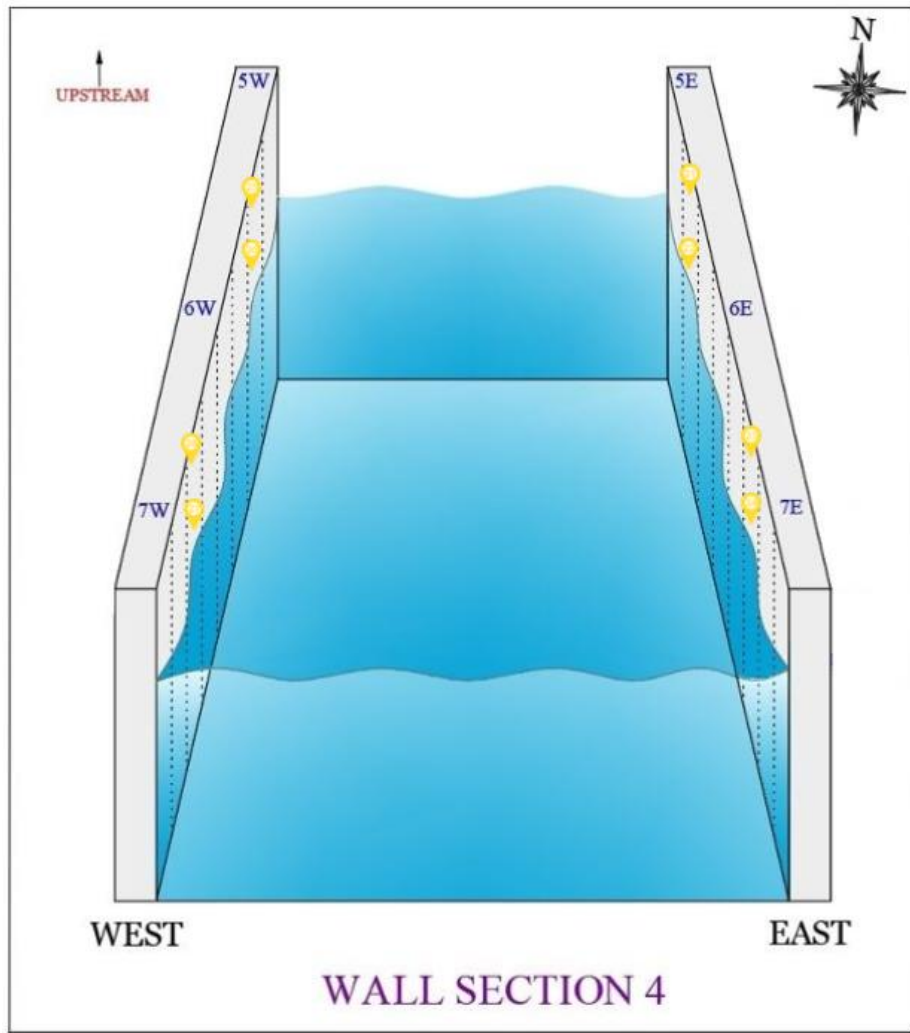
Figure 27: Heat map and Observations at Above water 5-6 UPV

ID MARK	LOCATION	LOCATION	CORRECTED VELOCITY (km/s)	PROBING METHOD	REMARKS
21	Between 5E to 6E	Top	3.55	Indirect	Good
22	Between 5E to 6E	Bottom	3.51	Indirect	Good
23	Between 6E to 7E	Top	4.00	Indirect	Good
24	Between 6E to 7E	Bottom	3.93	Indirect	Good
25	Between 5w to 6w	Top	3.65	Indirect	Good
26	Between 5w to 6w	Bottom	3.73	Indirect	Good
27	Between 6w to 7w	Bottom	3.97	Indirect	Good
28	Between 6w to 7w	Top	3.56	Indirect	Good

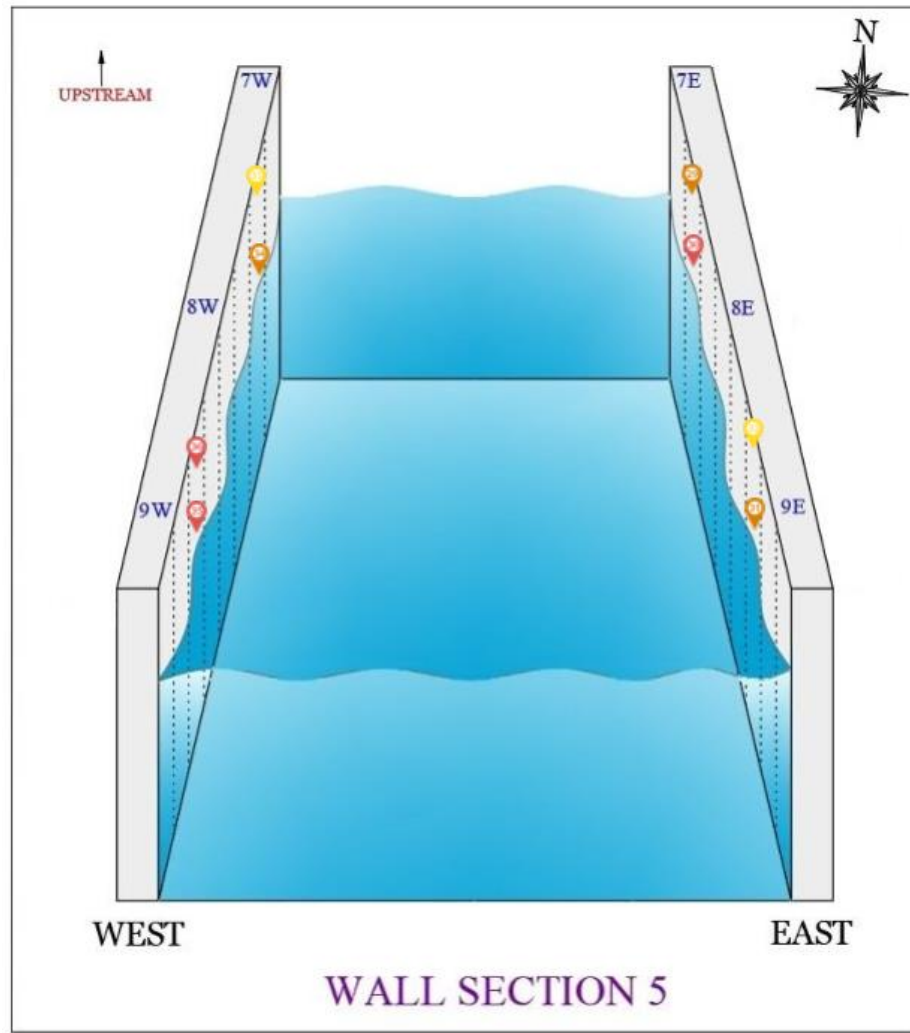
Figure 28: Heat map and Observations at Above water 7-8 UPV

ID MARK	LOCATION	LOCATION	CORRECTED VELOCITY (km/s)	PROBING METHOD	REMARKS
29	Between 7E to 8E	Top	3.27	Indirect	Medium
30	Between 7E to 8E	Bottom	2.67	Indirect	Doubtful
31	Between 8E to 9E	Bottom	3.18	Indirect	Medium
32	Between 8E to 9E	Top	3.84	Indirect	Good
33	Between 7w to 8w	Top	4.00	Indirect	Good
34	Between 7w to 8w	Bottom	3.20	Indirect	Medium
35	Between 8w to 9w	Bottom	2.85	Indirect	Doubtful
36	Between 8w to 9w	Top	2.60	Indirect	Doubtful

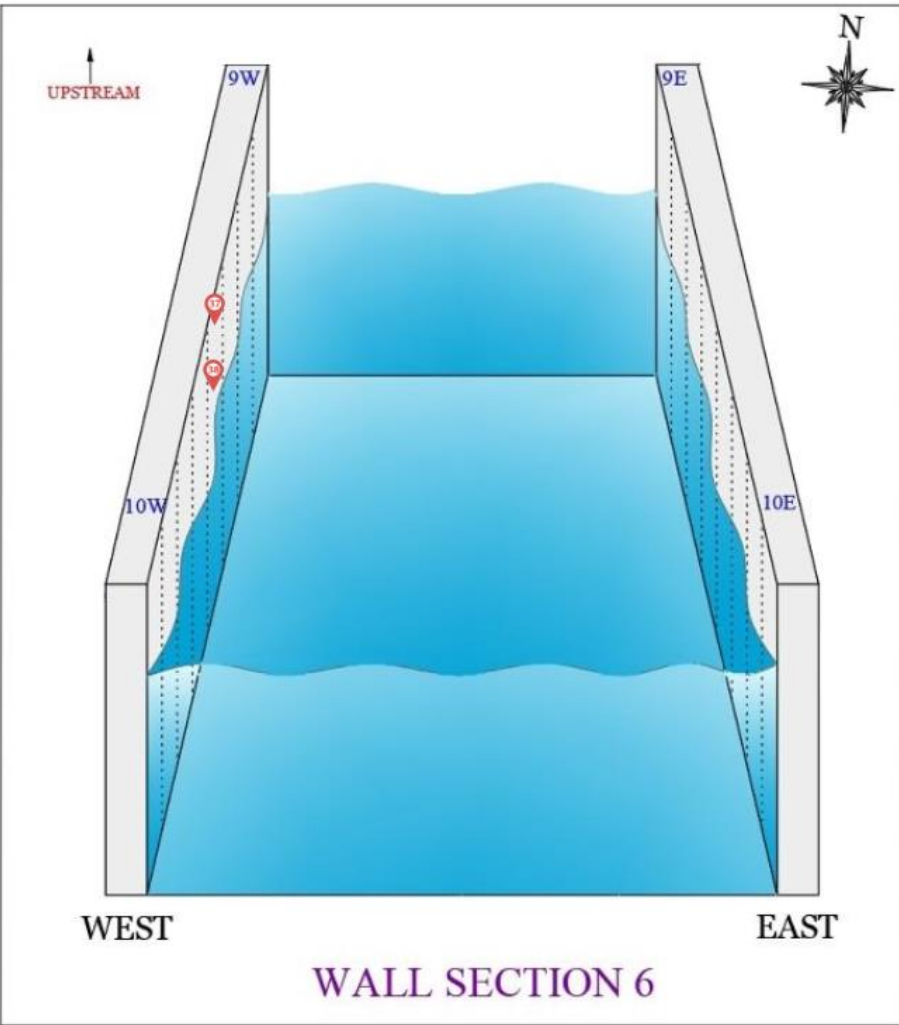
Figure 29: Heat map and Observations at Above water West 9-10 UPV

ID MARK	LOCATION	LOCATION	CORRECTED VELOCITY (km/s)	PROBING METHOD	REMARKS
37	Between 9w to 10w	Top	2.88	Indirect	Doubtful
38	Between 9w to 10w	Bottom	3.53	Indirect	Good

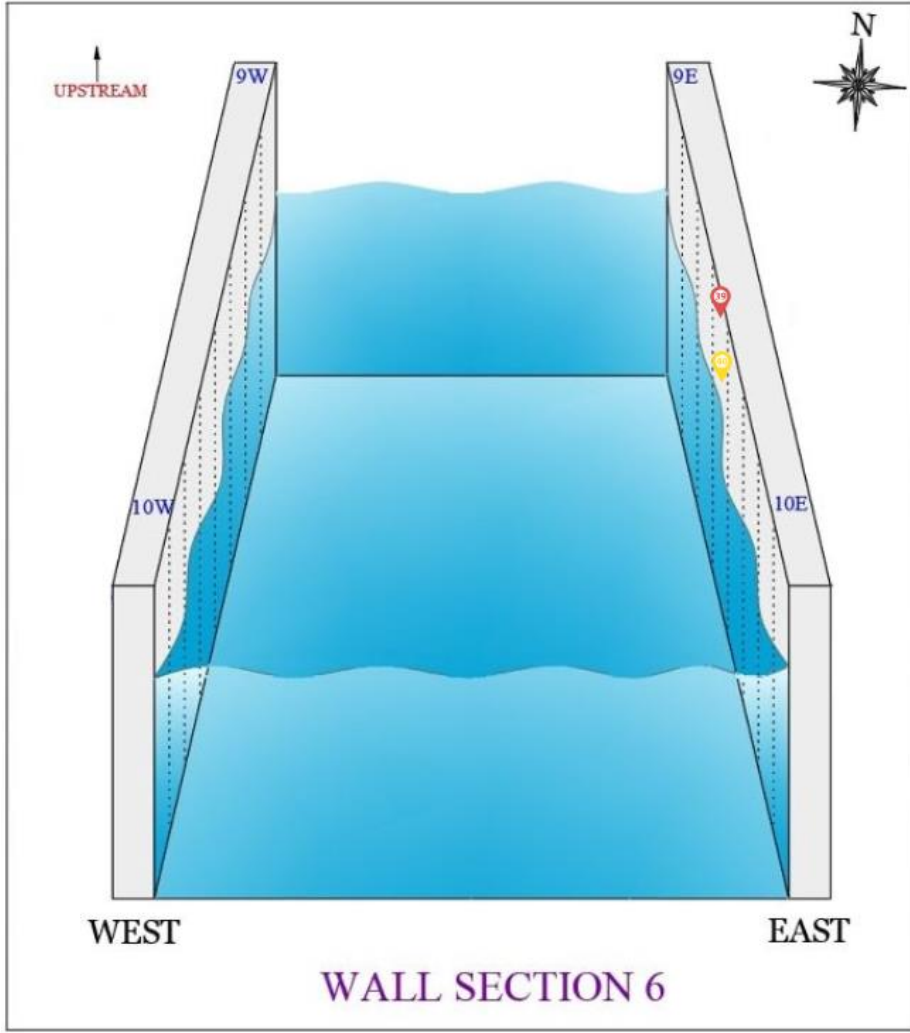
Figure 30: Heat map and Observations at Above water East 9-10 UPV

ID MARK	Member	LOCATION	CORRECTED VELOCITY (km/s)	PROBING METHOD	REMARKS
39	Between 9E to 10E	Top	2.70	Indirect	Doubtful
40	Between 9E to 10E	Bottom	2.76	Indirect	Doubtful

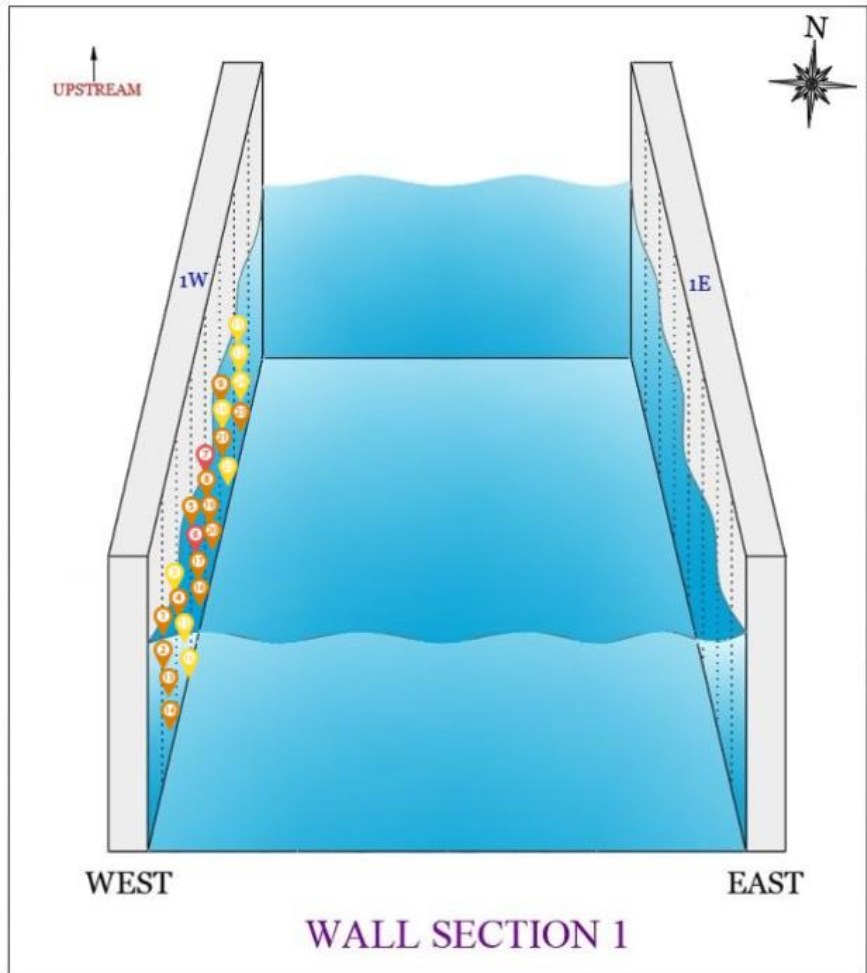
Figure 31: Heat map and Observations at Underwater West 1 UPV

S.No	Location	Depth(m)	Velocity(km/sec)	Remark
1	West 1 Zone 1	12.03	3.203	Medium
2	West 1 Zone 1	12.12	3.417	Medium
3	West 1 Zone 1	11.31	3.683	Good
4	West 1 Zone 1	11.02	3.289	Medium
5	West 1 Zone 1	11.01	3.029	Medium
6	West 1 Zone 1	10.97	2.808	Doubtful
7	West 1 Zone 1	10.96	2.928	Doubtful
8	West 1 Zone 1	11.53	3.271	Medium
9	West 1 Zone 1	12.16	3.029	Medium
10	West 1 Zone 1	12.35	3.639	Good
11	West 1 Zone 1	12.48	3.705	Good
12	West 1 Zone 1	12.75	3.535	Good

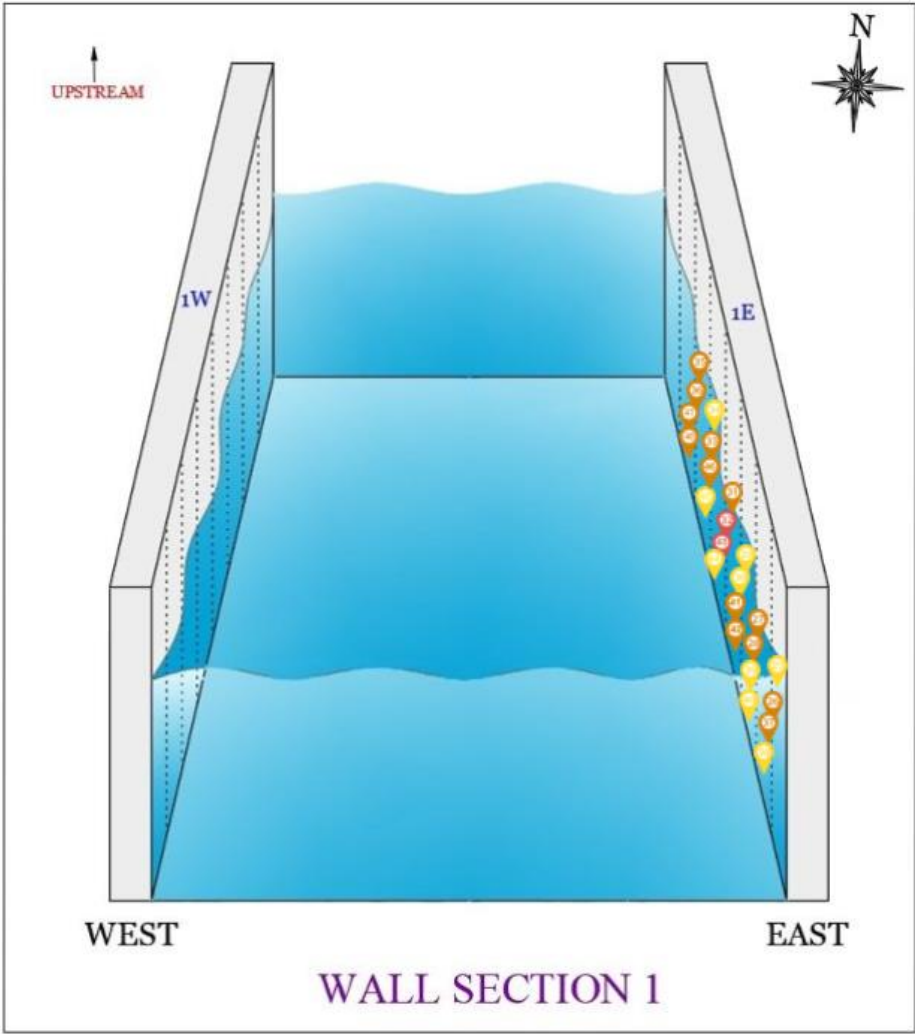
Figure 32: Heat map and Observations at Underwater East 1 UPV

S.No	Location	Depth(m)	Velocity(km/sec)	Remark
25	East 1 Zone 1	9.79	3.535	Good
26	East 1 Zone 1	9.82	3.186	Medium
27	East 1 Zone 1	9.97	3.475	Medium
28	East 1 Zone 1	10.19	3.186	Medium
29	East 1 Zone 1	10.25	3.750	Good
30	East 1 Zone 1	10.29	3.750	Good
31	East 1 Zone 1	10.37	3.014	Medium
32	East 1 Zone 1	11.07	2.942	Doubtful
33	East 1 Zone 1	11.52	3.361	Medium
34	East 1 Zone 1	11.07	3.597	Good
35	East 1 Zone 1	11.17	3.237	Medium
36	East 1 Zone 1	11.24	3.137	Medium

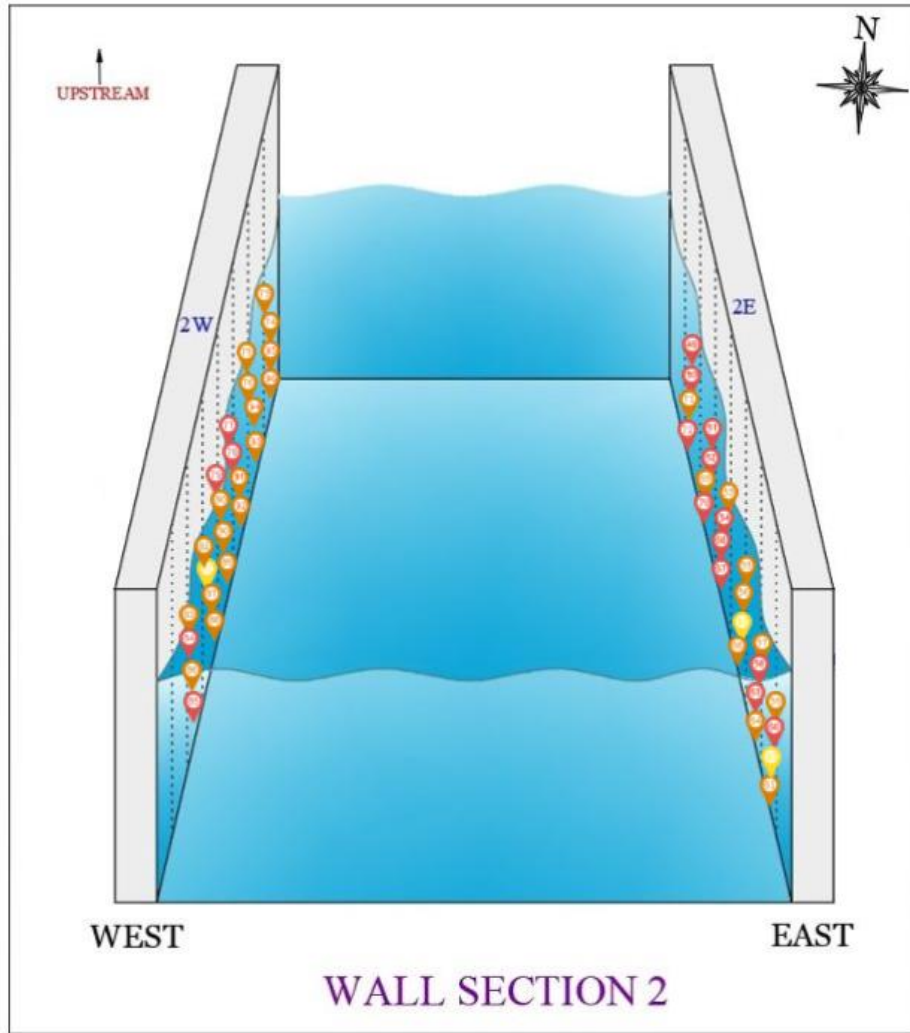
Figure 33: Heat map and Observations at Underwater East West 2 UPV

S.No	Location	Depth(m)	Velocity(km/sec)	Remark
49	East 2 Zone 1	10.37	2.820	Doubtful
50	East 2 Zone 1	10.87	2.985	Doubtful
51	East 2 Zone 1	10.97	2.860	Doubtful
52	East 2 Zone 1	11.27	2.733	Doubtful
53	East 2 Zone 1	11.37	3.106	Medium
54	East 2 Zone 1	11.55	2.499	Doubtful
55	East 2 Zone 1	10.53	3.379	Medium
56	East 2 Zone 1	11.42	3.342	Medium
57	East 2 Zone 1	11.23	3.398	Medium
58	East 2 Zone 1	11.52	2.985	Doubtful
59	East 2 Zone 1	11.46	3.220	Medium
60	East 2 Zone 1	11.53	2.970	Doubtful

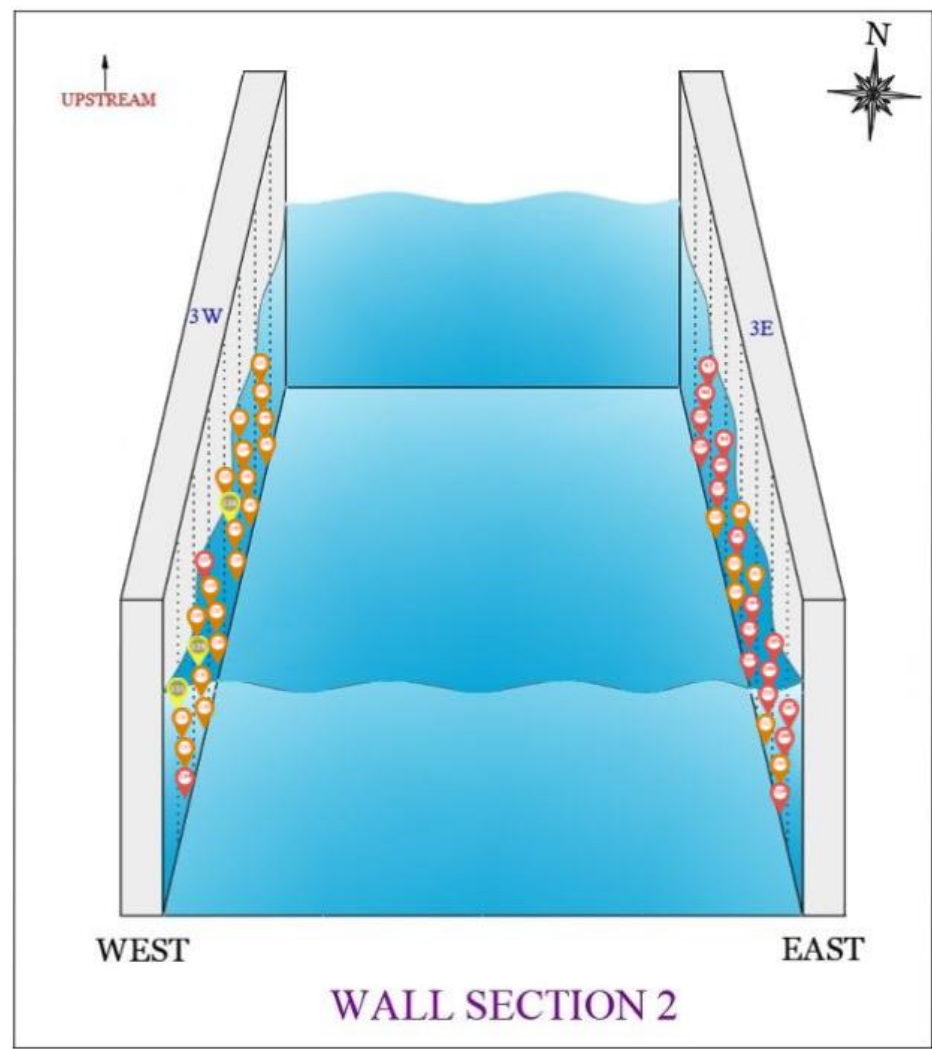
Figure 34: Heat map and Observations at Underwater East West 3 UPV

S.No	Location	Depth(m)	Velocity(km/sec)	Remark
97	East 3 Zone 1	10.43	2.009	Doubtful
98	East 3 Zone 1	10.67	2.583	Doubtful
99	East 3 Zone 1	11.07	2.720	Doubtful
100	East 3 Zone 1	11.41	2.887	Doubtful
101	East 3 Zone 1	11.3	3.436	Medium
102	East 3 Zone 1	11.25	2.942	Doubtful
103	East 3 Zone 1	11.16	3.014	Medium
104	East 3 Zone 1	10.12	2.401	Doubtful
105	East 3 Zone 1	9.71	2.673	Doubtful
106	East 3 Zone 1	9.71	2.900	Doubtful
107	East 3 Zone 1	10.02	2.942	Doubtful
108	East 3 Zone 1	10.07	2.551	Doubtful

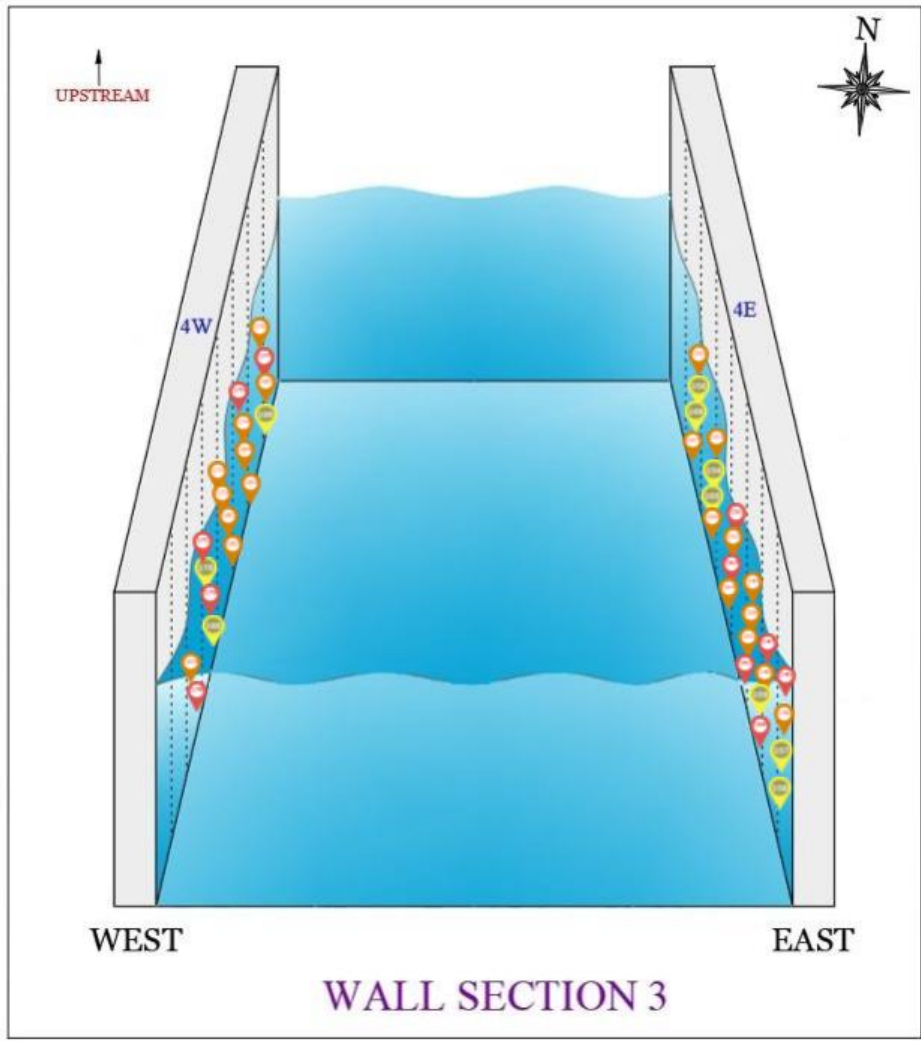
Figure 35: Heat map and Observations at Underwater East West 4 UPV

S.No	Location	Depth(m)	Velocity(km/sec)	Remark
145	East 4 Zone 1	9.67	2.942	Doubtful
146	East 4 Zone 1	9.69	3.186	Medium
147	East 4 Zone 1	10.07	2.985	Doubtful
148	East 4 Zone 1	9.72	3.455	Medium
149	East 4 Zone 1	10.07	3.455	Medium
150	East 4 Zone 1	10.47	3.186	Medium
151	East 4 Zone 1	10.67	2.745	Doubtful
152	East 4 Zone 1	11.17	3.475	Medium
153	East 4 Zone 1	11.56	3.170	Medium
154	East 4 Zone 1	11.47	3.645	Good
155	East 4 Zone 1	11.49	3.379	Medium
156	East 4 Zone 1	11.13	3.555	Good

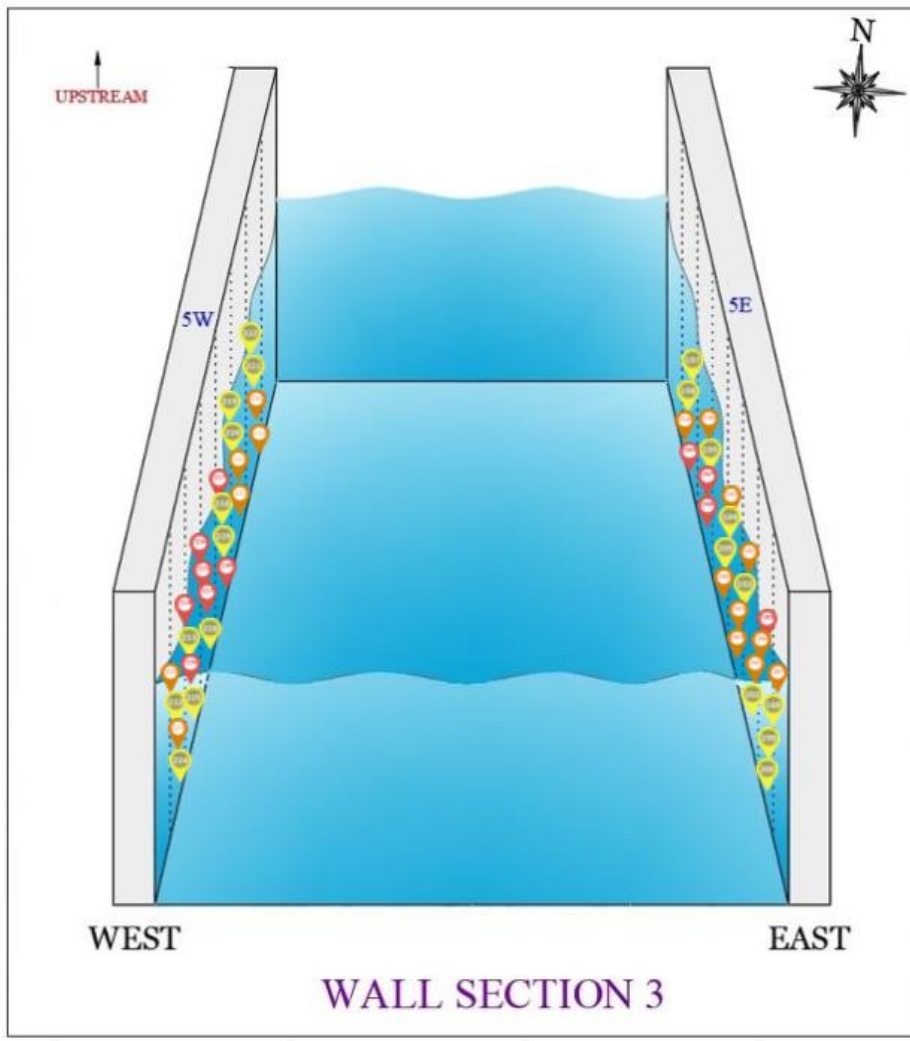
Figure 36: Heat map and Observations at Underwater East West 5 UPV

S.No	Location	Depth(m)	Velocity(km/sec)	Remark
187	East 5 Zone 1	9.67	3.186	Medium
188	East 5 Zone 1	9.75	3.514	Good
189	East 5 Zone 1	10.37	2.440	Doubtful
190	East 5 Zone 1	9.97	3.154	Medium
191	East 5 Zone 1	10.37	3.342	Medium
192	East 5 Zone 1	10.57	3.514	Good
193	East 5 Zone 1	11.43	3.22	Medium
194	East 5 Zone 1	11.77	3.597	Good
195	East 5 Zone 1	11.57	3.618	Good
196	East 5 Zone 1	10.73	3.379	Medium
197	East 5 Zone 1	11.77	3.576	Good
198	East 5 Zone 1	11.87	3.639	Good

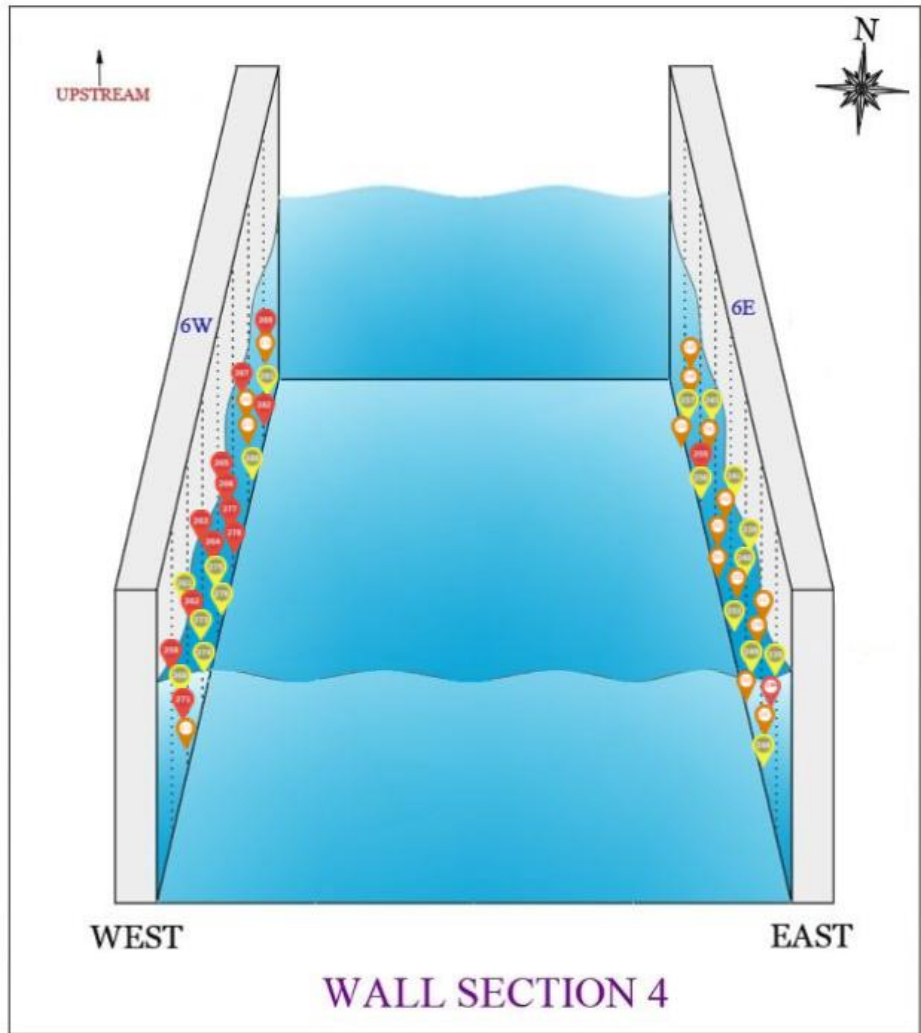
Figure 37: Heat map and Observations at Underwater East West 6 UPV

S.No	Location	Depth(m)	Velocity(km/sec)	Remark
235	East 6 Zone 1	9.67	3.639	Good
236	East 6 Zone 1	9.82	2.847	Doubtful
237	East 6 Zone 1	9.69	3.014	Medium
238	East 6 Zone 1	9.72	3.029	Medium
239	East 6 Zone 1	9.87	3.514	Good
240	East 6 Zone 1	10.07	3.705	Good
241	East 6 Zone 1	10.17	3.597	Good
242	East 6 Zone 1	10.77	3.209	Medium
243	East 6 Zone 1	10.87	3.535	Good
244	East 6 Zone 1	11.07	3.289	Medium
245	East 6 Zone 1	11.01	3.475	Medium
246	East 6 Zone 1	11.12	3.22	Medium
