**Subject:** Revised Condition Survey Report of Consultancy Services for Preparation of Detailed Project Report (DPR) for the work of Renovation/Modernization of Existing Navigation Lock at Farakka.

## CONSULTANCY SERVICES FOR PREPARATION OF DETAILED PROJECT REPORT (DPR) FOR THE WORK OF RENOVATION/MODERNIZATION OF EXISTING NAVIGATION LOCK AT FARAKKA

## Condition Survey Report

August 2022

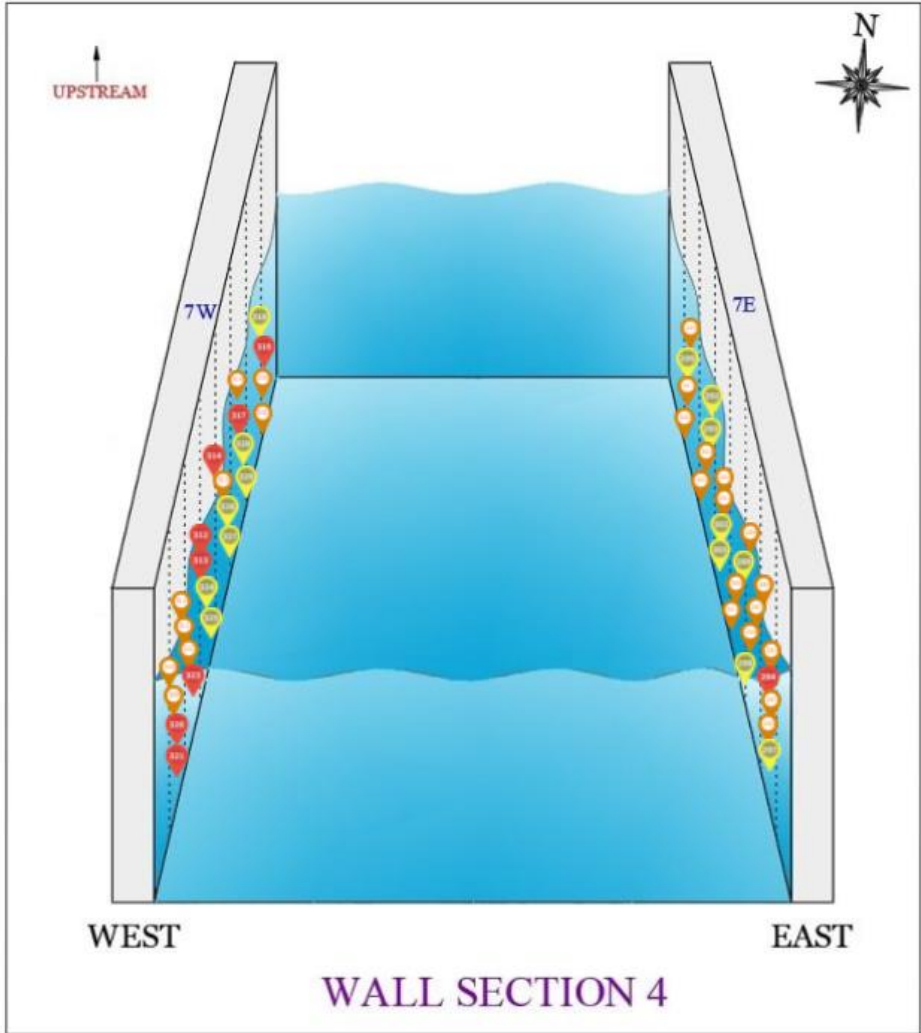
Figure 38: Heat map and Observations at Underwater East West 7 UPV

S.No	Location	Depth(m)	Velocity(km/sec)	Remark
283	East 7 Zone 1	9.72	3.324	Medium
284	East 7 Zone 1	10.47	2.914	Doubtful
285	East 7 Zone 1	10.77	3.044	Medium
286	East 7 Zone 1	11.33	3.361	Medium
287	East 7 Zone 1	11.67	3.271	Medium
288	East 7 Zone 1	11.97	3.170	Medium
289	East 7 Zone 1	12.07	3.597	Good
290	East 7 Zone 1	11.77	3.417	Medium
291	East 7 Zone 1	11.92	3.494	Medium
292	East 7 Zone 2	11.97	3.705	Good
293	East 7 Zone 1	11.98	3.661	Good
294	East 7 Zone 1	11.50	3.324	Medium

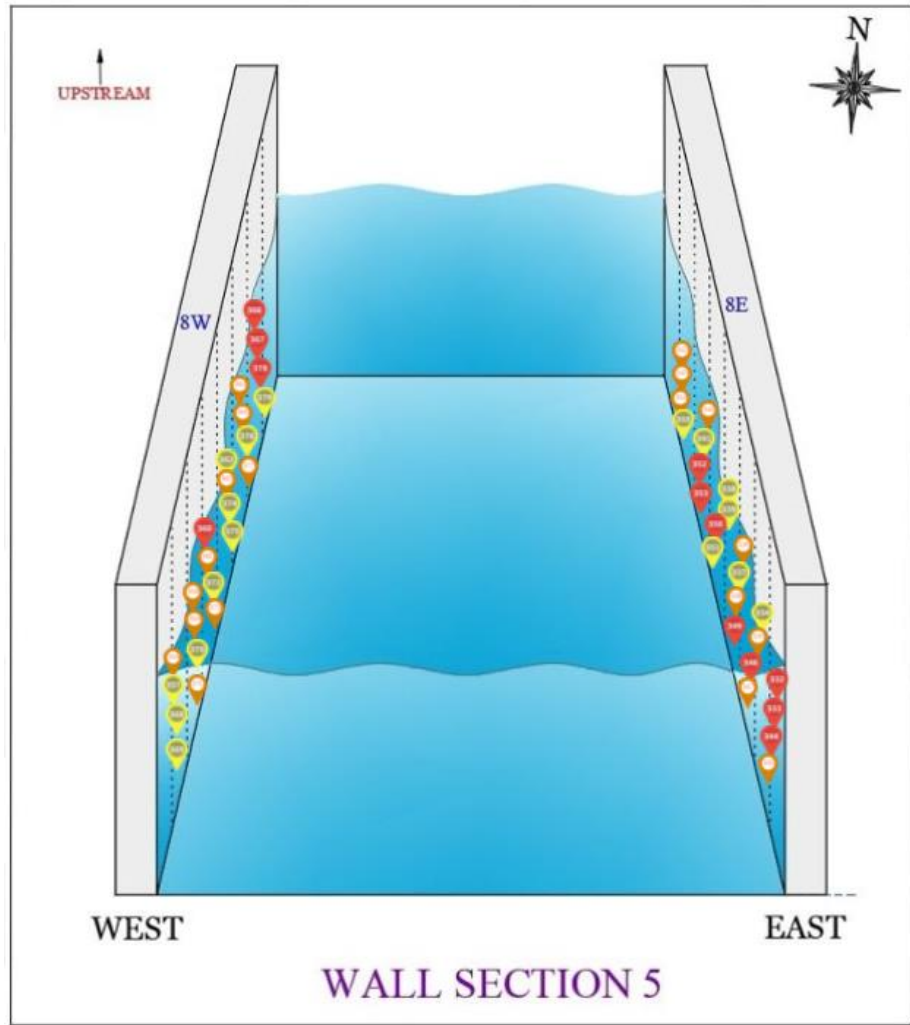
Figure 39: Heat map and Observations at Underwater East West 8 UPV

S.No	Location	Depth(m)	Velocity(km/sec)	Remark
332	East 8 Zone 1	9.89	2.639	Doubtful
333	East 8 Zone 1	10.79	2.956	Doubtful
334	East 8 Zone 1	11.01	3.661	Good
335	East 8 Zone 1	11.35	3.09	Medium
336	East 8 Zone 1	11.41	3.417	Medium
337	East 8 Zone 1	11.54	3.661	Good
338	East 8 Zone 1	11.47	3.618	Good
339	East 8 Zone 1	11.33	3.683	Good
340	East 8 Zone 1	10.96	3.137	Medium
341	East 8 Zone 1	10.62	3.639	Good
342	East 8 Zone 1	10.42	3.271	Medium
343	East 8 Zone 1	10.75	3.455	Medium

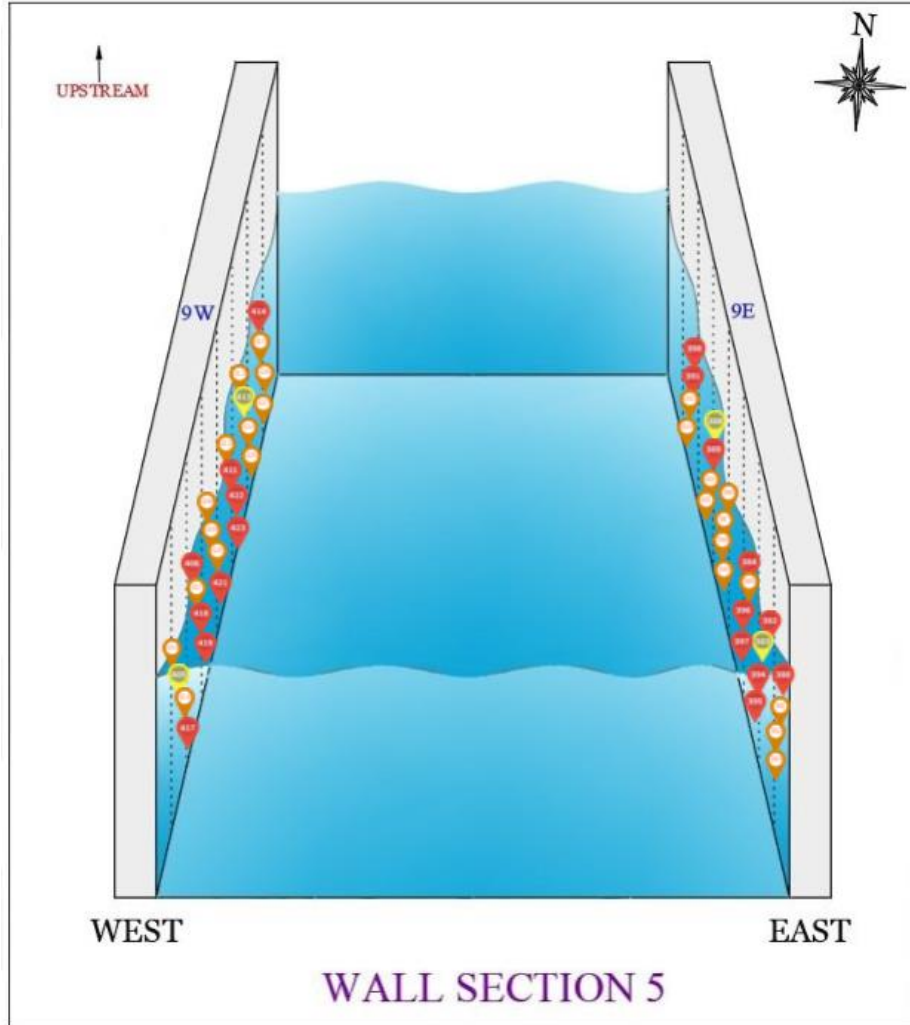
Figure 40: Heat map and Observations at Underwater East West 9 UPV

S.No	Location	Depth(m)	Velocity(km/sec)	Remark
380	East 9 Zone 1	11.09	2.833	Doubtful
381	East 9 Zone 1	10.89	3.203	Medium
382	East 9 Zone 1	10.56	2.860	Doubtful
383	East 9 Zone 1	10.39	3.555	Good
384	East 9 Zone 1	10.84	2.211	Doubtful
385	East 9 Zone 1	11.01	3.342	Medium
386	East 9 Zone 1	11.07	3.044	Medium
387	East 9 Zone 1	10.89	3.09	Medium
388	East 9 Zone 1	10.53	3.597	Good
389	East 9 Zone 1	10.88	2.900	Doubtful
390	East 9 Zone 1	11.35	2.860	Doubtful
391	East 9 Zone 1	11.49	2.820	Doubtful

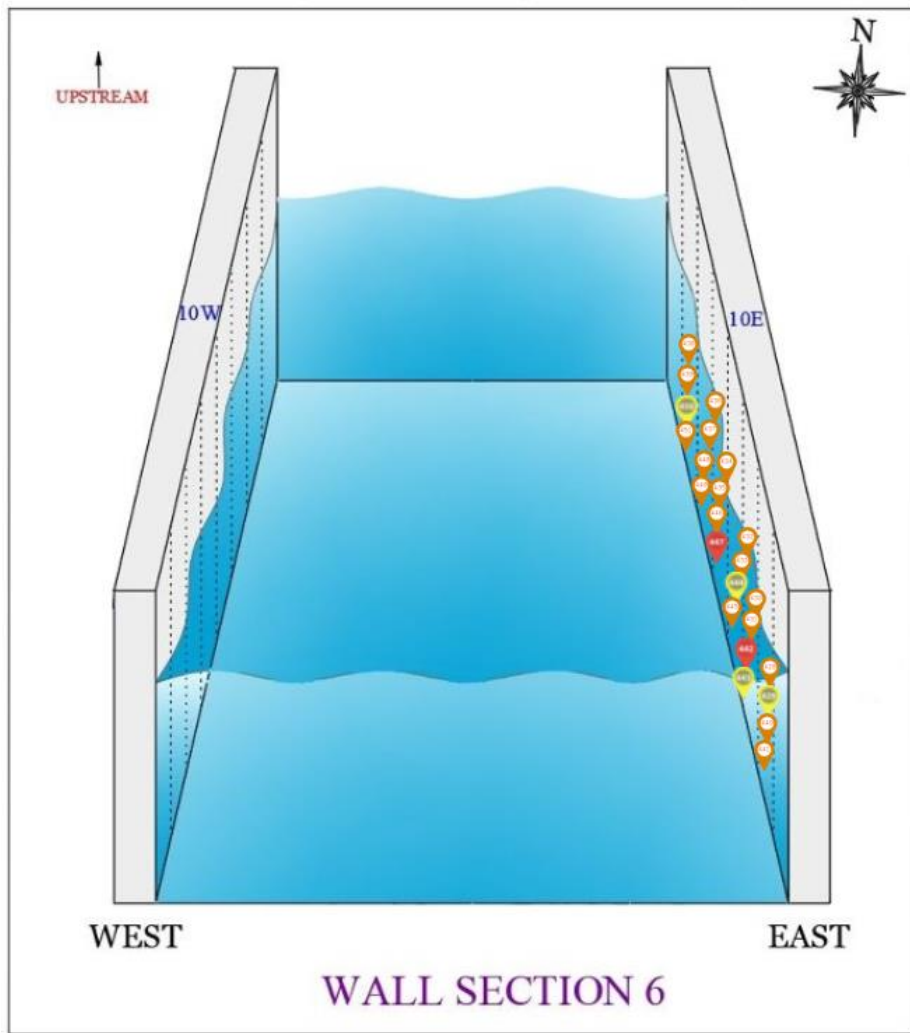
Figure 41: Heat map and Observations at Underwater East 10 UPV

S.No	Location	Depth(m)	Velocity(km/sec)	Remark
428	East 10 Zone 1	10.93	3.186	Medium
429	East 10 Zone 1	10.97	3.535	Good
430	East 10 Zone 1	10.95	3.494	Medium
431	East 10 Zone 1	11.02	3.137	Medium
432	East 10 Zone 1	11.37	3.271	Medium
433	East 10 Zone 1	11.26	3.289	Medium
434	East 10 Zone 1	11.43	3.306	Medium
435	East 10 Zone 1	11.56	3.121	Medium
436	East 10 Zone 1	12.07	3.029	Medium
437	East 10 Zone 1	12.00	3.186	Medium
438	East 10 Zone 1	11.91	3.455	Medium
439	East 10 Zone 1	12.55	3.455	Medium

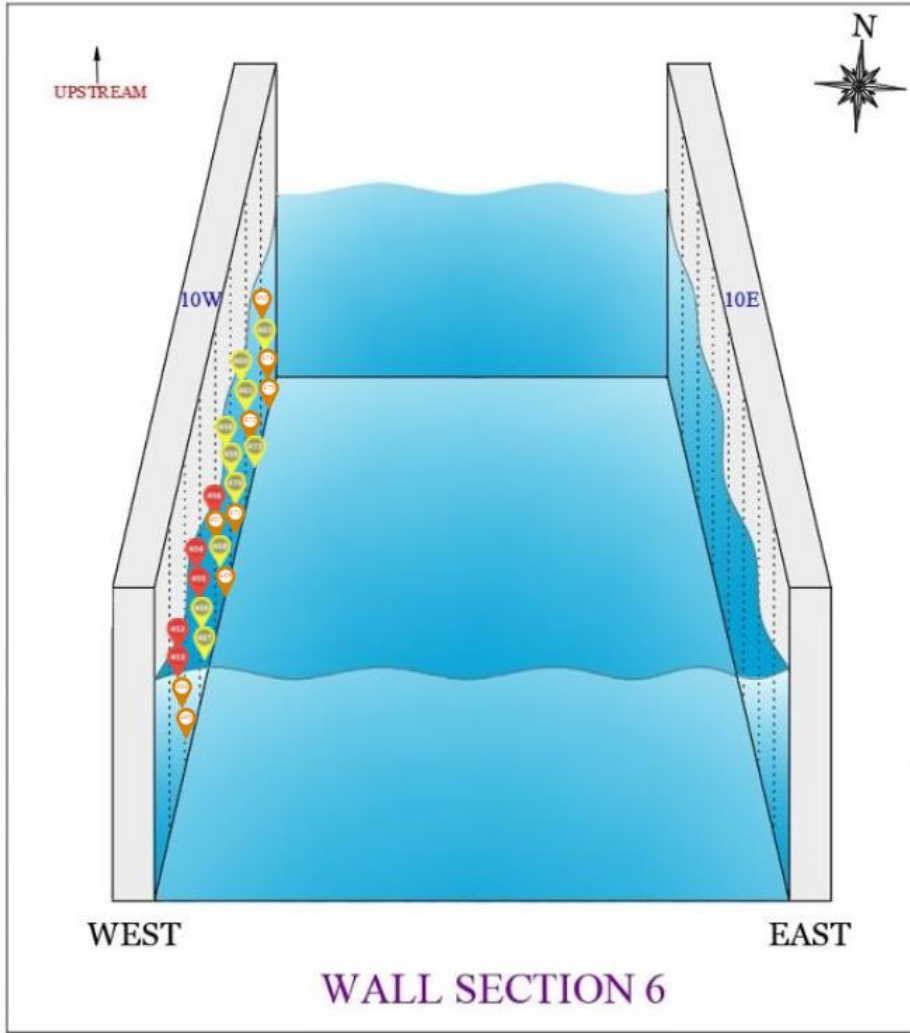
Figure 42: Heat map and Observations at Underwater West 10 UPV

S.No	Location	Depth(m)	Velocity(km/sec)	Remark
452	West 10 Zone 1	11.11	2.914	Doubtful
453	West 10 Zone 1	11.57	2.847	Doubtful
454	West 10 Zone 1	11.59	2.914	Doubtful
455	West 10 Zone 1	11.74	2.970	Doubtful
456	West 10 Zone 1	11.57	2.820	Doubtful
457	West 10 Zone 1	11.93	3.289	Medium
458	West 10 Zone 1	11.80	3.514	Good
459	West 10 Zone 1	11.86	3.683	Good
460	West 10 Zone 1	11.97	3.728	Good
461	West 10 Zone 1	11.92	3.618	Good
462	West 10 Zone 1	12.18	3.436	Medium
463	West 10 Zone 1	12.17	3.661	Good

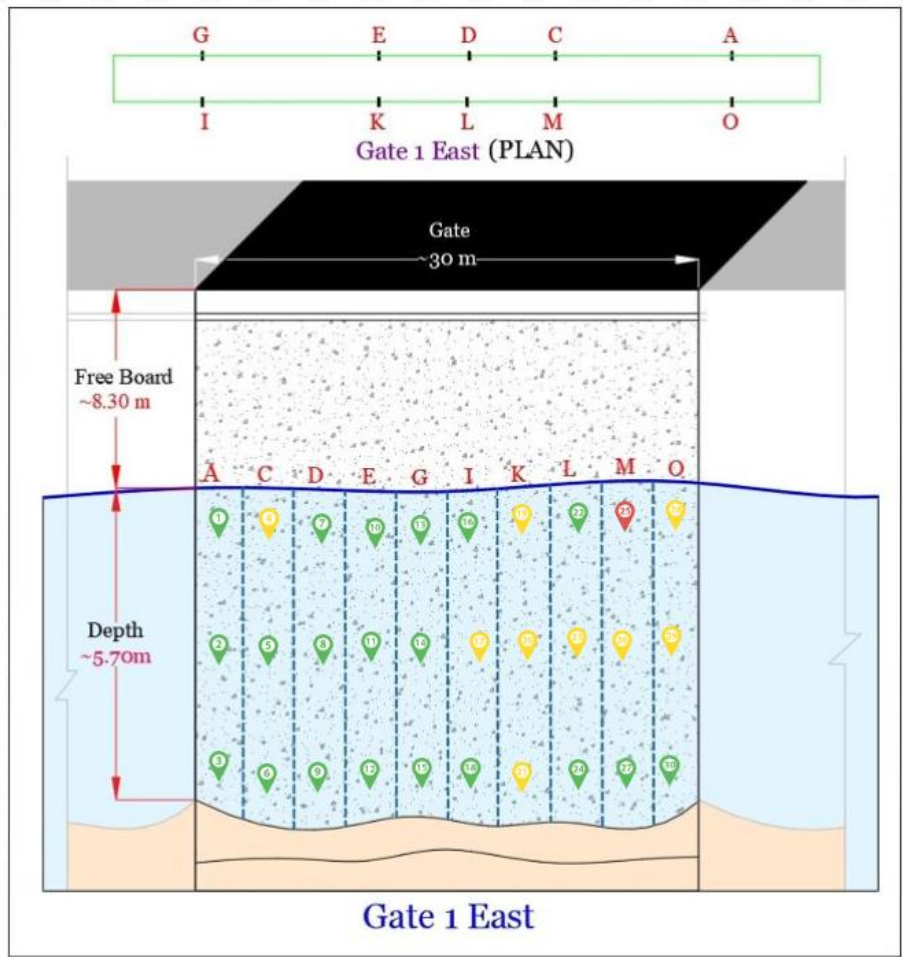
Figure 43: Heat map and Observations at UT 1

S.No	Location	Depth(m)	R1(mm)	R2(mm)	R3(mm)	R4(mm)	R5(mm)	R6(mm)	Average(mm)
1	A1	9.35	20.30	18.85	19.40	18.75	18.70	18.70	19.12
2	A2	11.42	22.00	22.00	22.00	22.00	22.00	22.00	22.00
3	A3	12.97	22.00	17.80	17.30	22.00	22.00	22.00	20.52
4	C1	9.43	17.55	17.90	17.85	17.80	19.75	19.60	18.41
5	C2	11.42	22.00	22.00	22.00	22.00	22.00	22.00	22.00
6	C3	12.99	22.00	22.00	22.00	22.00	22.00	22.00	22.00
7	D1	9.30	17.55	18.00	20.90	20.30	17.85	20.75	19.23
8	D2	10.70	21.50	21.45	22.00	22.00	22.00	22.00	21.83
9	D3	13.01	17.85	17.90	22.00	17.85	15.40	21.50	18.75
10	E1	9.50	20.10	20.00	20.15	19.50	17.50	NA	19.45
11	E2	11.28	22.00	22.00	22.00	22.00	22.00	NA	22.00
12	E3	13.05	22.00	22.00	22.00	22.00	22.00	22.00	22.00

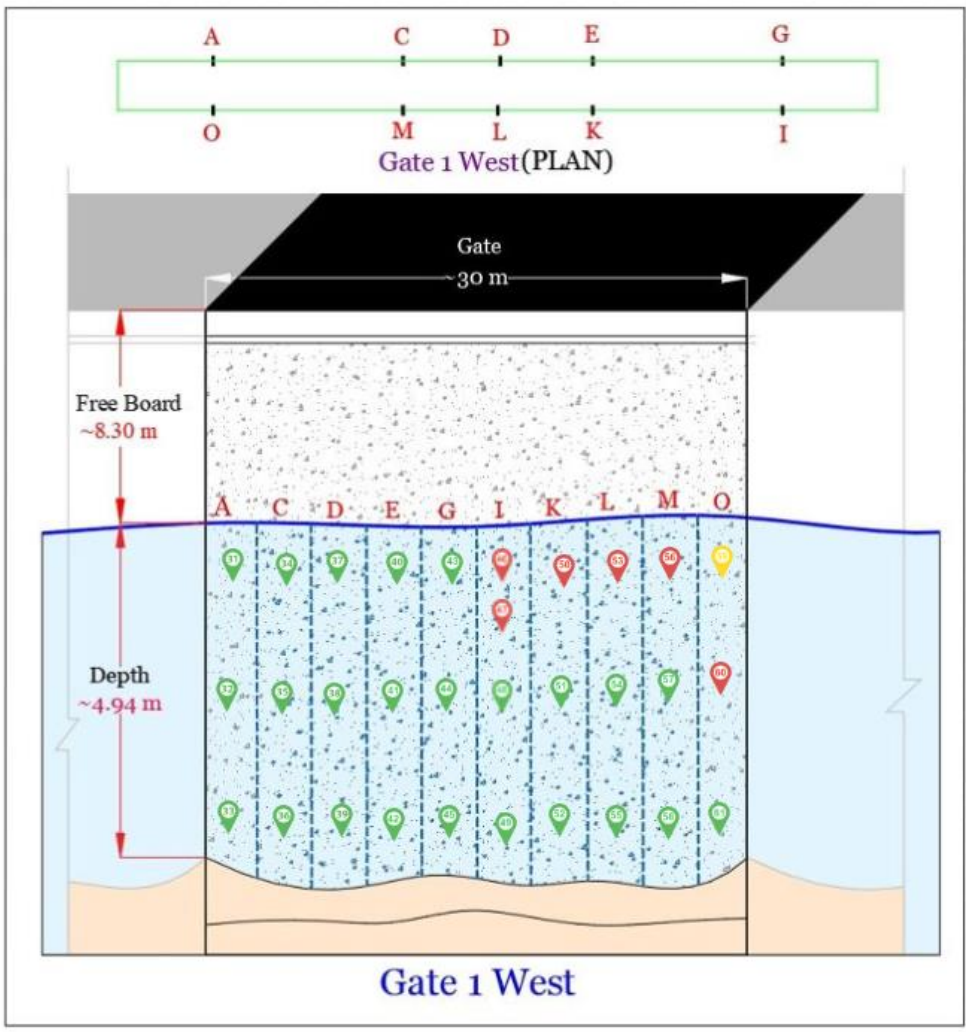
Figure 44: Heat map and Observations at UT 2

S.No	Location	Depth(m)	R1(mm)	R2(mm)	R3(mm)	R4(mm)	R5(mm)	R6(mm)	Average(mm)
31	A1	9.56	22.00	21.15	21.20	21.25	20.10	NA	21.14
32	A2	11.39	22.00	22.00	22.00	22.00	22.00	NA	22.00
33	A3	12.97	16.55	17.95	21.40	22.00	22.00	NA	19.98
34	C1	9.62	19.95	19.65	18.04	17.55	NA	NA	18.80
35	C2	11.03	22.00	22.00	22.00	22.00	22.00	NA	22.00
36	C3	12.99	22.00	22.00	17.90	22.00	22.00	22.00	21.32
37	D1	9.91	17.85	22.00	22.00	22.00	22.00	22.00	21.31
38	D2	10.93	22.00	22.00	22.00	22.00	22.00	NA	22.00
39	D3	12.44	22.00	22.00	22.00	22.00	22.00	NA	22.00
40	E1	9.38	20.00	22.00	19.95	17.65	19.15	NA	19.75
41	E2	11.23	22.00	22.00	22.00	22.00	22.00	NA	22.00

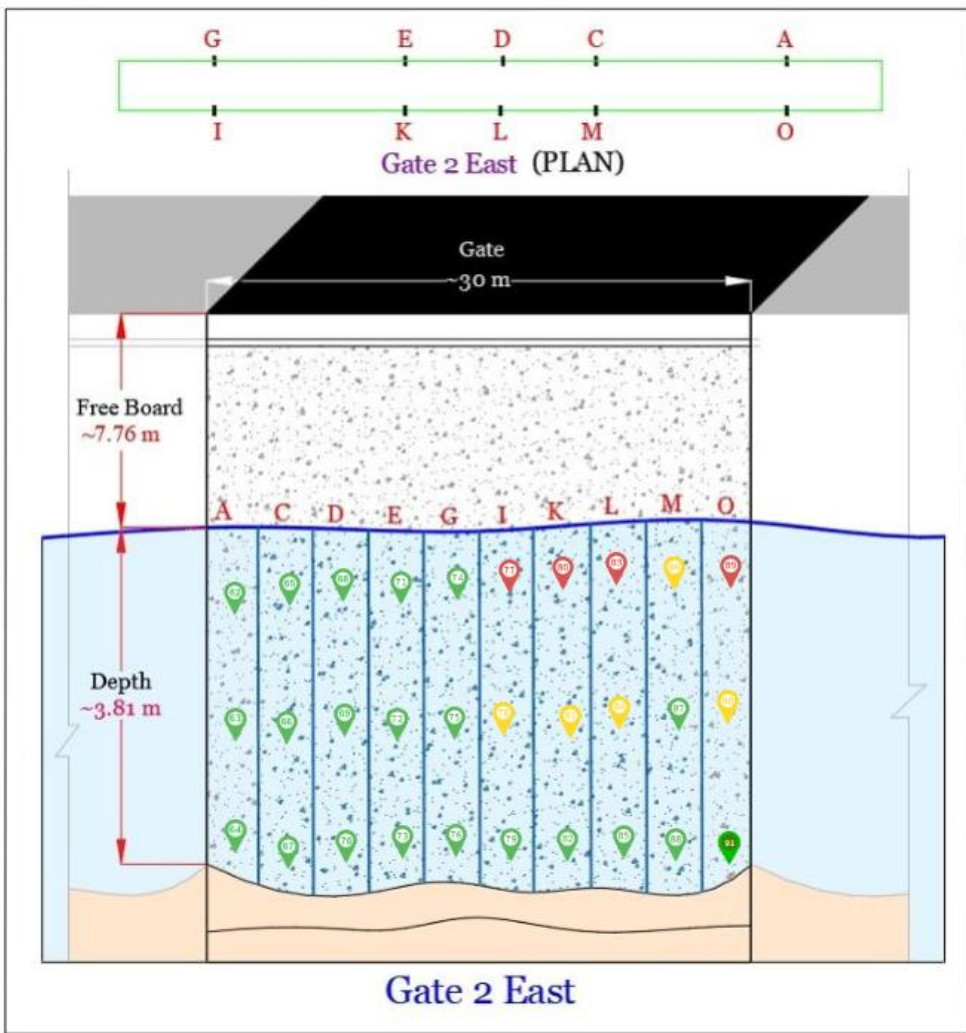
Figure 45: Heat map and Observations at UT 3

S. No	Location	Depth(m)	R1(mm)	R2(mm)	R3(mm)	R4(mm)	R5(mm)	R6(mm)	Average(mm)
62	A1	8.36	16.00	16.00	16.00	16.00	16.00	16.00	16.00
63	A2	9.17	14.75	16.00	16.00	15.55	16.00	16.00	15.72
64	A3	10.77	22.00	15.35	22.00	22.00	22.00	22.00	20.89
65	C1	8.46	16.00	16.00	16.00	16.00	16.00	16.00	16.00
66	C2	9.91	22.00	22.00	22.00	22.00	17.75	17.80	20.59
67	C3	10.95	22.00	22.00	21.45	22.00	22.00	NA	21.89
68	D1	8.72	16.00	16.00	16.00	16.00	16.00	16.00	16.00
69	D2	10.00	18.25	22.00	17.25	22.00	22.00	20.05	20.26
70	D3	10.99	3.31	21.85	22.00	22.00	22.00	22.00	18.86
71	E1	8.61	16.00	16.00	16.00	16.00	16.00	16.00	16.00
72	E2	9.08	16.00	16.00	16.00	16.00	16.00	16.00	16.00

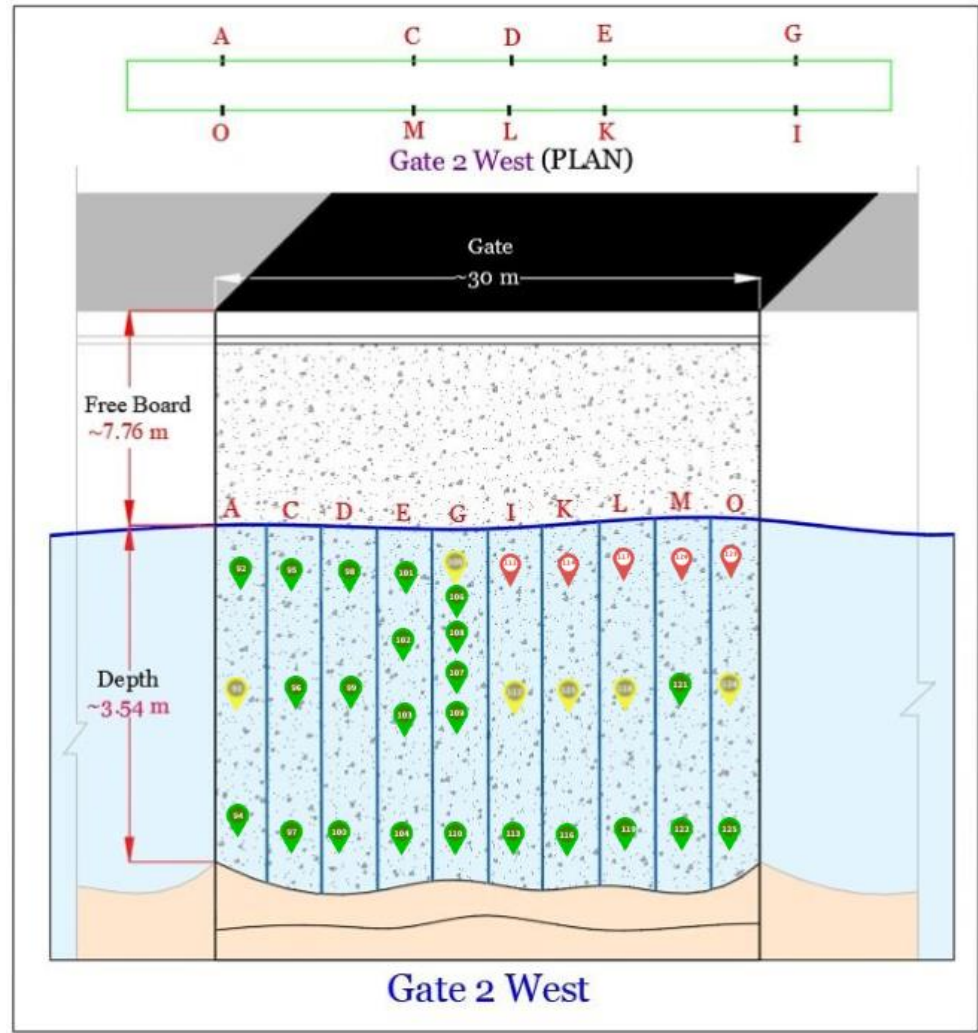
Figure 46: Heat map and Observations at UT 4

S.No	Location	Depth(m)	R1(mm)	R2(mm)	R3(mm)	R4(mm)	R5(mm)	R6(mm)	Average(mm)
92	A1	8.59	16.00	12.00	16.00	16.00	14.75	16.00	15.13
93	A2	9.61	22.00	22.00	15.75	15.05	17.85	17.75	18.40
94	A3	10.58	22.00	22.00	22.00	22.00	21.50	22.00	21.92
95	C1	8.55	16.00	16.00	16.00	16.00	16.00	16.00	16.00
96	C2	9.39	16.00	16.00	16.00	16.00	16.00	16.00	16.00
97	C3	10.49	17.90	17.90	17.80	17.85	22.00	22.00	19.24
98	D1	8.15	16.00	16.00	16.00	16.00	16.00	16.00	16.00
99	D2	9.20	16.00	16.00	10.95	14.80	16.00	16.00	14.96
100	D3	10.18	22.00	22.00	22.00	22.00	22.00	22.00	22.00
101	E1	8.28	16.00	16.00	16.00	16.00	16.00	16.00	16.00
102	E2	9.18	16.00	16.00	16.00	16.00	16.00	16.00	16.00

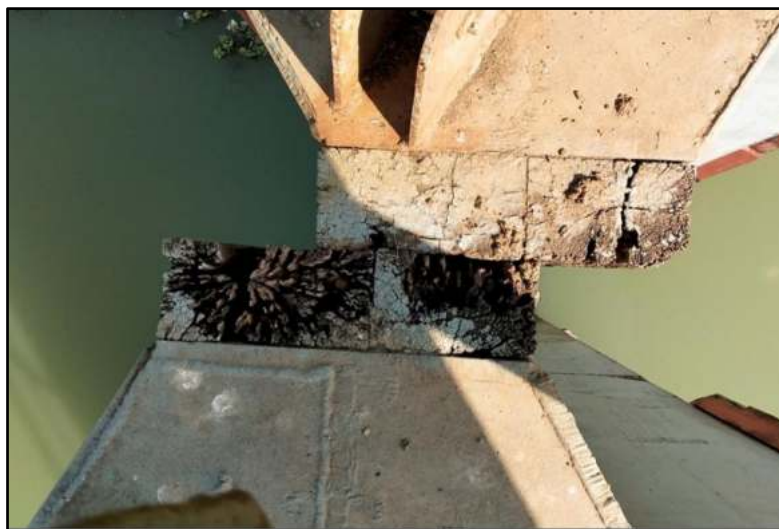
Figure 48: Condition of Seals of Mitre Gate of Farakka Lock

During visual survey it was observed that the submerged portion of gates have significant leakages from bottom and front portion and structural components of these portion were found to be severally corroded (Figure 47). The wooden and rubber seals were found to be damaged and not effectively sealing openings/gaps between the structure and skin plates from both ends (b/w gates and b/w gate and corners (Figure 48)

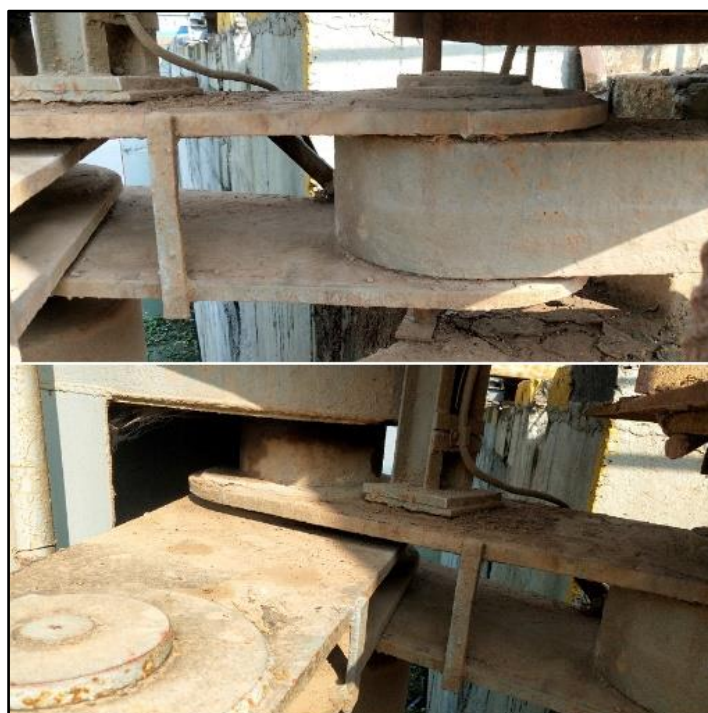
**Figure 49: Top Bearing of Mitre Gates of Farakka Lock**

These timings are quite high compared to the proposed Opening/Closing Time of 3-5 min for new lock's Mitre Gates and the operational capability and reliability of present mechanism is doubtful in future if the traffic across the Lock is further increased. During the operation of the gates, it was noted that top hinges of both gates are almost in the end period of their use and significant part of them is corroded with noise being observed for some period of operations from top bearings (Figure 49). It was noted that the greasing arrangement for the bearing is abandoned and has never been used. Hinges of one of the gate was damaged and subsequently replaced in 2020.

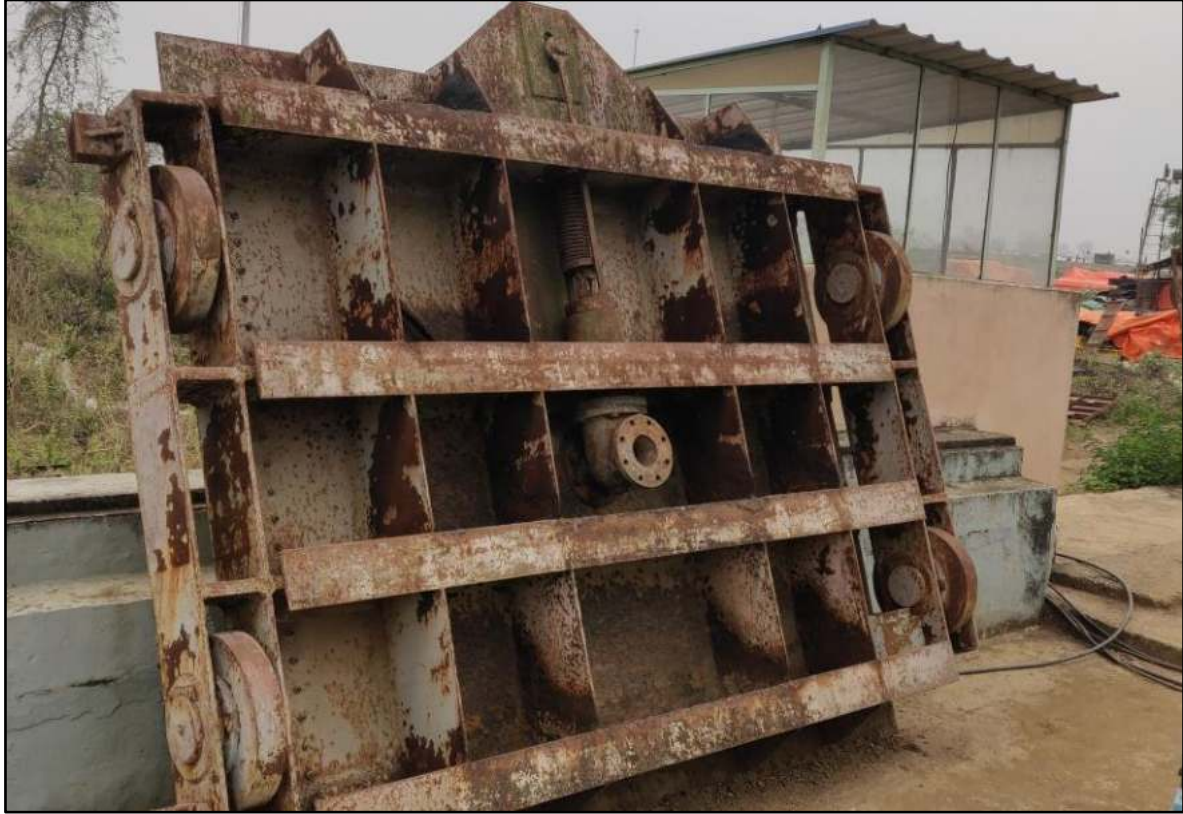
**Figure 54: Bulkhead Gates for Radial Gate Maintenance**

To isolate the existing radial gates for inspection and maintenance 8 Nos Bulkhead gates (2 Nos for each radial gate at its U/S and D/S) have been provided (Figure 54). These gates are critical to proper functioning of the Lock as they are necessary for maintenance and upkeep of radial gate and reduce the risk of failure. These are fixed wheel type vertical lift gates. Bulkhead Gates for Radial Gate Maintenance are shown in Figure 54. All gates were observed and also reported to be of different dimensions with not all of them being interchangeable. Most of the gates were kept outside in open atmosphere.

All structural members of the bulkheads were visually inspected and were found to be heavily corroded and beyond any chances of use in operation and not in a position of rehabilitation. The seals of all gates are in damaged conditions (Figure 54

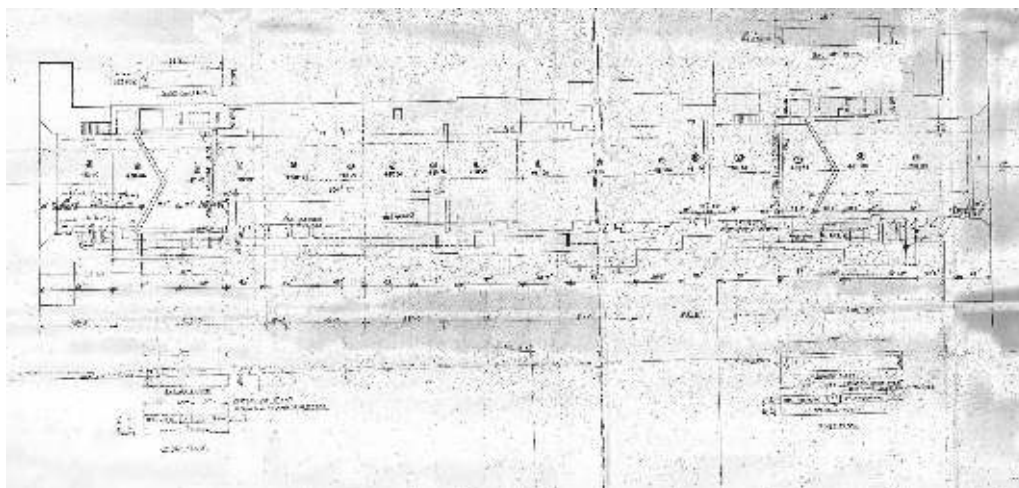
**Figure 58: Navigational lock layout with filling/emptying system**

The lock is filled using filling water conductors running either side of the upstream mitre gates, with inlets on each side of the lock head structure, and outlets in the walls inside the chamber and downstream of the mitre gates. These water conductors are controlled using radial gates and are shown in Figure 58.

It was not possible to inspect the condition of the f/e culverts, which could have deteriorated due to erosion caused by water flows or mechanical damage from abrasion and impact of water-borne sediments and debris. The f/e water conductors could not be inspected even with the underwater robots due to the limited size of the opening at inlet and outlet points. As such an inspection is necessary under dry conditions. The water conductors along with filling / emptying system should be inspected in dry condition when rehabilitation is undertaken in the lock structure.

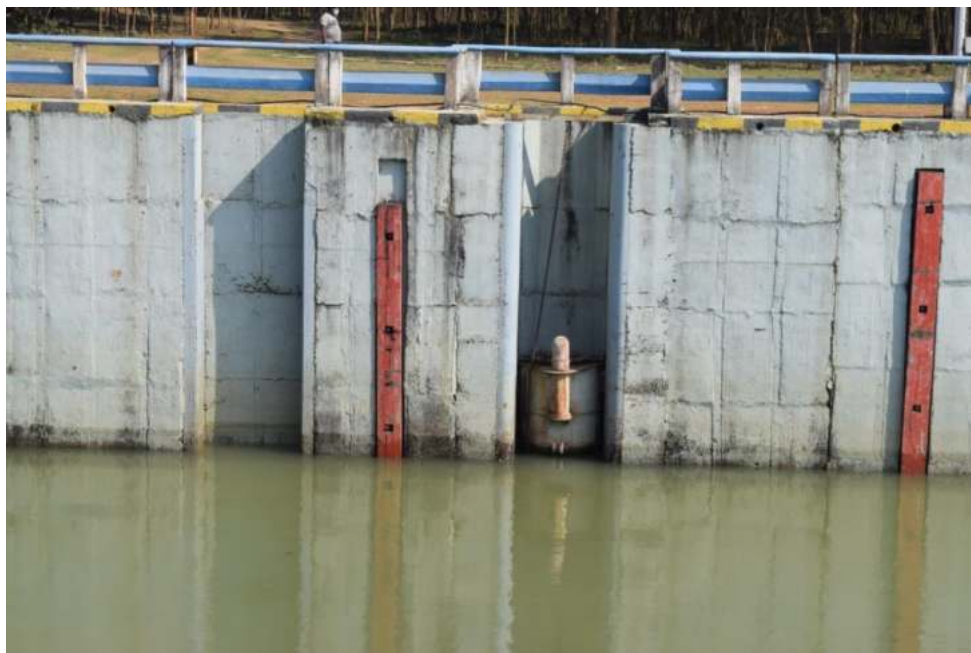
Figure 60: Floating Type Bollards

Conventional moorings systems viz. floating and fixed bollards are in place in the navigational lock. There are Bollards – eight (8) numbers floating type (four (4) on each bank) and fourteen (14) numbers fixed type (seven (7) on each bank). Most of the floating bollards are non-functional and even few of the fixed type bollards are damaged.

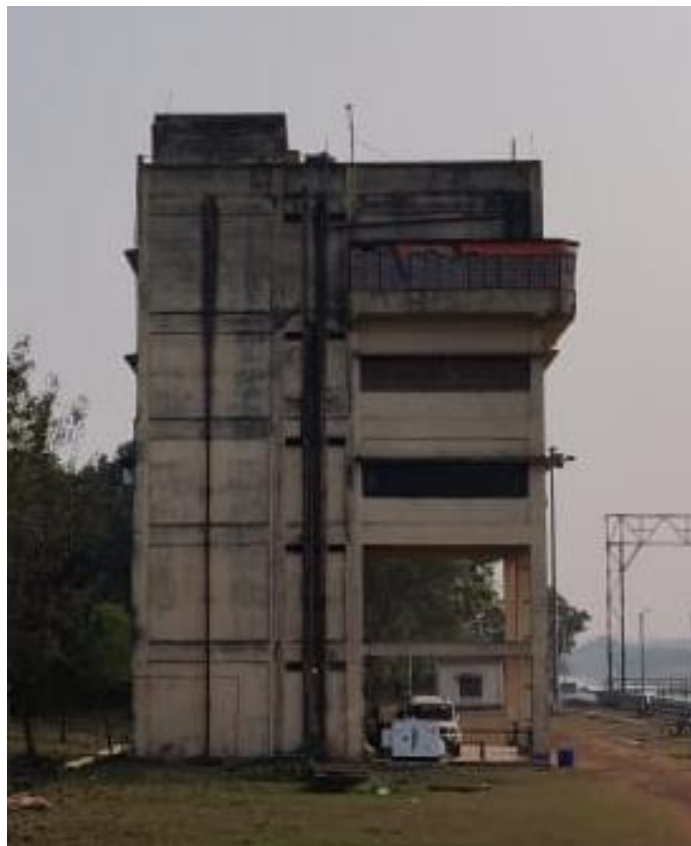
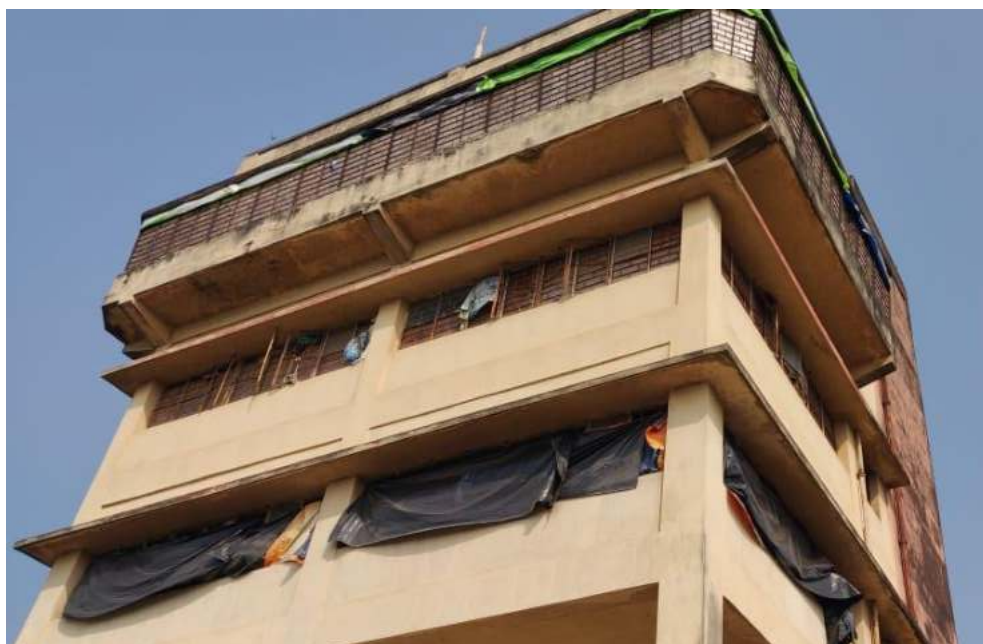
Figure 62: Control room building

A G+4-storey central control room building is on the left bank of the existing navigational lock (Figure 62 and 63).

The structural condition of the Control room building is good but the building lacks basic amenities or the amenities are in very poor condition like lift, water supply, sanitation, lighting, etc. as shown in Figure 64.

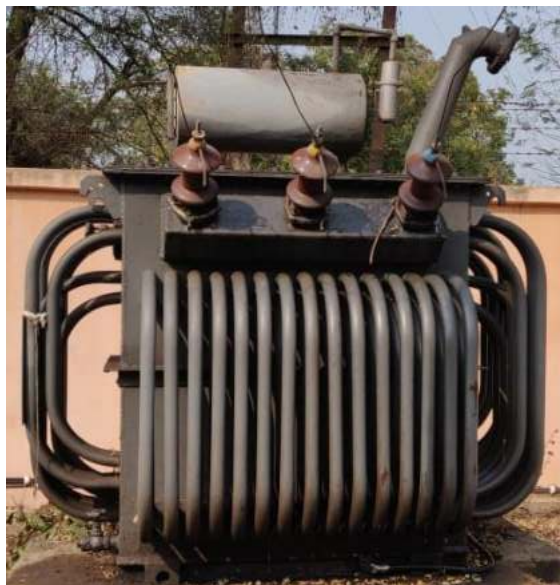
**Figure 70: 11 kV to 415 V Transformer**

Power comes onto the site via an 11kV substation inside the perimeter walls. The substation is outside of the scope of the survey, but looks in poor condition. It provides a 440 V 3-phase plus neutral supply via a single, overhead, 16 mm<sup>2</sup> (according to the OandM manual) cable which emerges at the downstream mitre gate power distribution house. 80 kA, 415 V, HRC in-line fuse links are in position. The power is distributed around the site via covered trenches and or overhead lines.

All electrical equipment inspected was barely serviceable and in a dangerous condition whereby three-phase electricity can be directly touched. There is an alternative power source in the form of a DG set (Figure 73) which is in good shape.

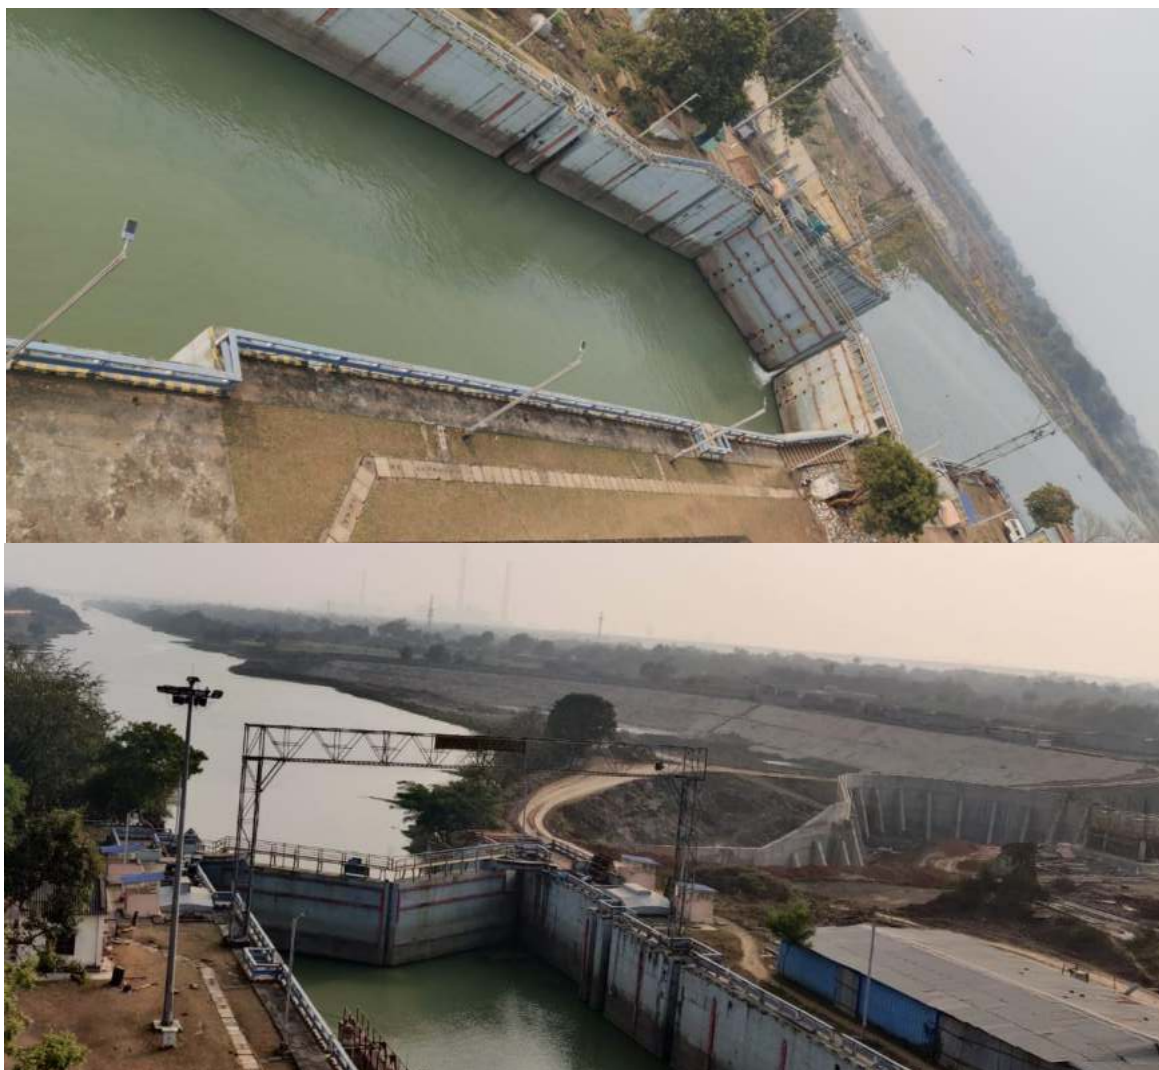
**Figure 74: Lighting system at the lock site**

There are a small number of low capacity street lamps along the lock chamber and two high mast lights (Figure 74). Night navigation is not operational at present.

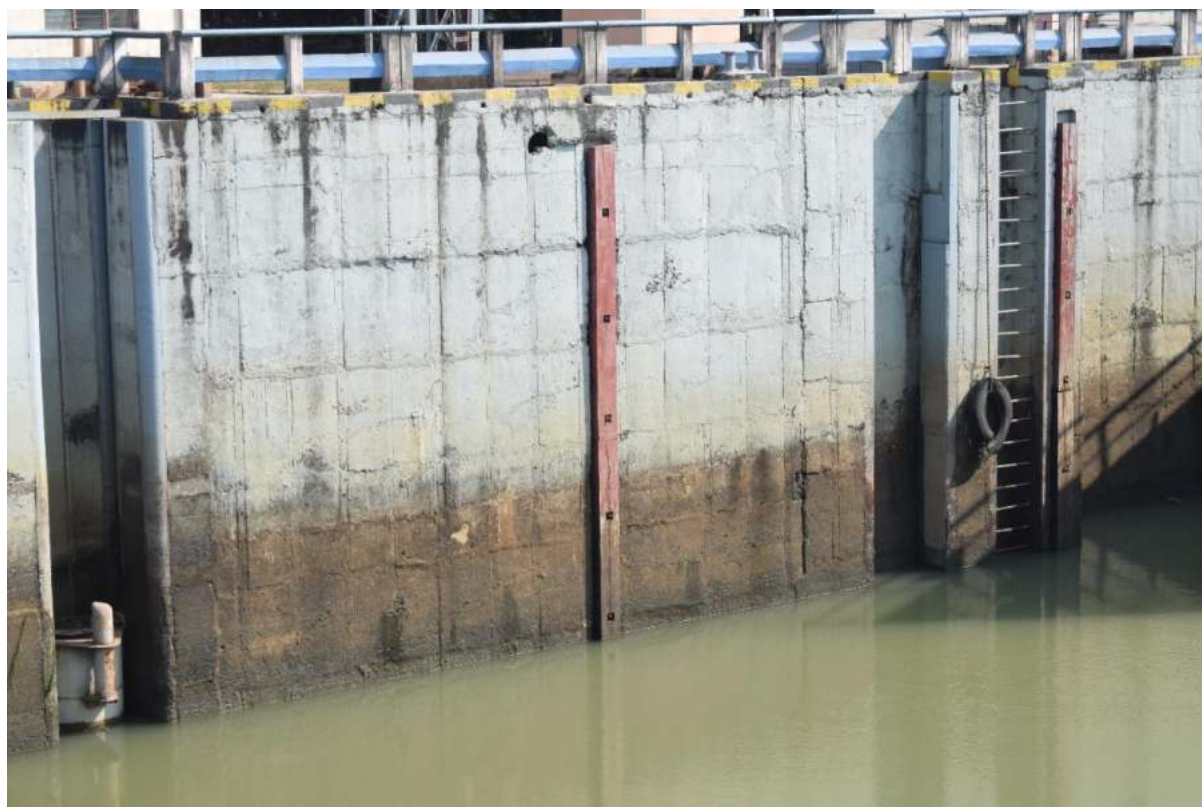
**Figure 75: Wooden and rubber tyre fender arrangement**

Provisions for fenders in the form of wooden logs and hanging tyres are provided in the lock chamber. There are 25 wooden fenders on each wall of dimension 6 in x 4 in and variable height. The wooden fenders are in poor condition with some fenders not in place while some are damaged. The rubber tyre fenders are also in dilapidated condition (Figure 75).
