**Subject:** Submission of Revised Inception Report of Consultancy Services for Preparation of Detailed Project Report (DPR) for the work of Renovation/Modernization of Existing Navigation Lock at Farakka.

## CONSULTANCY SERVICES FOR PREPARATION OF DETAILED PROJECT REPORT (DPR) FOR THE WORK OF RENOVATION/MODERNIZATION OF EXISTING NAVIGATION LOCK AT FARAKKA

## Inception Report

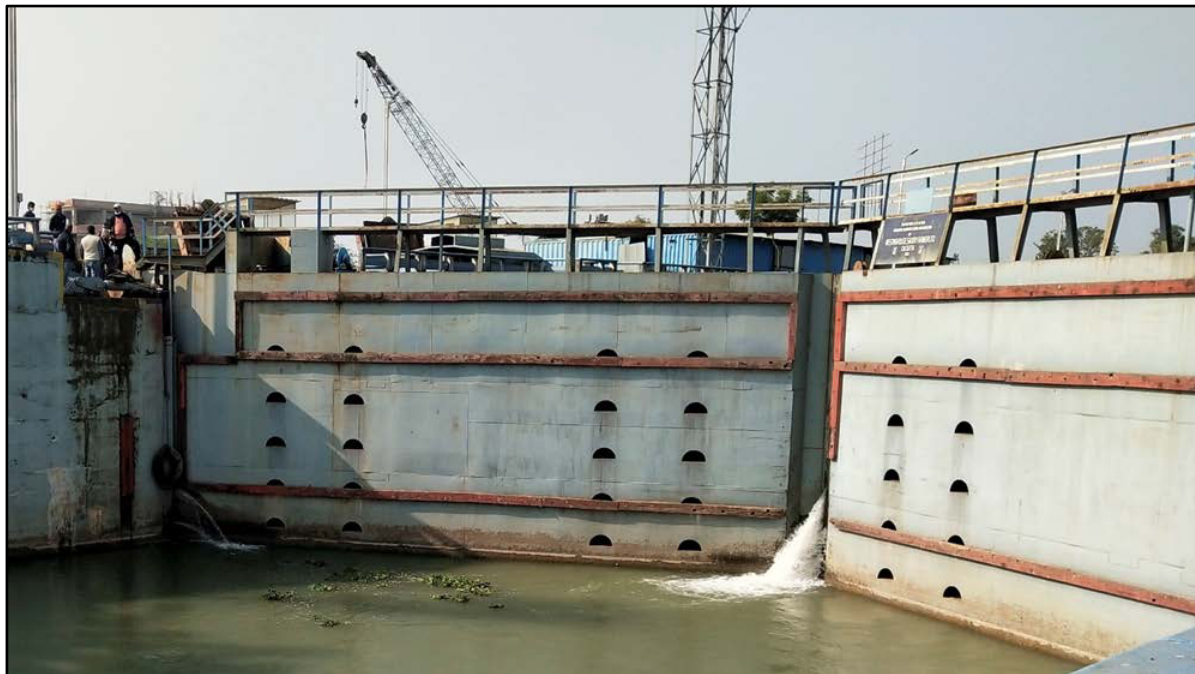
Figure 4.2 Mitre Gates of Farakka Lock

Two set of vertical Mitre gates with mechanical hinges driven by twin rope mechanism form the primary navigational gates for Farakka Lock (Figure 4.2). The dimensions of the gates as per the O&M manual are 15.354 m (B) X 11.880 (H) X 1.3 M (T) at U/S and 15.354 m (B) X 10.110 (H) X 1.3 M in D/S with weights of 90 T (U/S) and 85 T (D/S) (Figure 4.3). The material properties and design elements of the gate components are not known hence could not be ascertained at site.

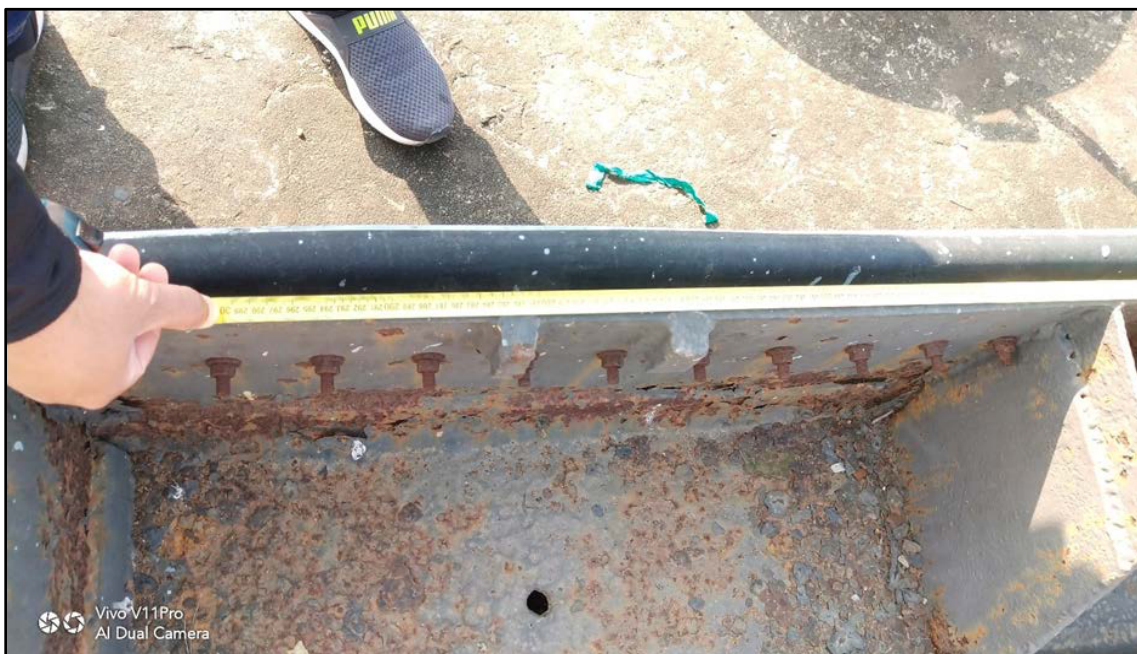
**Figure 4.12 Dimensioning of Bulkhead Gates of Farakka Lock**

All gates were observed and reported to be of different dimensions with not all of them being interchangeable (Figure 4.12). Most of the gates were in dogged position with each gate having different dogging arrangement.

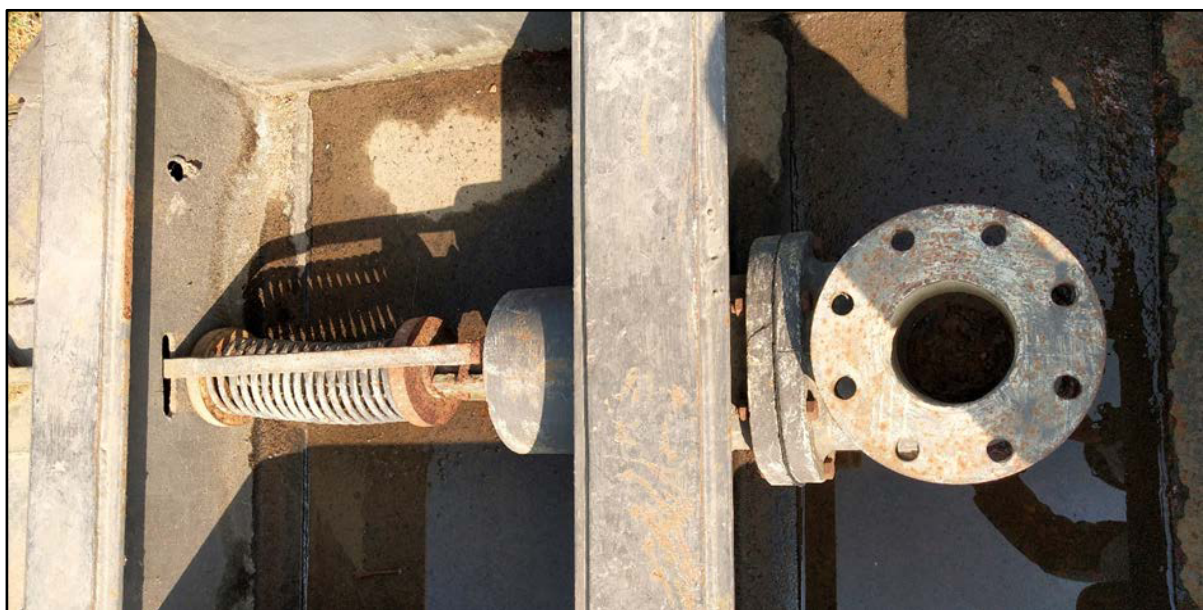
**Figure 4.34 Filling Valve of Bulkhead Gates of Farakka Lock**

The filling valve arrangement of gates was also in depilated state with corrosion on all sides (Figure 4.14). The Wheels are jammed and not rotating freely, greasing system was not functioning and with bearings needs to replaced. After going through various national and international codes of practices for bulkhead fixed wheel gates design, following are the suggested system updation:

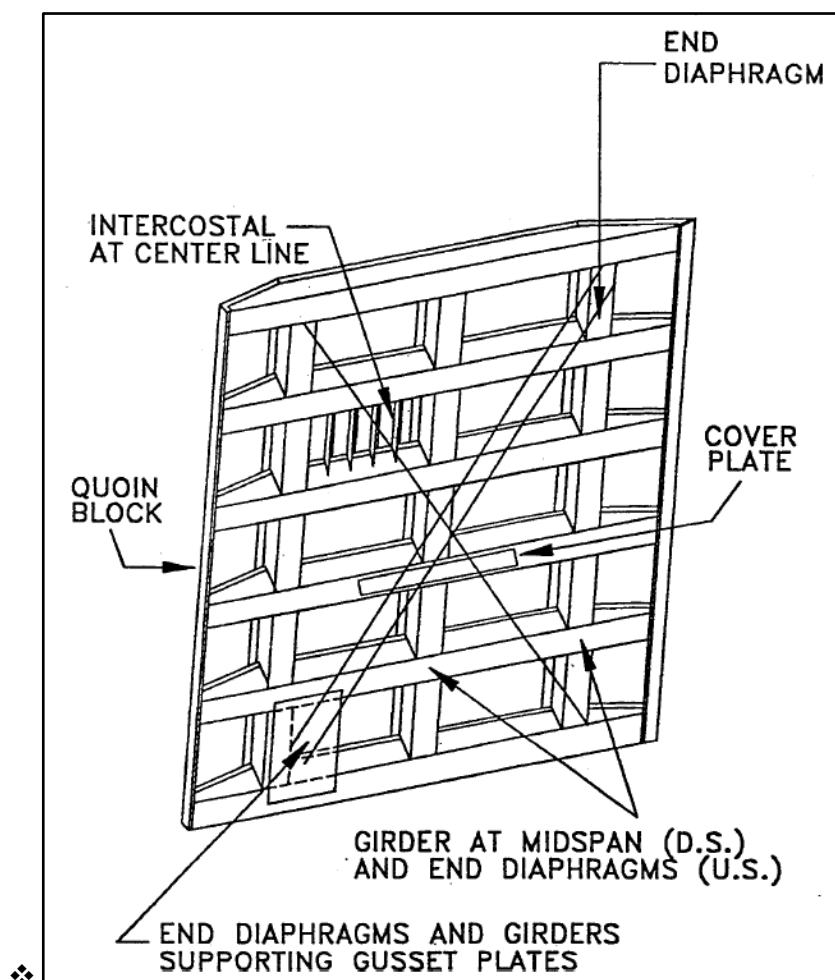
**Figure 6.7 Critical Areas of Mitre Gates**

- Horizontal girder-to-mitre and quoin post connections (thick plates, high constraint, high stress).
- The ends of diaphragm flanges were attached to downstream girder flanges (high stress, stress concentration).
- Connections at ends of diagonal members (high stress, fracture critical).

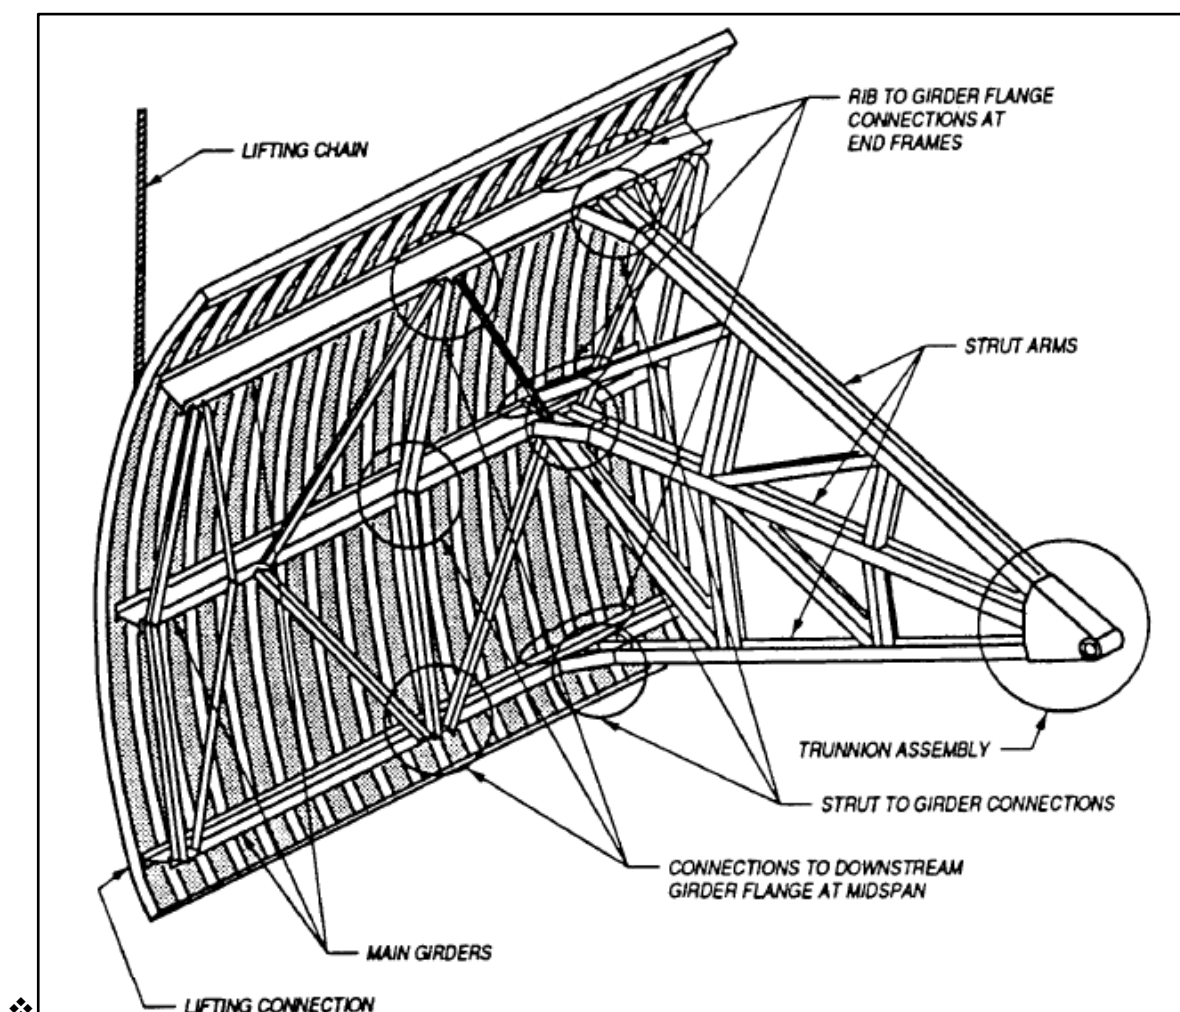
**Figure 6.8 Critical Areas of Radial Gates**

- Girder-rib-skin-plate connection on the upstream girder flange near the end frames and the bracing-to-downstream-girder-flange connection near mid span (critical tension stress/detail combinations).
- Connections of main framing members such as the girder-to-strut connection (fracture critical, high moments).
- Seal lip plate if it is fabricated from stainless steel or other dissimilar metal (galvanic and/or crevice corrosion).
